REPORT**Environmental Monitoring Completion Report**

Milne Port Freight Dock Construction Project, Baffin Island, Nunavut

1663724-180-R-Rev0-32000

4 March 2020

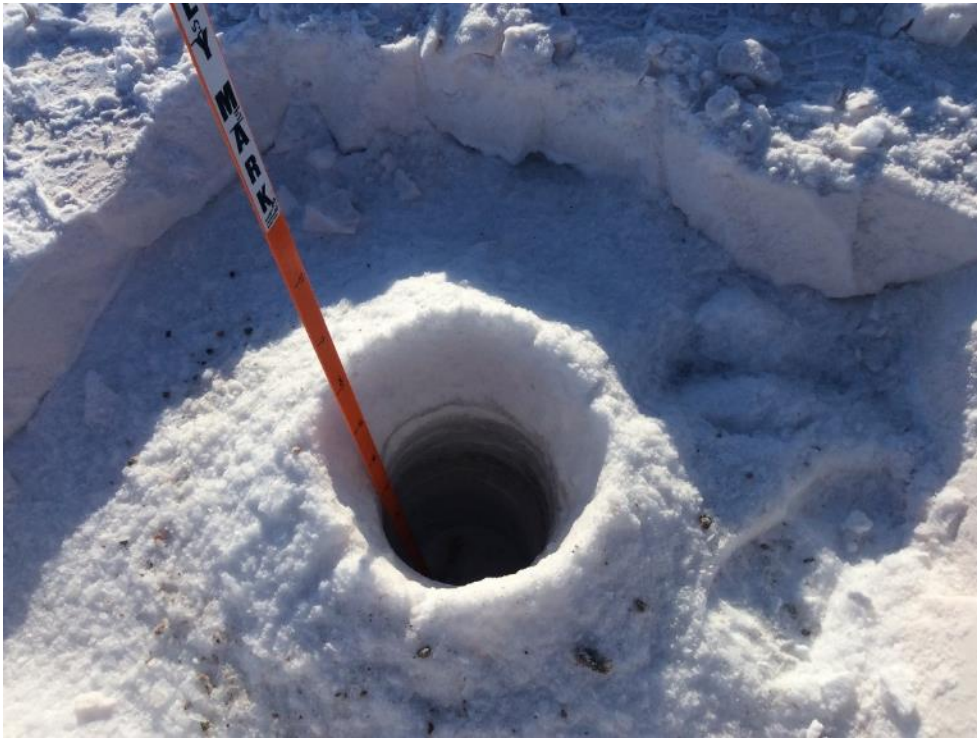
Photo 9 - Ice profiling hole showing 0.7 m of ice thickness. The minimum ice thickness required for the necessary equipment load is 0.55 m, 13 April 2019

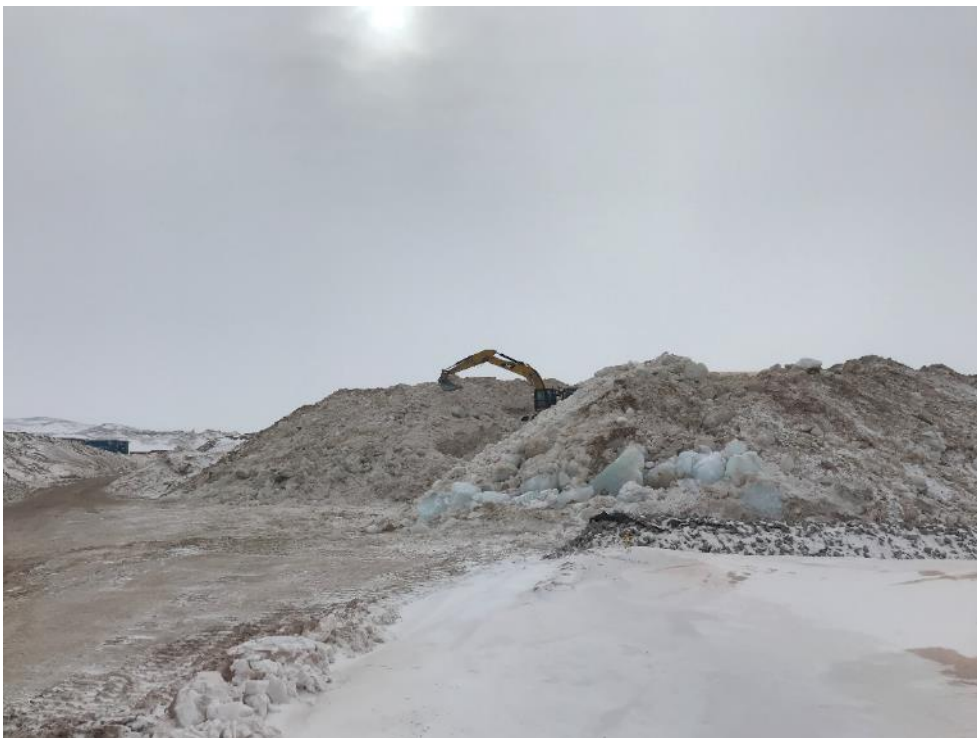
Photo 16 - Snow/sand stockpile extending beyond the containment berm, with excavator working to move material inside the bermed area (looking south), 28 April 2019

Multiple incidences of stockpiled material exceeding capacity of containment areas and disposed of material spilling over onto containment berms.	Clean up and dispose of material in containment areas. Increase the capacity of containment areas or create additional containment area for stockpiled material.	Inadequately sized containment areas and berms were replaced and spilled stockpiled material was cleaned up.
Following dredging activities, the high tide was overtopping the edge of the Freight Dock and resuspending spilled sediments from dredging within the water column (18 May 2019).	Build the perimeter rock crest higher to delineate Freight Dock pad from the ocean. Perimeter crest will aid in filtering receding tidal waters.	Communicated with Nuna night shift foreman, and he directed excavator to build the perimeter crest higher. EM site inspection after construction of perimeter rock crest indicated constructed crest was aiding in filtering receding turbid tide water.

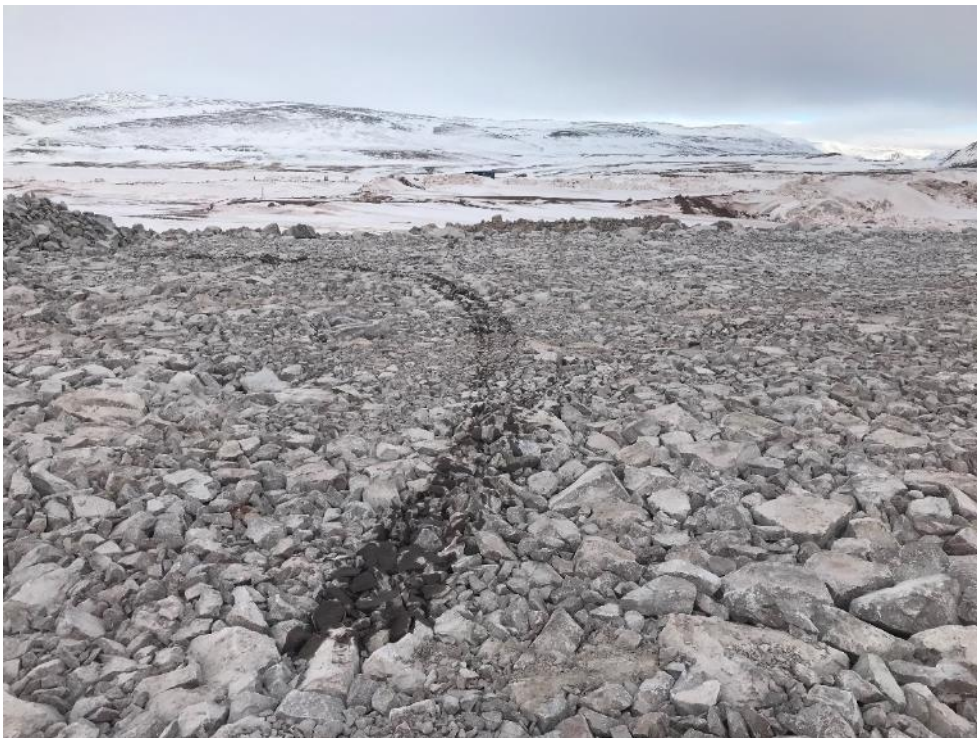
Approximately 10 L of hydraulic fluid from a hydraulic line failure was spilled along the Freight Dock and causeway from an articulated truck while in motion (3 May 2019).	Affected soil/rock should be removed and disposed of in a designated area.	The affected material was cleaned up and disposed of appropriately. An incident report was generated by the contractor, reviewed by Golder and submitted to Baffinland Site Environment.
1 to 5 L of transmission fluid was released from a 45-ton haul truck along the B1 pad and Freight Dock causeway (26 May 2019).	Contain the release of transmission fluid and segregate affected soils and rock to be removed and disposed of in a designated area.	The leak was contained by a spill tray when the vehicle was parked, and the affected rock and soils were removed by excavation and stored at the W10 laydown. On 27 May, the affected rocks were relocated and disposed of according to Baffinland procedures. The spill was cleaned up and an incident report was generated by the contractor, reviewed by Golder and submitted to Baffinland Site Environment.

Photo 18 - Spill of hydraulic fluids on the Freight Dock, approximately 120 m from the causeway entrance (looking south), 3 May 2019

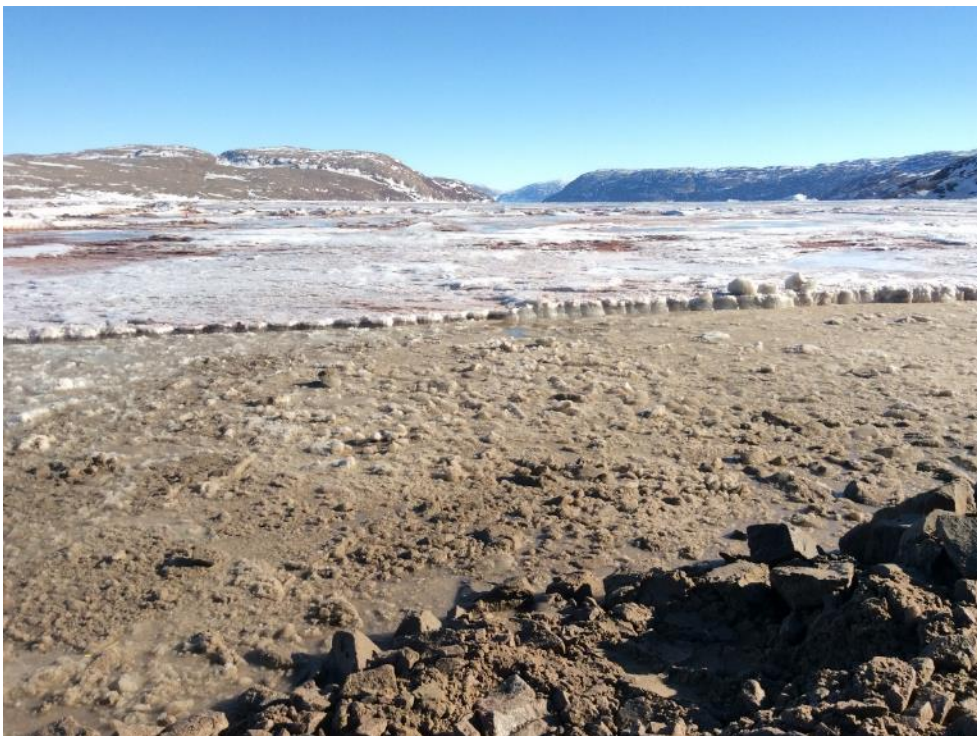
Photo 26 - Turbidity being contained within ice and slush on the water surface during dredging activities with an excavator, 16 May 2019

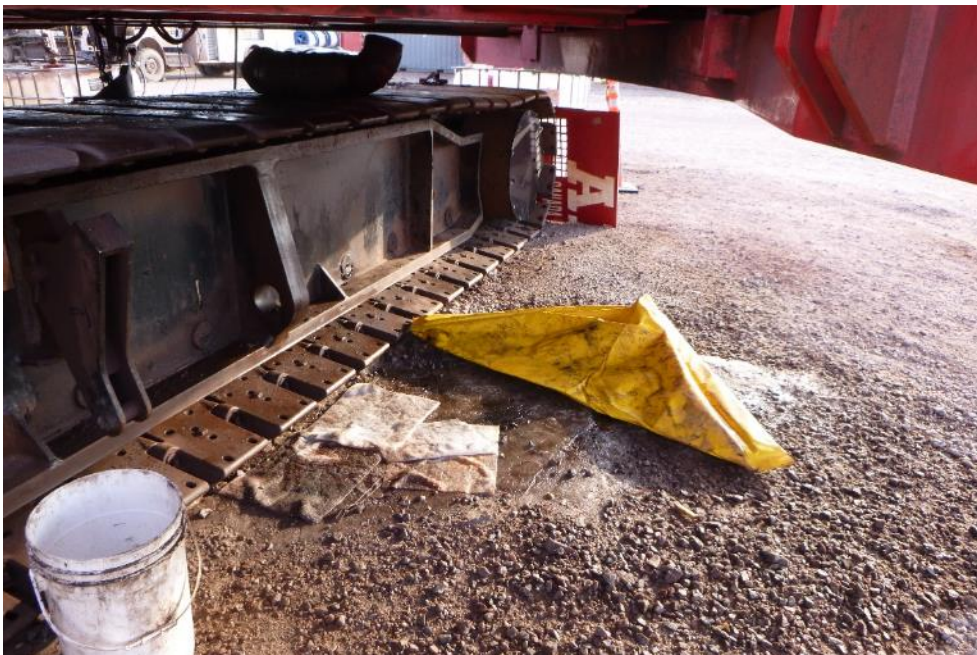
Photo 28 - Previously reported spill left without proper cleanup. Spill tray added to contain further drips was improperly anchored against wind, 22 May 2019

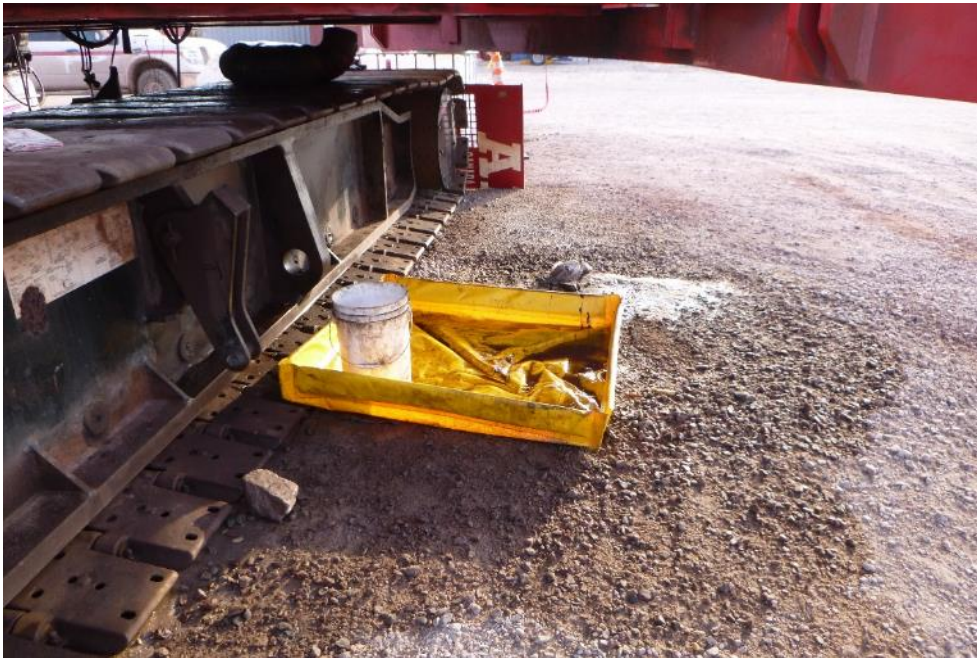
Photo 29 - Previously noted spill tray following clean up and maintenance efforts, 22 May 2019

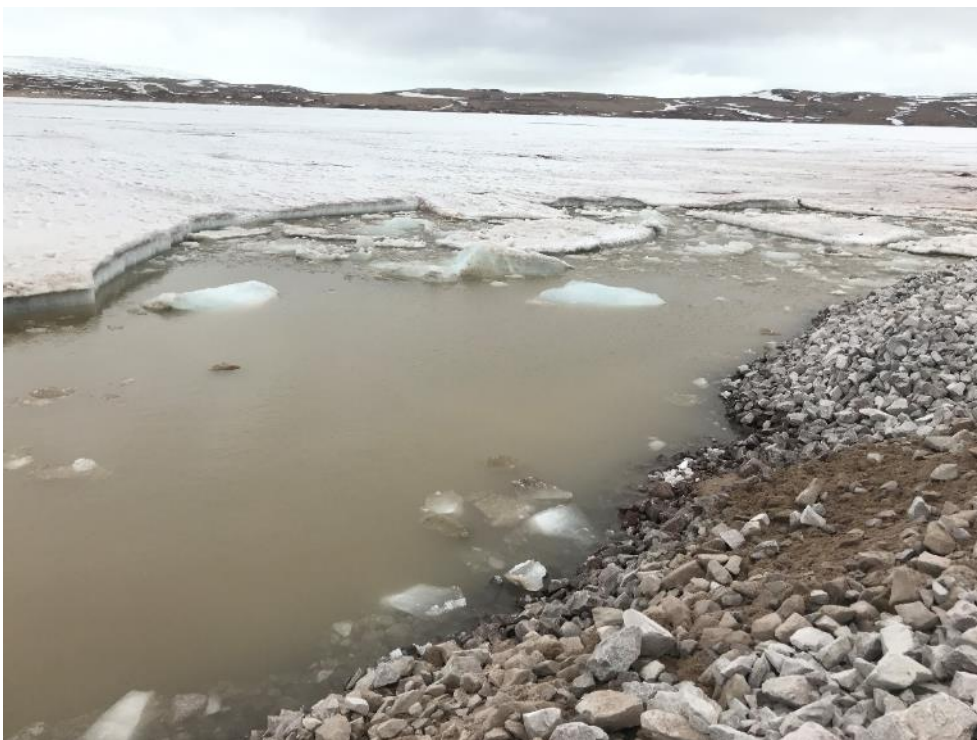
Photo 30 - Turbid water in the work area (looking east), 27 May 2019

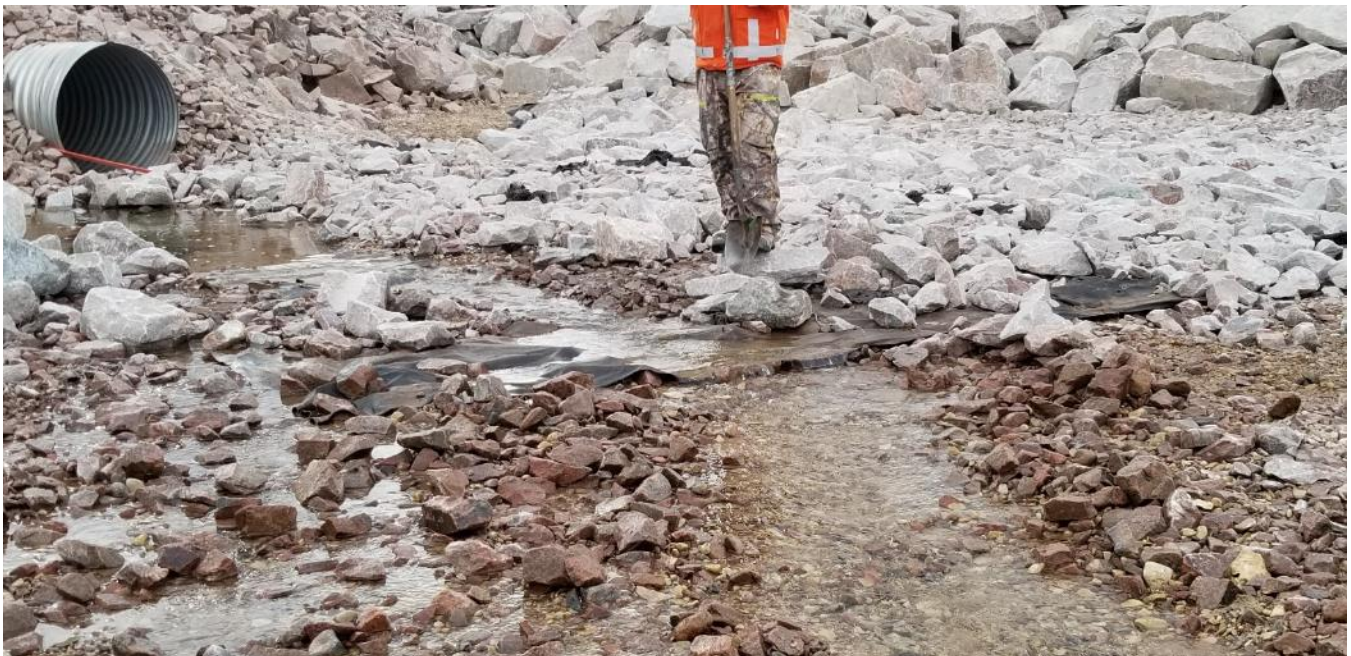
Photo 44 - Restored flow in stream M11-1 following removal of rocks that were blocking fish passage, 24 June 2019

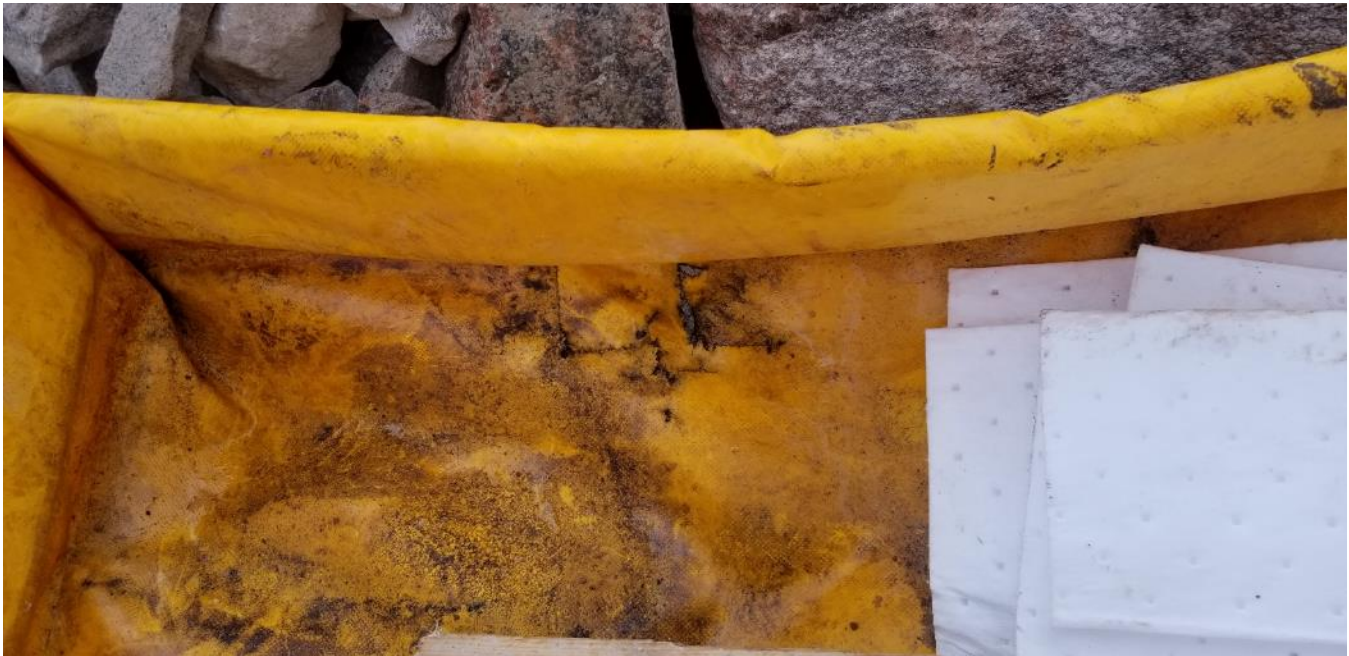
Photo 45 - Tear observed in spill tray located under equipment on the Freight Dock during fueling. A new spill tray was sourced for future fueling, 24 June 2019

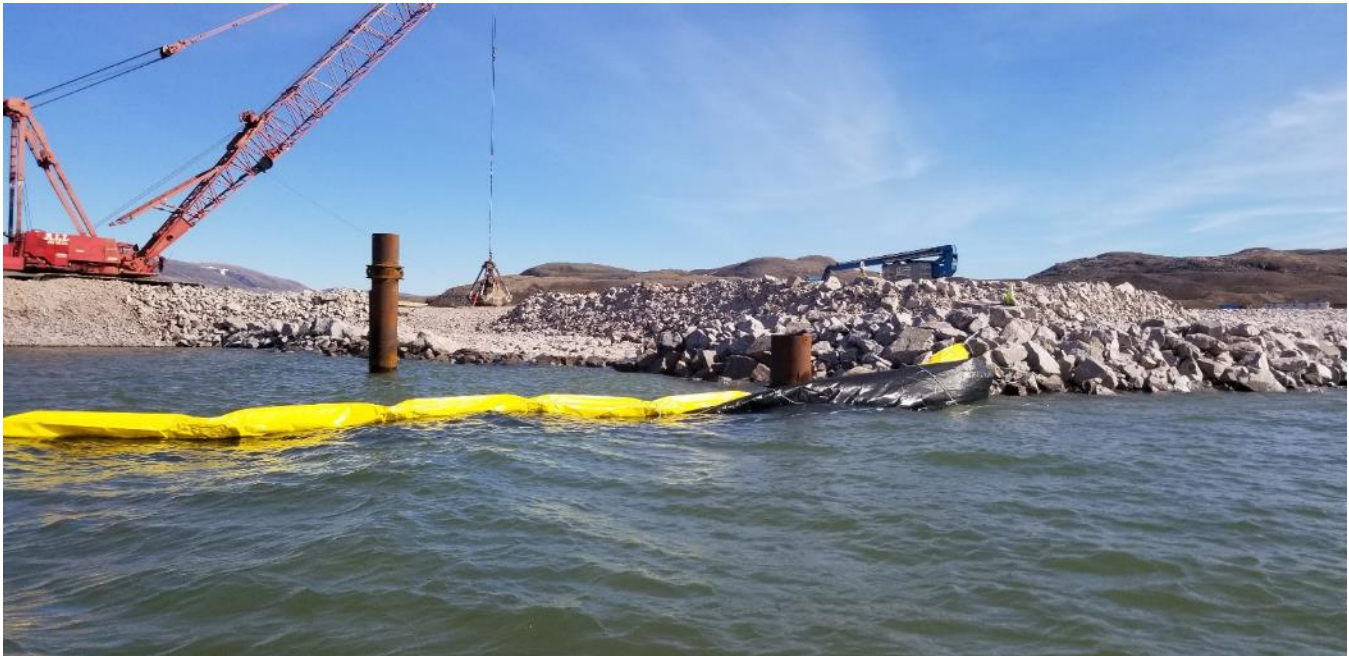
Issues noted following the deployment of the silt curtain during open water construction included: billowing panels lifting with waves and tides releasing turbid water, panels being snagged by pilings in the water leading to tears in the fabric, ice pushing against and disrupting the silt curtain, heavy waves and or wind causing panels or anchors to detach, heavy waves and or wind tearing apart sections and removing floats from the silt curtain, rising and falling tides leading to turbidity plumes releasing from the work area due to the curtain being too taut or too loose, sections of the silt curtain submerging and leaving gaps where sediment laden water would release.	Recommend daily inspections of the silt curtain to determine if it is functioning adequately prior to in-water works (i.e., dredging activities).	Silt curtain was inspected and maintained on a regular basis. During periods of heavy waves and wind, the silt curtain was adjusted, when safe to do so, to confirm panels were properly deployed and submerged. The silt curtain was also adjusted accordingly to account for the rising and falling tides.

Photo 47 - Falling tide and currents lifting panel on silt curtain off of the west bund on the Freight Dock, 28 June 2019

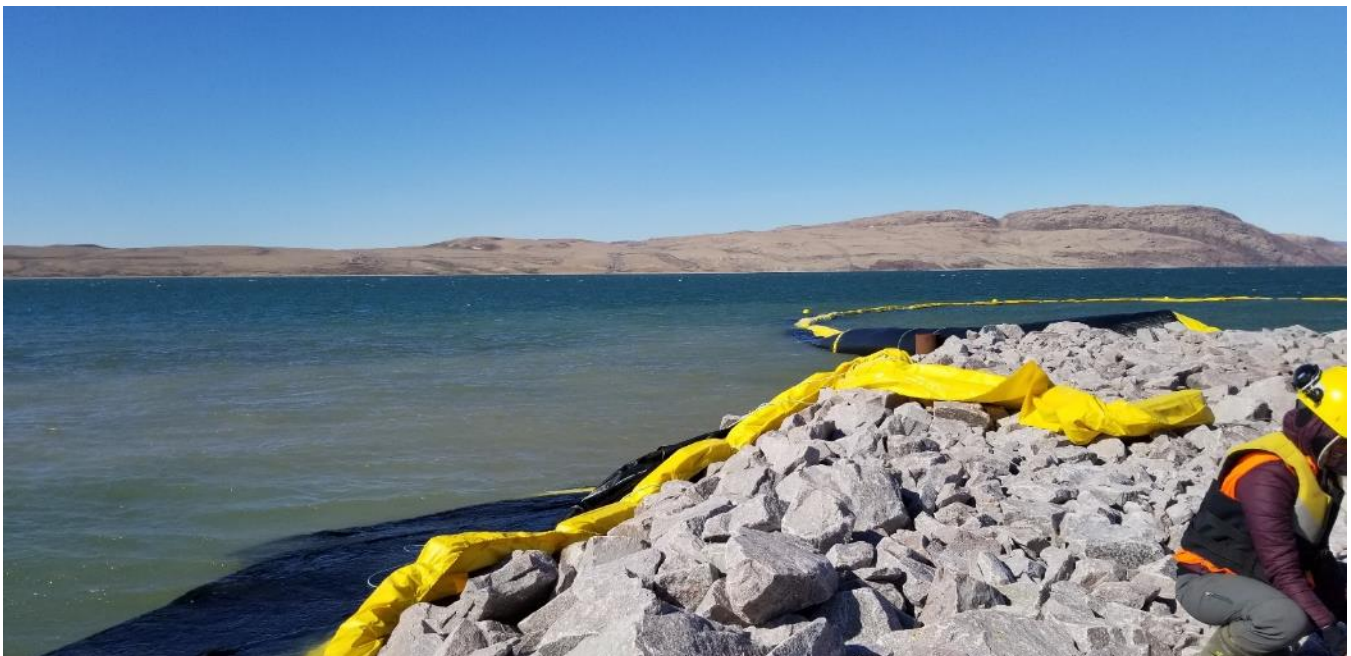
Photo 50 - Billowing panels on the silt curtain releasing plumes of turbid water from the work area, 30 June 2019

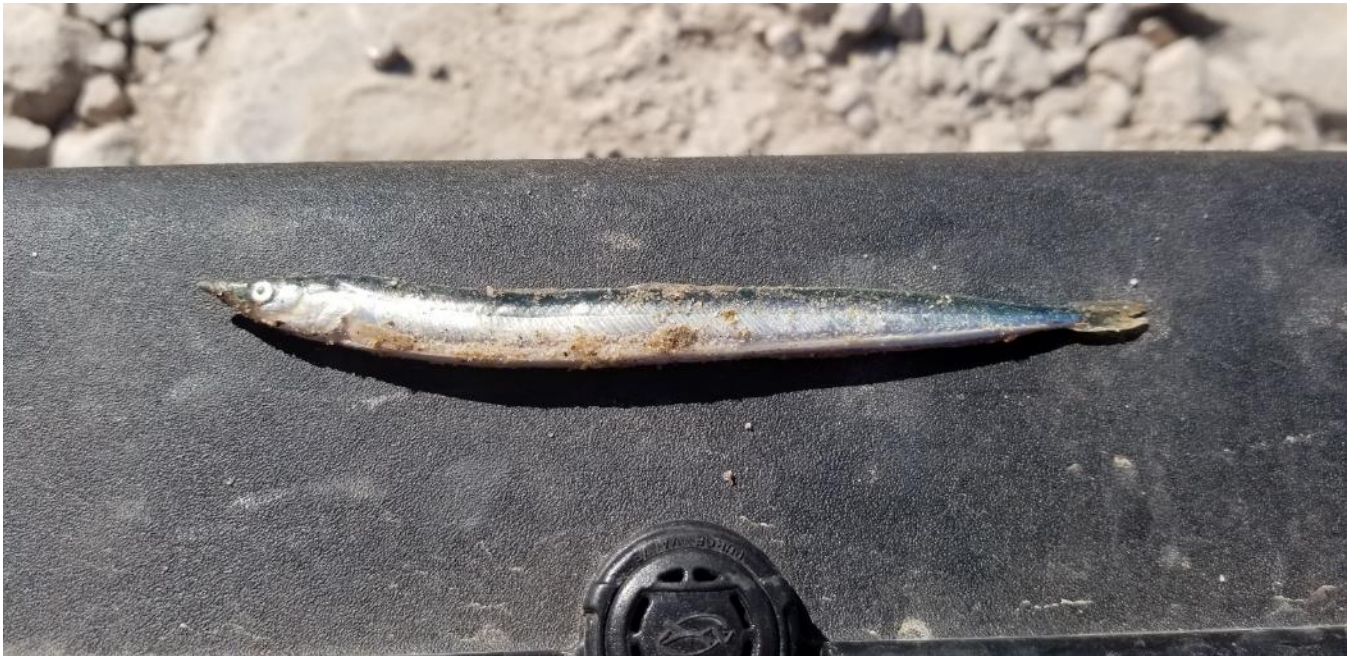
Photo 51 - Dead sand lance found in dredge material spilled on Freight Dock, 30 June 2019

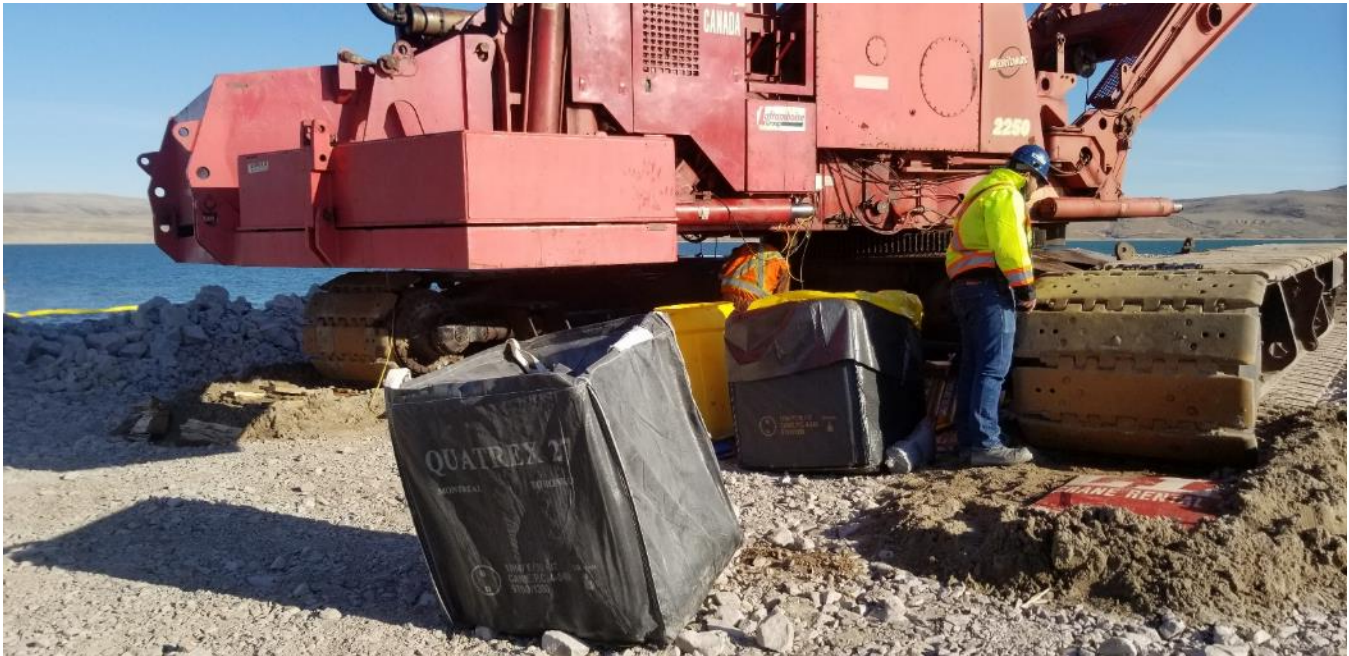
Photo 55 - Clean up and crane maintenance following spill on the Freight Dock during dredging, 3 July 2019

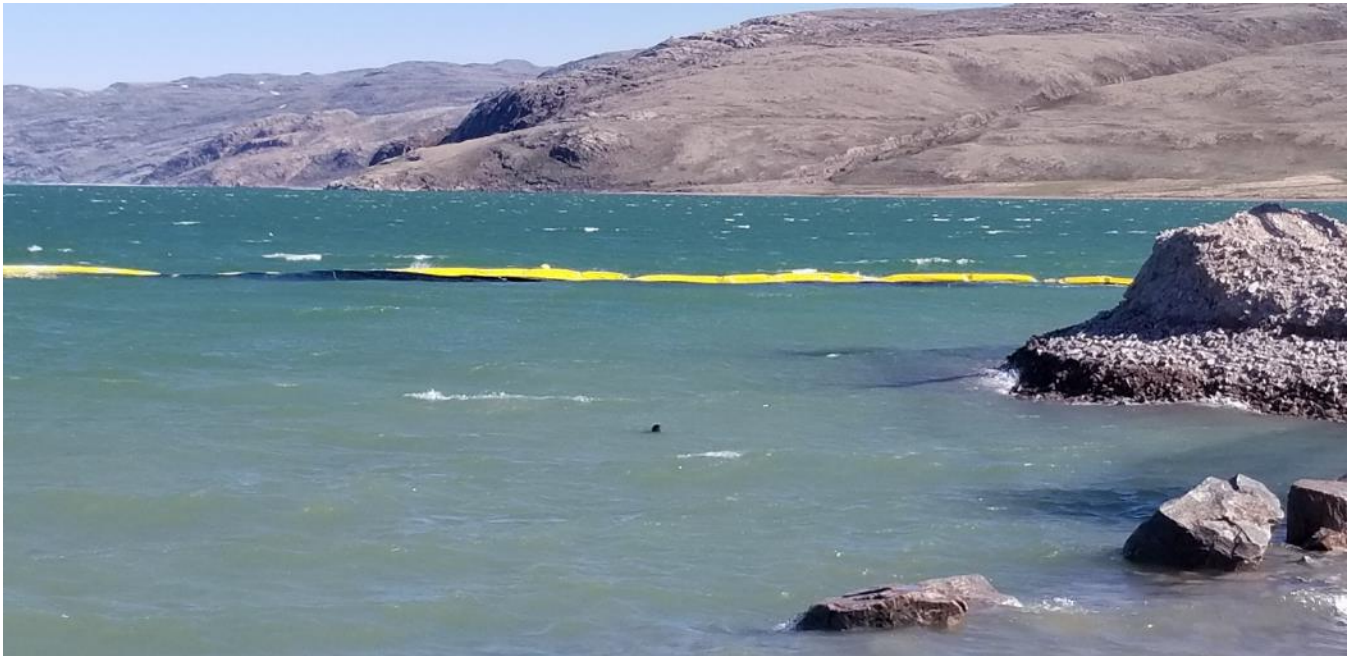
Date	Species	Observations and Response
3 July 2019	Ringed seal	Swimming inside and outside of the silt curtain, diving within the dredge area and along the silt curtain edge during a break in dredging activities, In-water works resumed 30 minutes following the last observation of the seal within the exclusion zone.
14 July 2019	Ringed seal	Two seals were observed outside of the exclusion zone, one seal entered the 200 m boundary and the work area. The placement of scour material was halted following the seal entering the exclusion zone. Work resumed 30 minutes following the last observation.
17 July 2019	Ringed seal	Observed within the 200 m exclusion zone, diving and surfacing inside and around the silt curtain. No in-water works was occurring at the time and work did not resume that day.
20 July 2019	Ringed seal	Observed diving and surfacing within the work area. No in-water works was occurring at the time of observation, and in-water works did not commence until two hours following the observation.

Photo 57 - Ringed seal observed in the dredge area during a break in in-water activity, 3 July 2019
