BAFFINLAND IRON MINES CORPORATION
MARY RIVER PROJECT**Freshet 2020 Monitoring Report****Rev 0**

This report was prepared by Baffinland Iron Mines Corporation (Baffinland) to present the results of the 2020 freshet water quality monitoring program and to document the corrective actions taken in response to observed sediment releases that occurred during freshet 2020 at the Mary River Project (the Project). Surface water runoff during freshet causes ongoing challenges for the Project that Baffinland is committed to facing by implementing effective mitigation measures to minimize effects on water quality.

Two unauthorized releases of sediment occurred during freshet 2020 on May 16, 2020 and June 14, 2020 that were reported to Environment and Climate Change Canada (ECCC), Crown-Indigenous Relations and Northern Affairs Canada (CIRNAC), Qikiqtani Inuit Association (QIA), the Nunavut Water Board (NWB), and the Nunavut 24-hour spill report line (NT-NU 24-Hour Spill Report Line). The sediment release on May 16, 2020 was recorded as NT-NU Spill Report No. 20-141 and the release on June 14, 2020 was recorded as NT-NU Spill Report No. 20-179. Immediate and follow up corrective actions and m

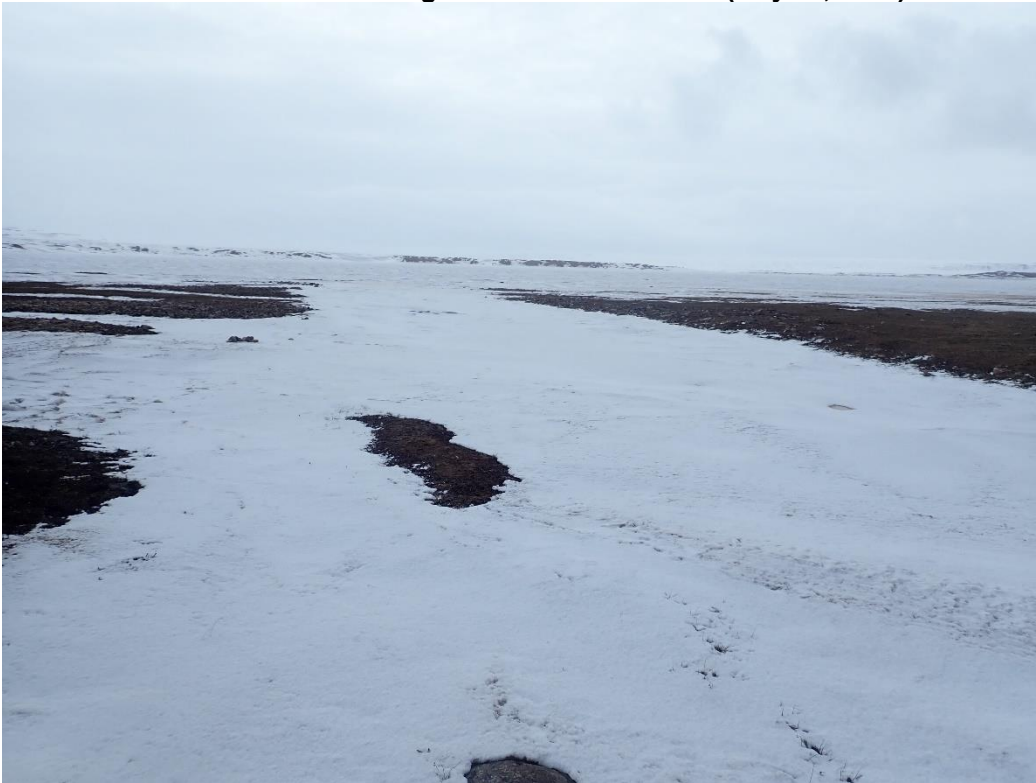
Photo 2. CLT Outfall on May 14, 2020

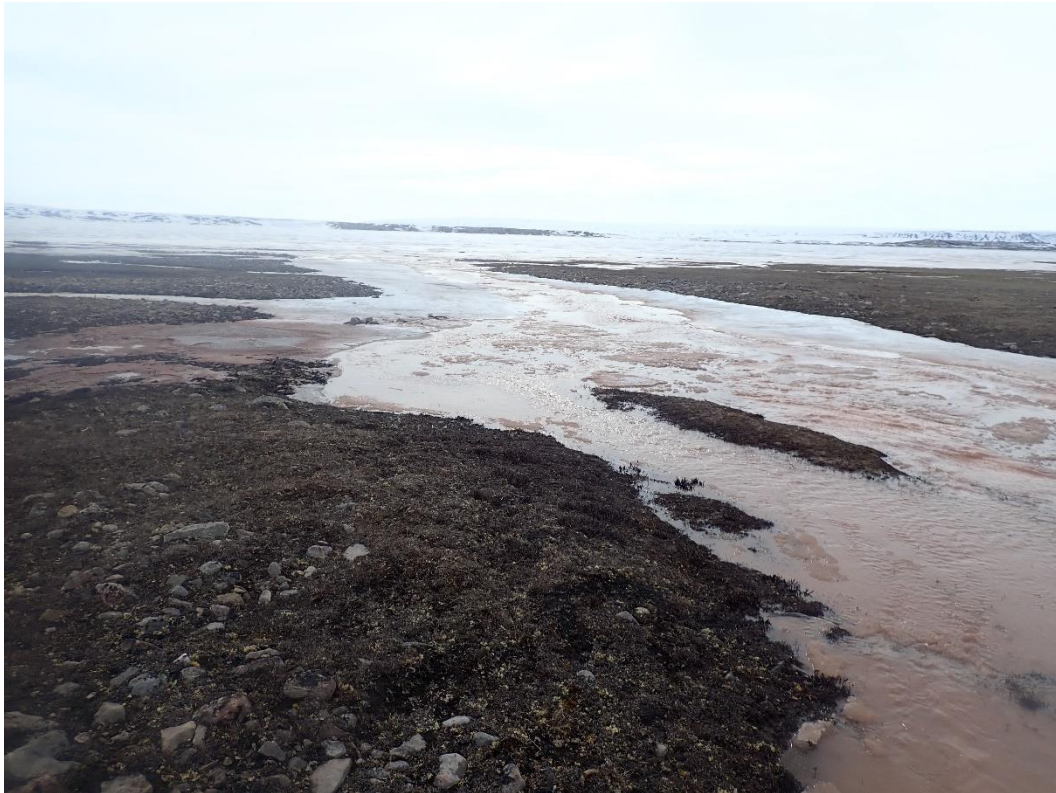
Photo 3. CLT Outfall on May 16, 2020

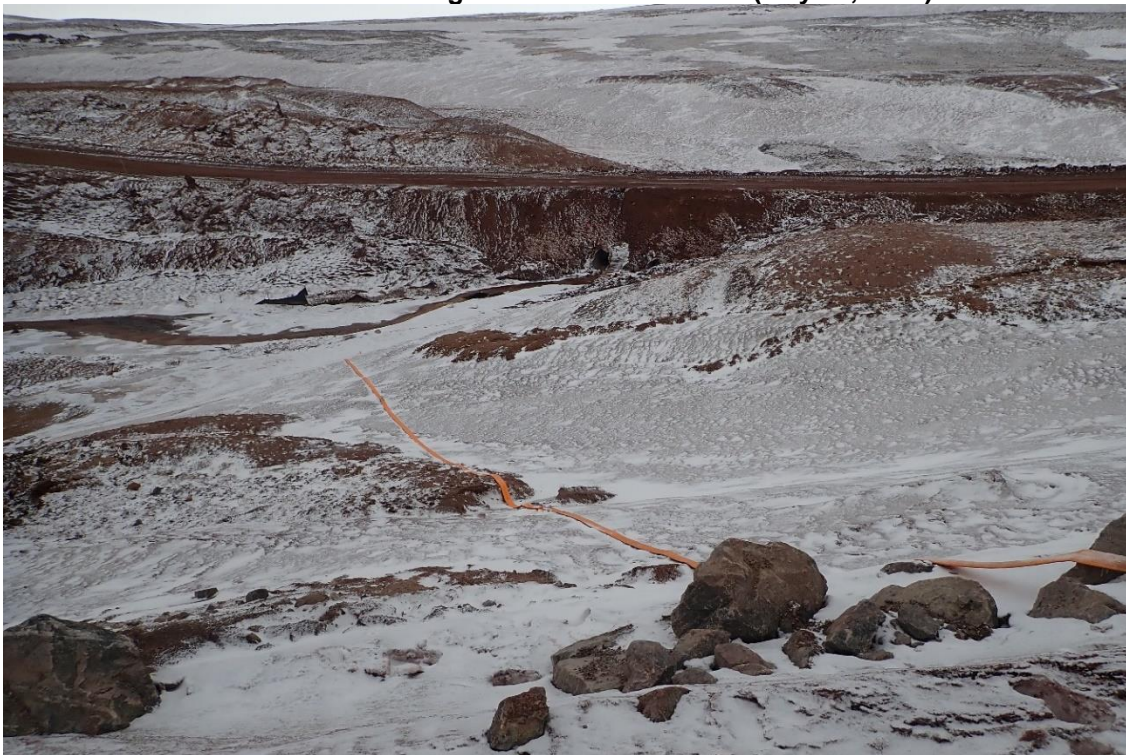
Photo 6. Pumping Diversion from Unstable Sandy Slope at the Outlet of BG-01 (May 18, 2020)

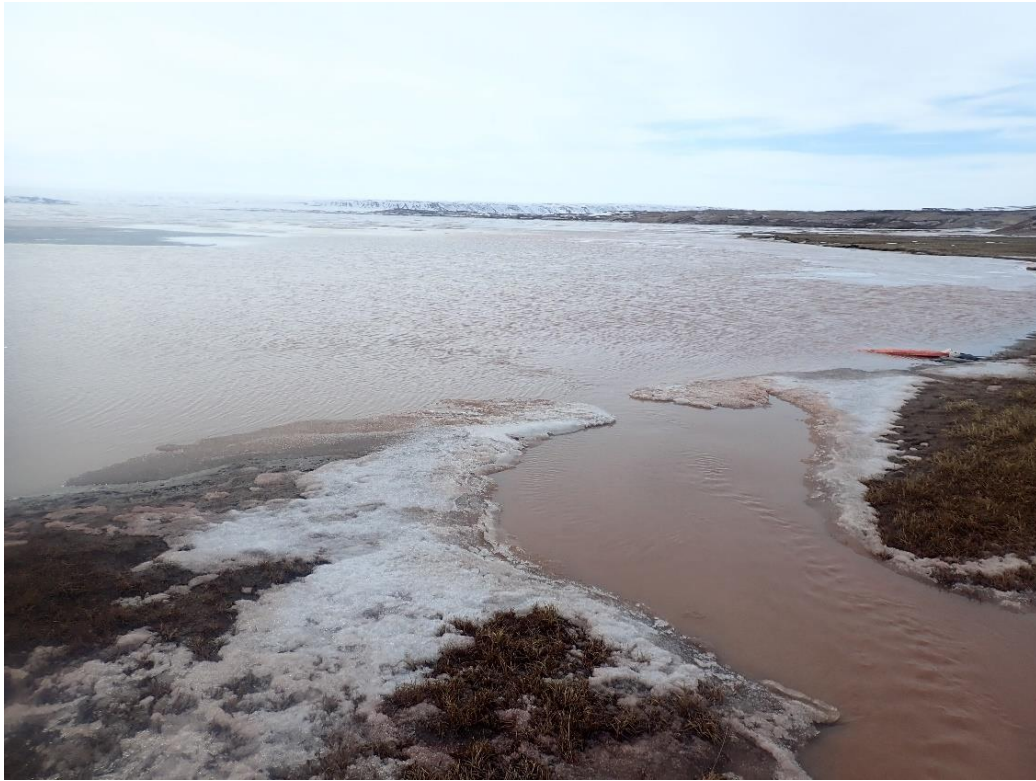
Photo 3: CLSP Outfall on May 16, 2020

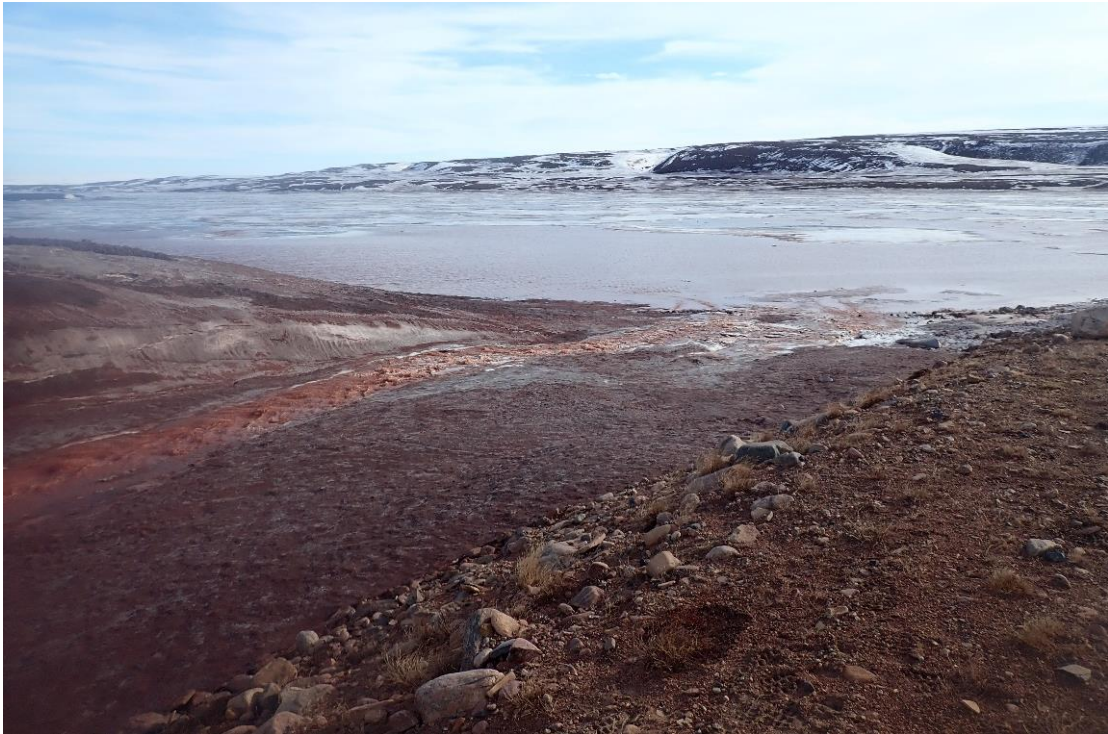
Photo 3. SDLT Outfall on May 16, 2020

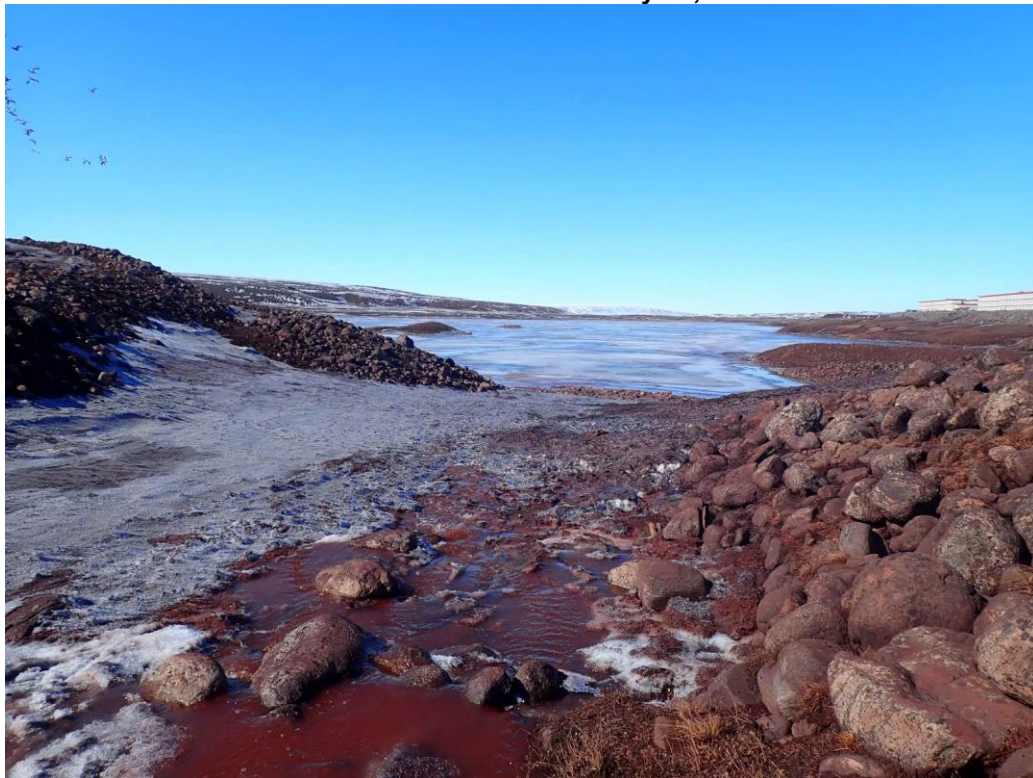
Photo 2: LDGF Outfall on May 17, 2020

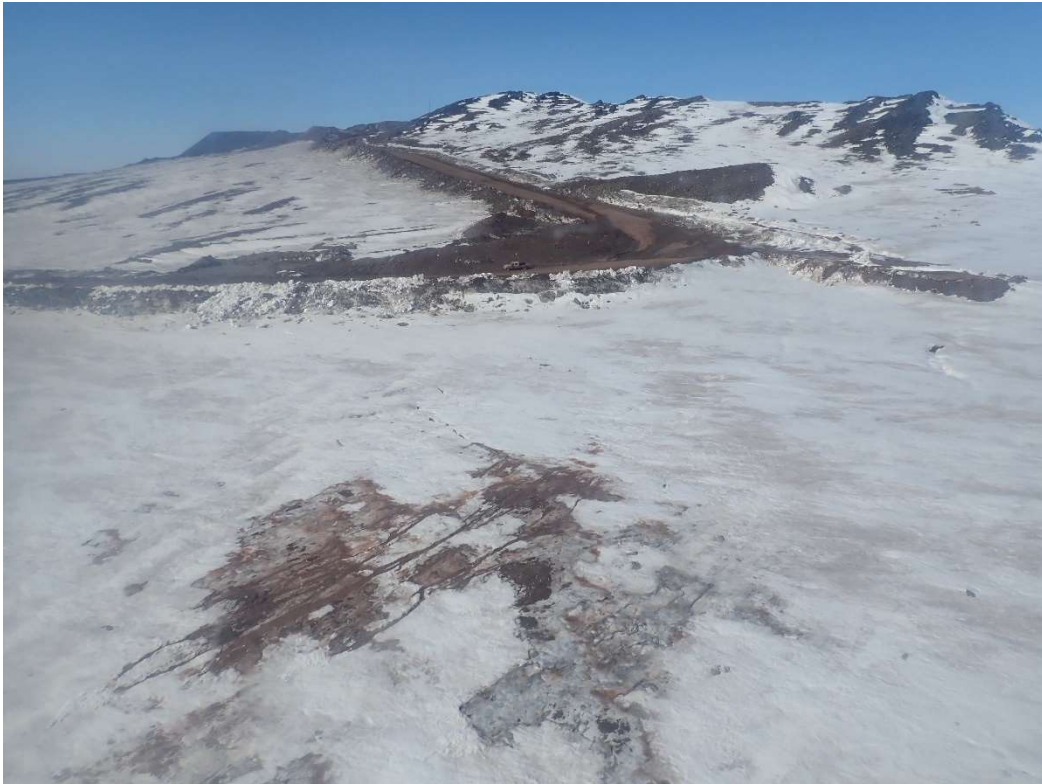
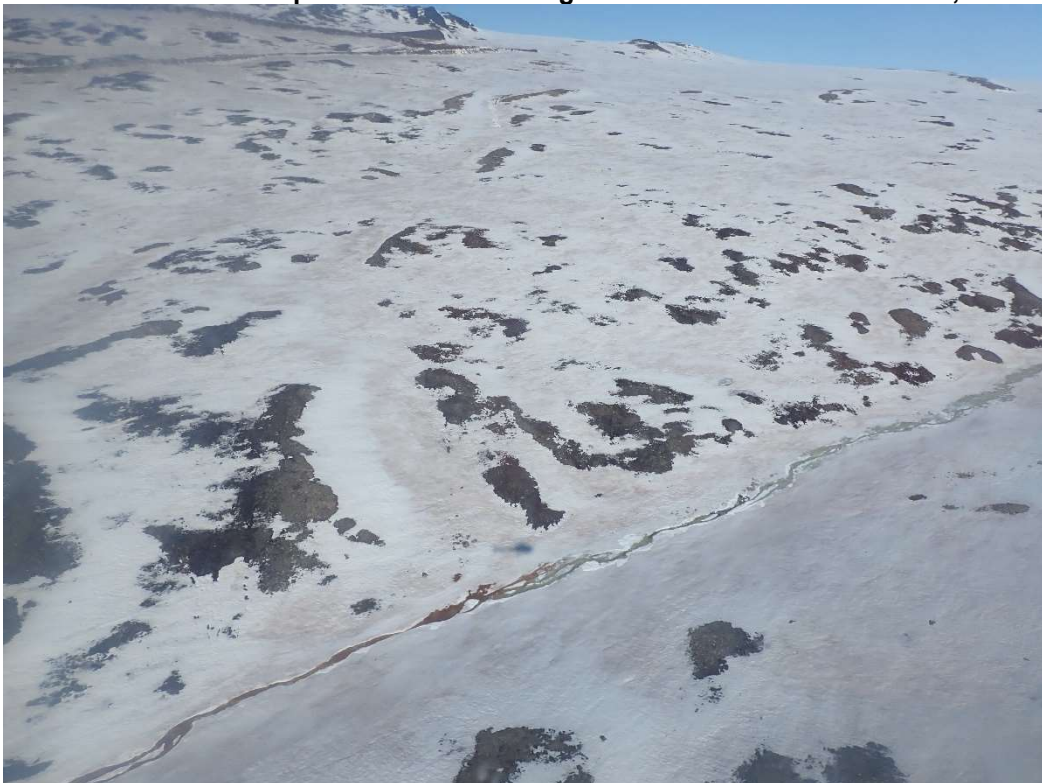
On June 14th 2020, temperature fluctuations experienced on Deposit 1 caused rapid snow melt/runoff from the Mine Haul Road ditches at km 108.5, 107 and 106.5 to flow onto the tundra. Water flowing through the road's ditching and culvert system resulting in sediment-impacted water traveling across the mountain tundra, entering the Mary River Tributary and Mary River.

Photo 2. Sediment impacted water traveling across the tundra on June 15, 2020

Photo 3. Sediment impacted water traveling across the tundra on June 15, 2020

Upon discovery of the elevated TSS conditions, as outlined in the Surface Water Aquatic Effects Management Plan, sedimentation mitigation measures were implemented. Project personnel worked to install sedimentation mitigation measures, including ditch maintenance to ensure all runoff reported to the ditches and reduced interaction with impacted road surfaces. Check dams were maintained and silt fences added in an attempt to settle sediments before reaching the receiving environment.

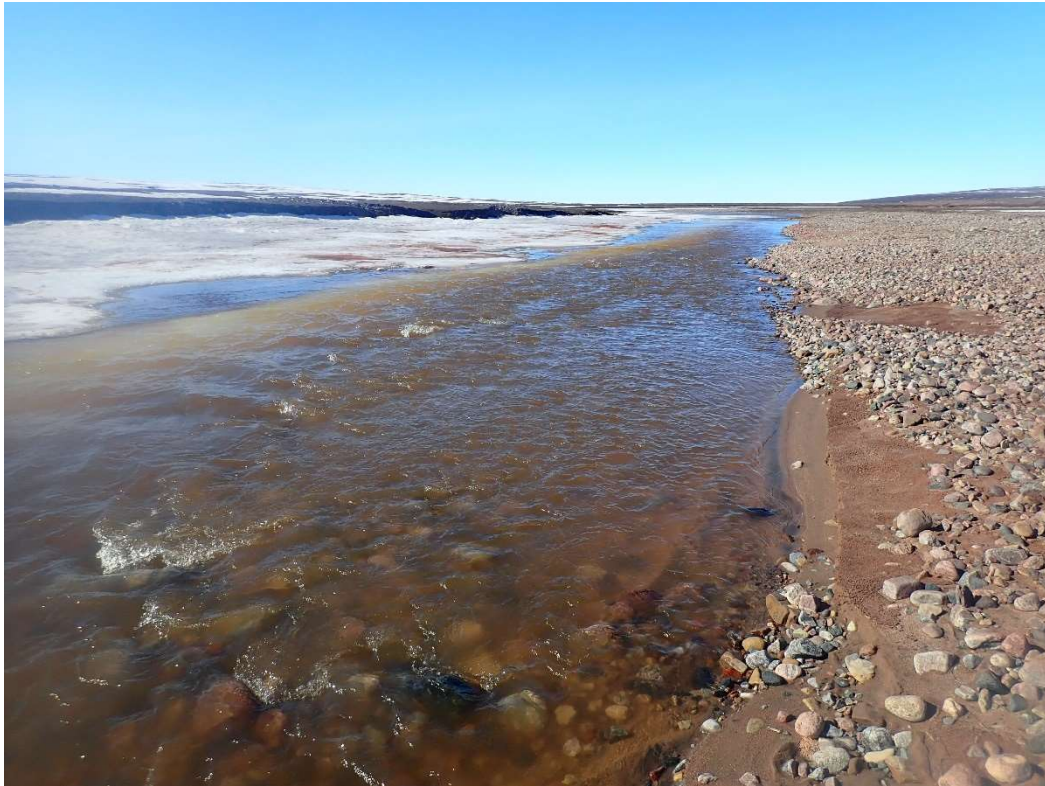
Photo 4. Sediment-impacted water quality at E0-20 on Mary River on June 15, 2020

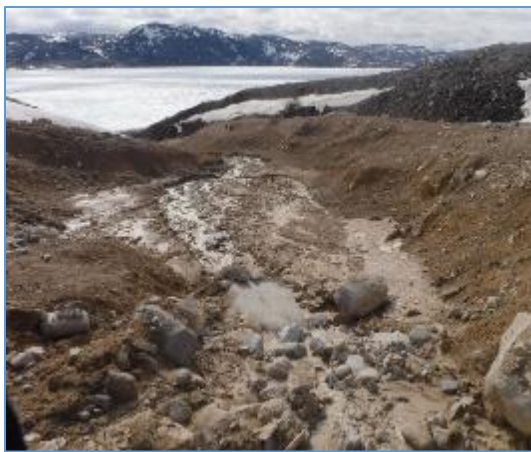
Description: Substrate in the natural sedimentation event area is an unconsolidated glacial till that is poorly sorted and has a high content of clay and silt (Fig. 1). There are seasonal streams and permanent ponded areas in the area where the natural sedimentation event occurred (Fig. 2). Water quality samples collected upstream and downstream of the confluence of the affected area on June 17, 2020 indicated that downstream total suspended solids (TSS) increased to 209 mg/L from the upstream TSS of 7.9 mg/L due to the event. The affected area is a seasonal drainage (Fig. 3) that is affected by natural sedimentation events each year during freshet and will be monitored again in 2021.

Figure 1. Substrate of affected area.

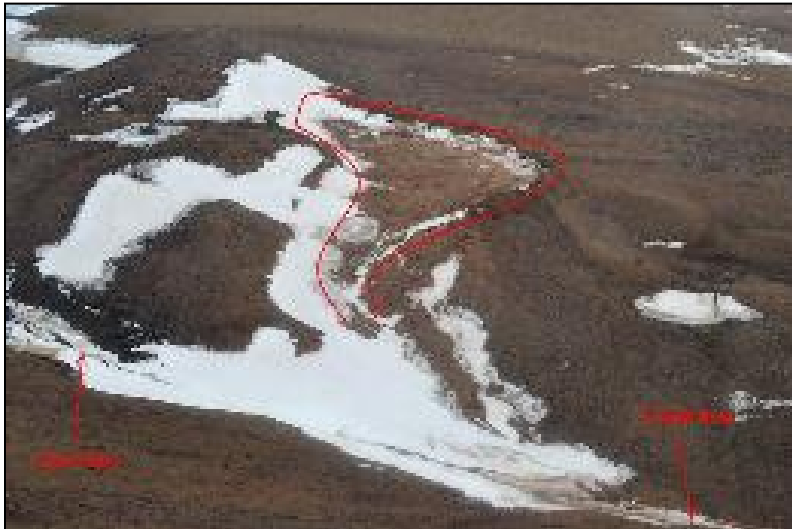
Description: The source of the natural sedimentation event identified as MIL-NATSED-2 was determined to be a sloughed hillslope of what appeared to be glacial till that was partially covered with snow (Fig. 1). The sloughed hillslope was causing sediment loading into the braided stream resulting in elevated turbidity in the downstream water bodies. Water quality samples collected upstream and downstream of the affected area on June 17, 2020 indicated that downstream total suspended solids (TSS) increased to 346 mg/L from the upstream TSS of <2.0 mg/L due to the event. The affected area is a seasonal drainage that is affected by natural sedimentation events each year during freshet and will be monitored again in 2021.

Figure 1. Overview of affected area.

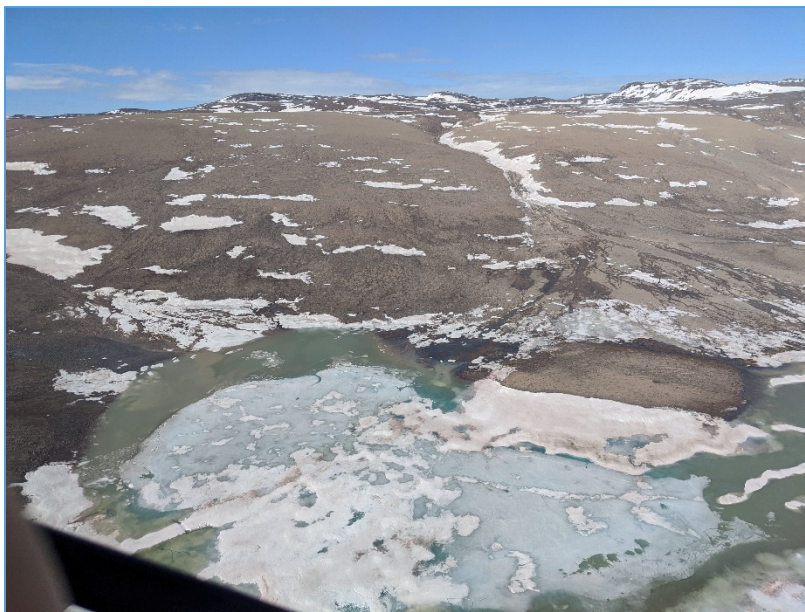
Description: Substrate in the natural sedimentation event area is an unconsolidated glacial till that is poorly sorted and has a high content of gravel, clay and silt. A seasonal stream drains through the affected area during freshet and carries sediment into the downstream water body. Water quality samples collected upstream and downstream of the affected area on June 17, 2020 indicated that downstream total suspended solids (TSS) increased to 168 mg/L from the upstream TSS of 7.1 mg/L due to the event.

Figure 1. Overview of the natural sedimentation event area.

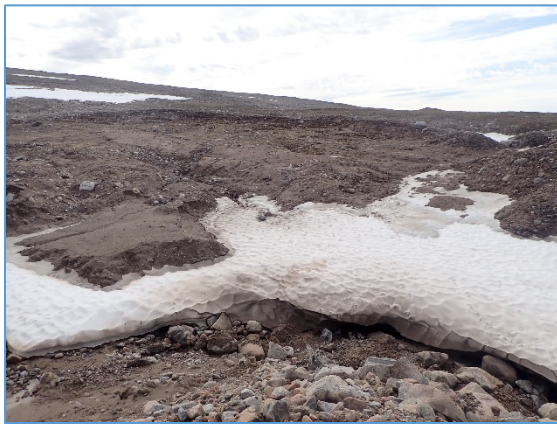
Description: Substrate is an unstable mix of gravel, sand/silt and large boulders (Fig. 1). Turbid flow from the mudslide was observed entering the Mary River (Fig. 2). Instream water quality monitoring performed upstream (Fig. 3) and downstream (Fig. 4) of the affected stream section on July 15, 2020 indicated that downstream turbidity increased to 38.5 NTU from the upstream turbidity of 30.5 NTU due to the event. When the site was inspected on July 15, 2020, it appeared that the mudslide was not at risk of further movement at that time and the effects on the Mary River water quality would likely be short-lived.

Figure 1. Substrate of mudslide area.

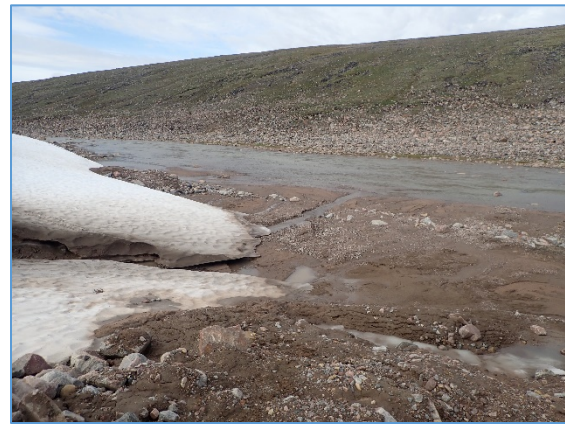
Figure 2. Turbid flow entering the Mary River.

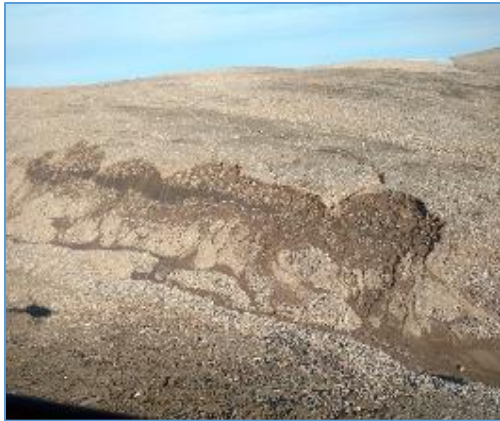
Description: Substrate is an unstable mix of gravel, cobble and sand/silt (Fig. 1). Sediment from the sloughed hillside was observed entering the tributary of the Mary River (Fig. 2). The sediment carried into the Mary River from the affected tributary was observed to increase turbidity in the Mary River downstream of the confluence. UTM coordinates for a water quality monitoring location downstream of the confluence are NAD83, Zone 17N, 574946 E, 7920199, N. UTM coordinates for a water quality monitoring location upstream of the confluence are NAD83, Zone 17N, 574934 E, 7920838 N. Water quality samples collected upstream and downstream of the confluence of the tributary with the Mary River on July 15, 2020 indicated that downstream total suspended solids (TSS) increased to 18.1 mg/L from the upstream TSS of 15.5 mg/L due to the event. Water quality samples collected upstream and downstream of the confluence of the tributary with the Mary River on July 19, 2020 indicated that downstream TSS increased to 16.8 mg/L from the upstream TSS of 6.4 mg/L due to the event. The sloughed hillslope is considered an active source of sedimentation loading into the Mary River and will be monitored again during the 2021 freshet season.

Figure 1. Substrate of sloughed hillside.

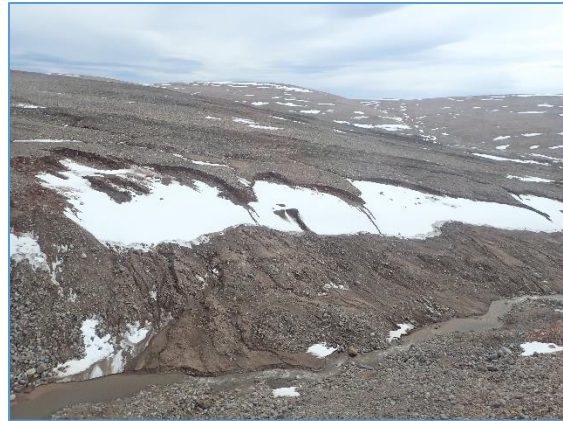
Figure 2. Sediment entering the tributary.

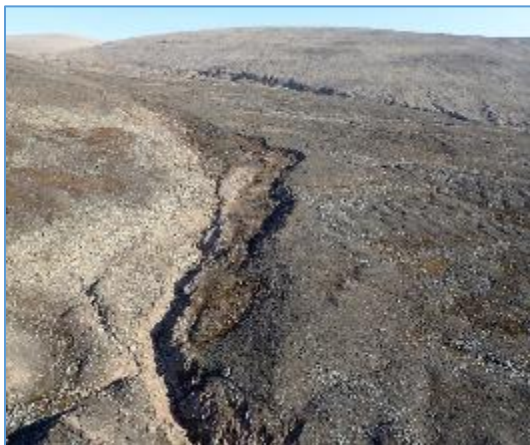
Description: Substrate is an unstable mix of gravel, cobble and sand/silt (Fig. 1). Sediment from the sliding slope was observed entering the Mary River (Fig. 2). The sediment carried into the Mary River from the affected slope was observed to increase downstream turbidity in the Mary River. UTM coordinates for a water quality monitoring location downstream of the confluence are NAD83, Zone 17N, 573616 E, 7925011 N. UTM coordinates for a water quality monitoring location upstream of the confluence are NAD83, Zone 17N, 573616 E, 7925011 N. Water quality samples collected upstream and downstream of the affected section of the Mary River on July 15, 2020 indicated that downstream total suspended solids (TSS) increased to 18.6 mg/L from the upstream TSS of 10.8 mg/L due to the event. Water quality samples collected upstream and downstream of the affected section of the Mary River on July 19, 2020 indicated that downstream total suspended solids (TSS) increased to 11.8 mg/L from the upstream TSS of 3.9 mg/L due to the event.

Figure 1. Substrate of sliding slope.

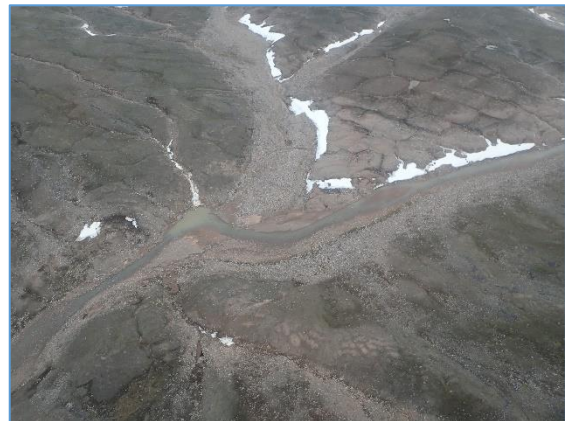
Figure 2. Sediment entering the Mary River.

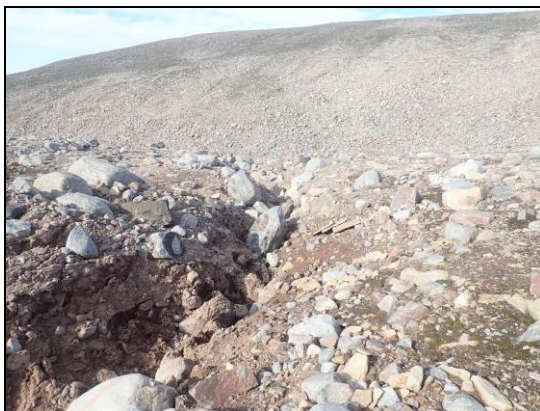
Description: Substrate is an unstable mix of gravel, sand/silt and large boulders (Fig. 2). Flow from the slumping hills enters a tributary that joins the Mary River downstream (Fig. 3).

Figure 2. Substrate of slumping hills.

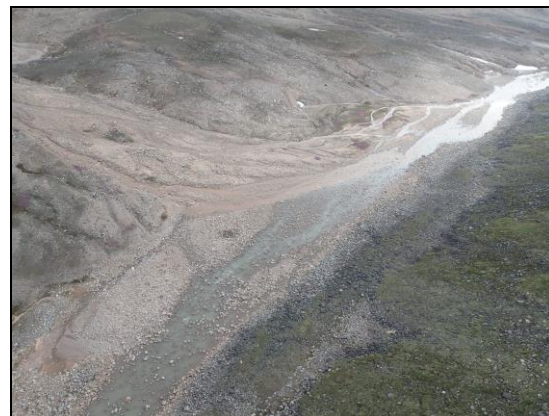
Figure 3. Turbid flow from MR-NATSED-4 entering the Mary River.

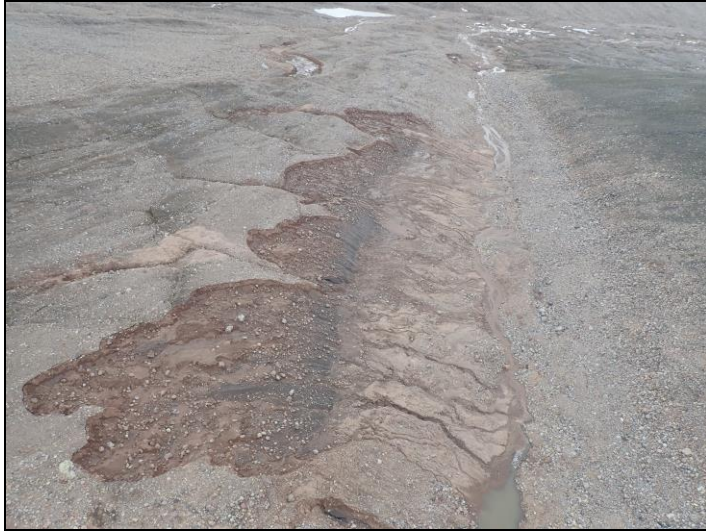
MR-NATSED-4: Slumping hills on the west side of a glacier along a tributary of the Mary River located approximately 16 km northeast of the Deposit 1 open pit at the Mary River Mine Site (Fig. 1).

Figure 4. Aerial photograph of sloughed hillside.
