**BAFFINLAND IRON MINES CORPORATION
MARY RIVER PROJECT**

**TOTE ROAD FISH HABITAT MONITORING
2020 ANNUAL REPORT
EARLY REVENUE PHASE - TOTE ROAD UPGRADES**

2020-12-29	0

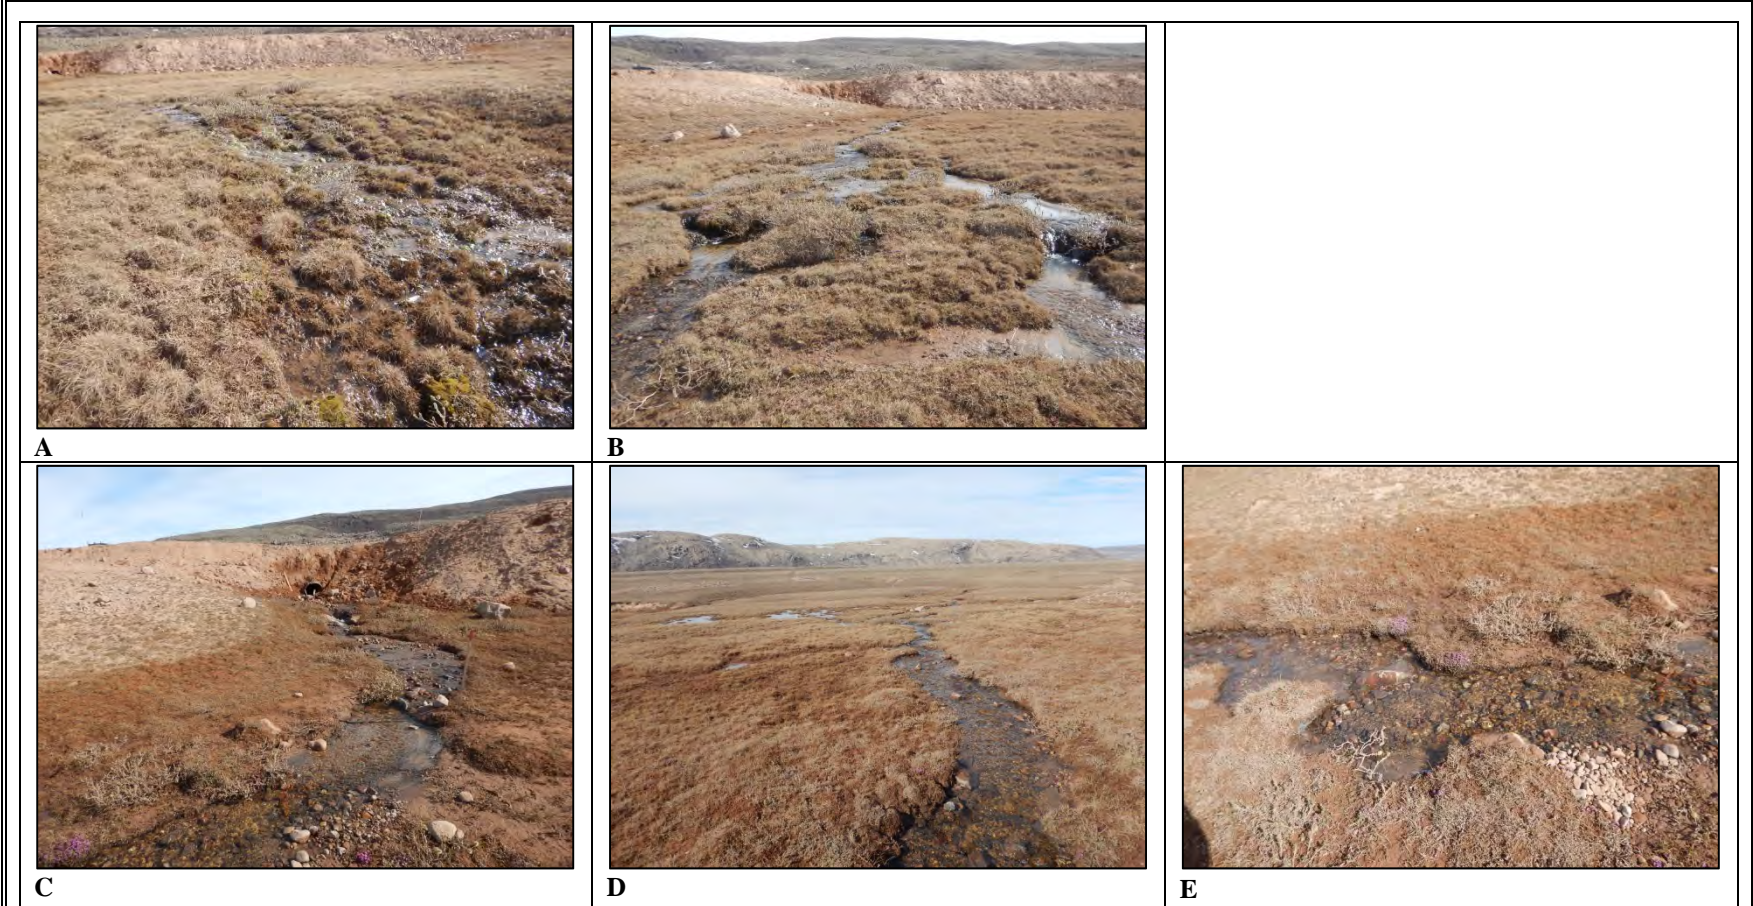
Summary: This small stream has several natural steep gradient and vertical drop barriers downstream that prevent fish access to the crossing area from Phillips Creek. There is no upstream overwintering habitat.

Photos 1. Photographs of the barriers downstream from the Tote Road crossing CV-170 (A,B); and photographs of habitat downstream of the Tote Road: (C) looking upstream; (D) looking downstream; and (E) across.

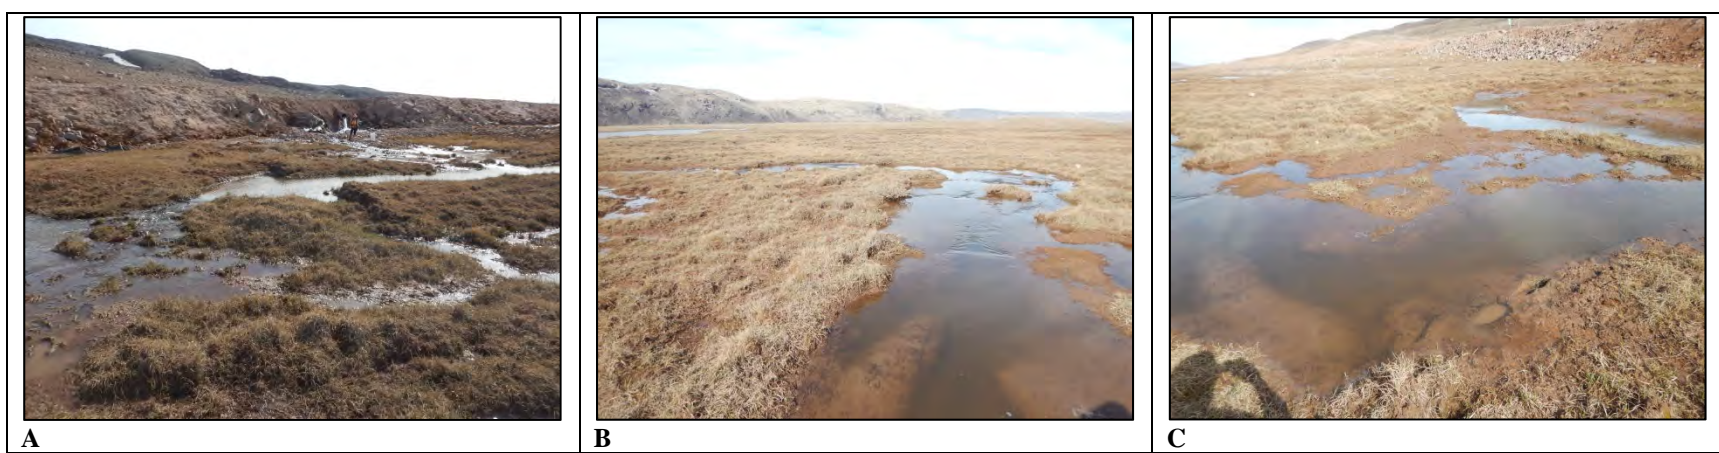
Summary: This small stream has a rocky berm barrier downstream that prevents fish access to the crossing area from a fish-bearing stream that flows parallel to the road. There is no habitat at the crossing due to this barrier. There is also no upstream overwintering habitat.

Photos 1. Photographs downstream of the Tote Road crossing CV-166: (A) looking upstream; (B) looking downstream; and (C) looking across.

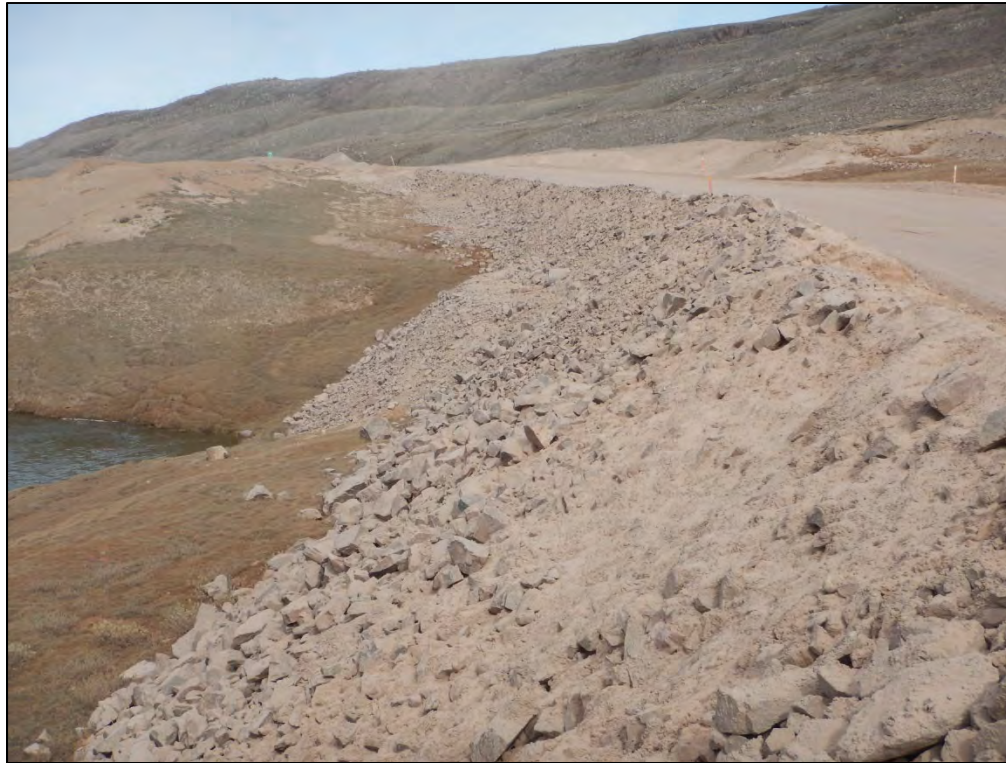
Summary: This small runoff stream is typically dry and has several natural steep gradient and vertical drop barriers downstream that prevent fish access to the crossing area from Phillips Creek. There is no upstream overwintering habitat.

Photos 1. Photograph of the dry, steep channel downstream of the Tote Road crossing CV-156.

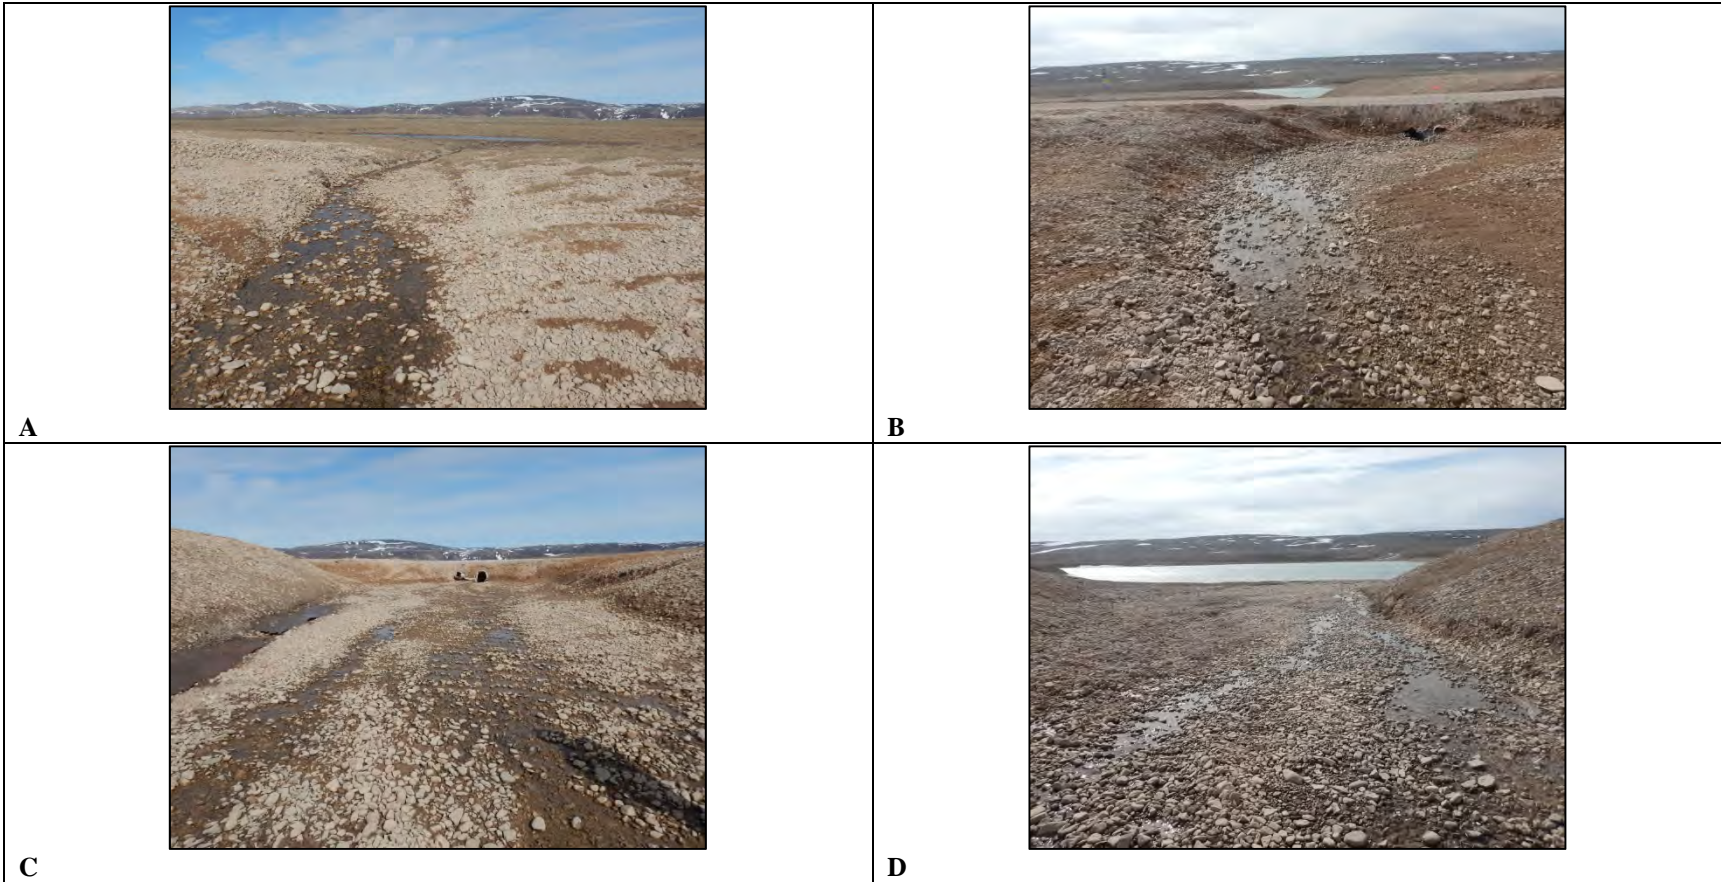
Summary: Stream has been regularly surveyed and is dry most years. There was very shallow surface water present during the freshet in 2020, but no fish were present.

Photos 1. Photographs upstream (top) and downstream (bottom) of the Tote Road crossing CV-115: (A,C) looking upstream; and (B,D) looking downstream.

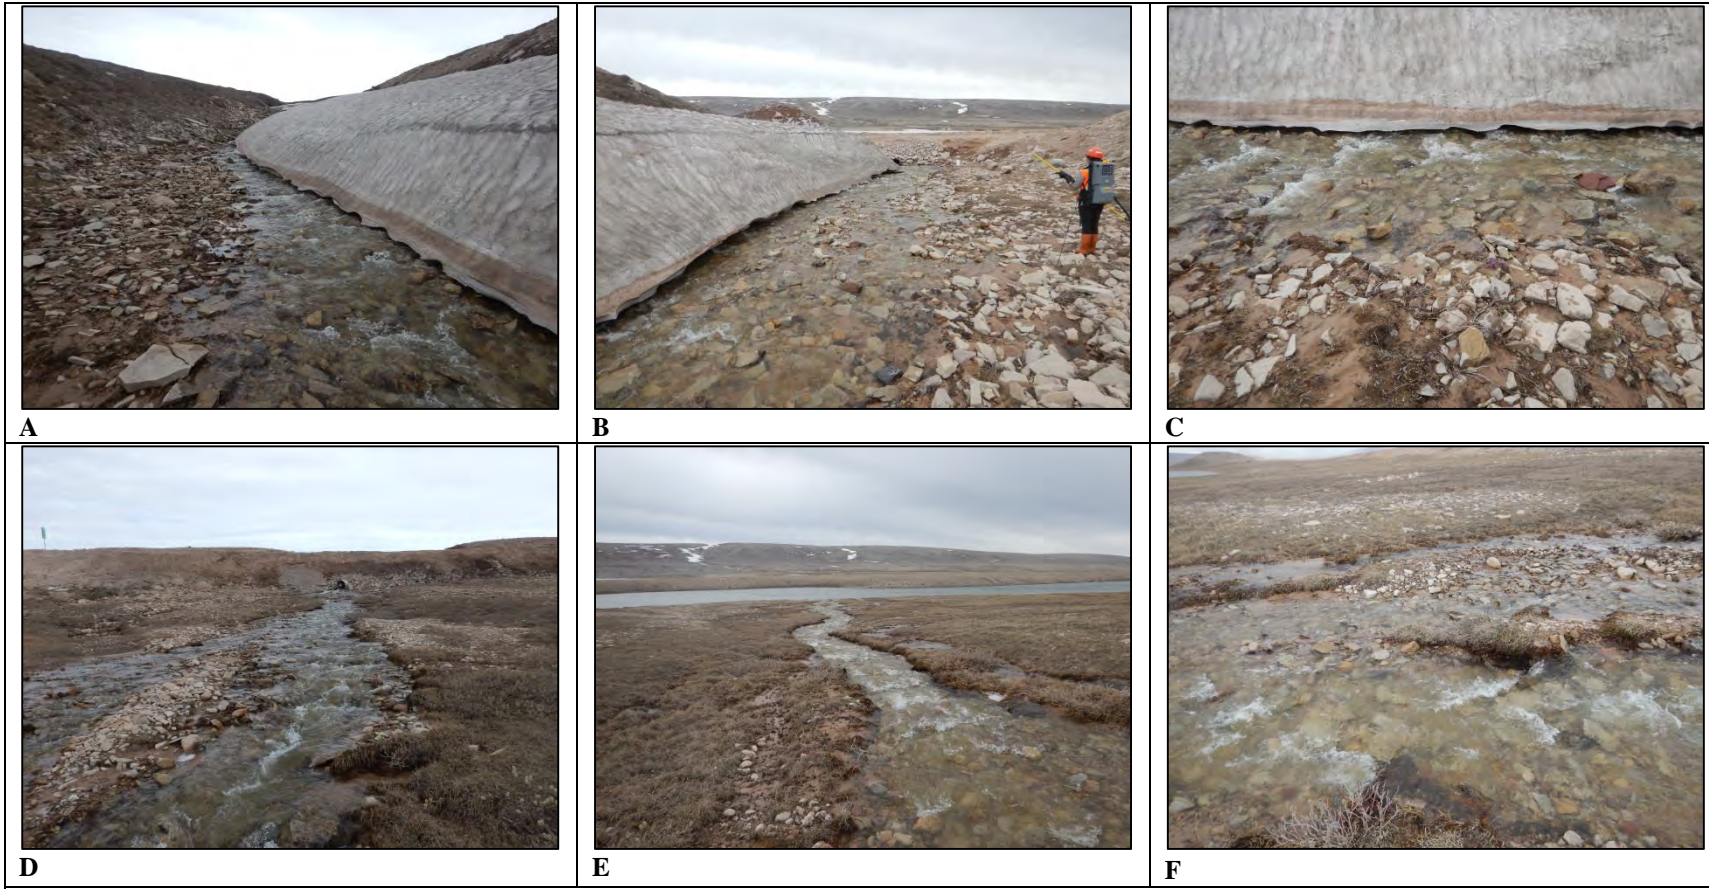
Summary: This stream provides summer rearing habitat for juvenile Arctic Char. Culvert was recently reinstalled and is perched. Remediation measures in 2019 were insufficient to improve fish access. Additional remediation required. See remediation Appendix C for details.

Photos 1. Photographs upstream (top) and downstream (bottom) of the Tote Road crossing CV-111: (A,D) looking upstream; (B,E) looking downstream; and (C,F) looking across.

The perch at CV-111 remains too high (0.25 m) to effectively mitigate with a rocky ramp and additional/alternative works will be required to restore access to upstream habitat for all of the size classes of juvenile Arctic Char found downstream of this crossing. The rock ramp installed at BG-50 in fall 2019 was washed away by high flows through the culverts during the 2020 freshet. Alternative remediation works will be required at this site, possibly by reconstructing the ramp with a base of larger, more erosion resistant material and placing smaller material over the base by hand or by reinstalling the culverts. Baffinland will work with the DFO prior to instream remediation work proceeding to decide upon a practical course of action for addressing the perched culvert outlets at the CV-111 and BG-50 crossings.

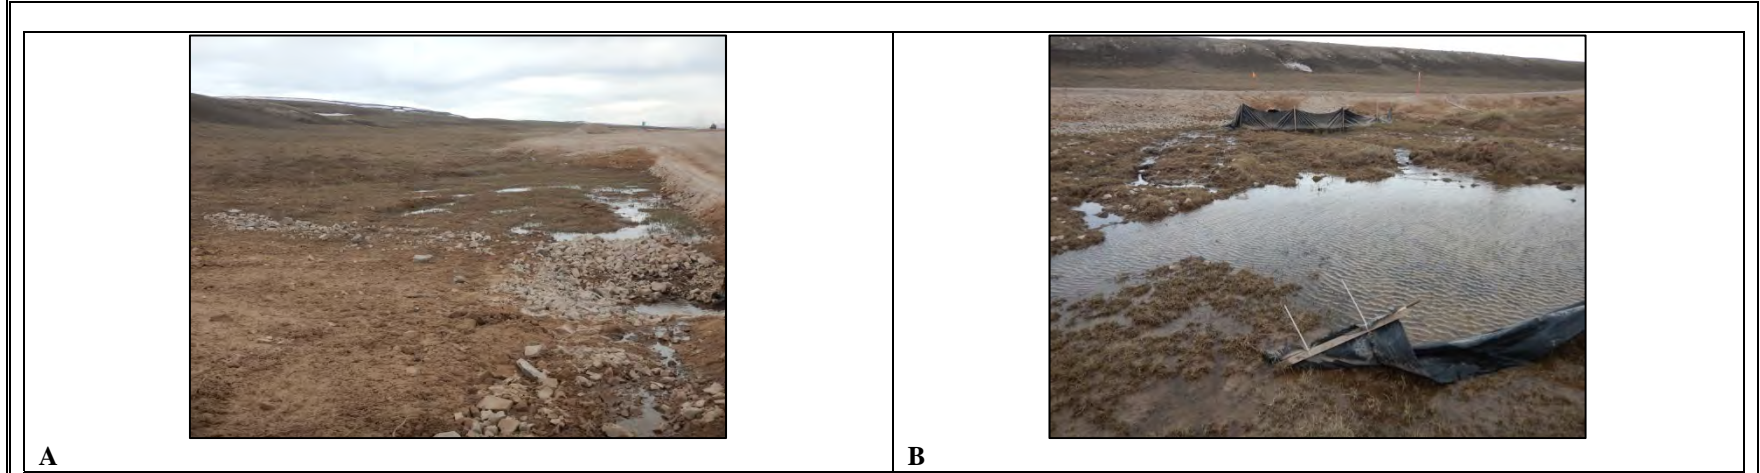
Summary: Site has no natural channel downstream, little surface flow, particularly following completion of freshet, and is not connected to Phillips Creek.

Photos 1. Photographs of the Tote Road crossing CV-202: (A) looking upstream from culvert; and (B) looking upstream towards culvert.

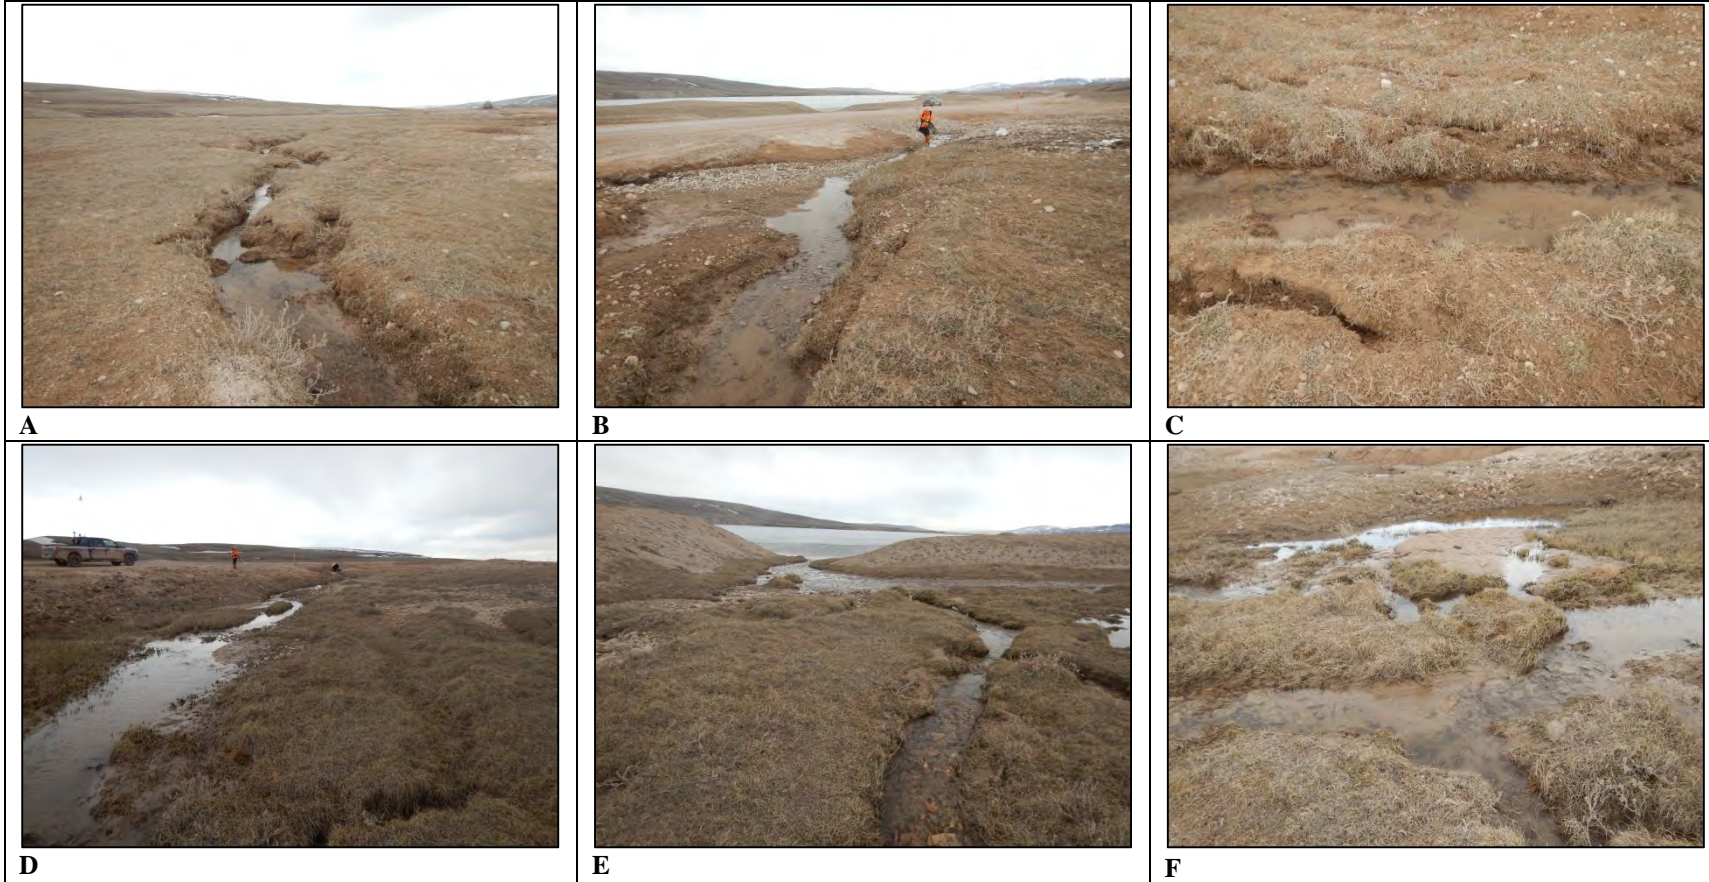
Summary: Stream provides summer rearing habitat for juvenile Arctic Char, though it frequently becomes dry following freshet without additional inputs of precipitation. An existing ramp (2018) designed to improve access received additional modifications in 2019 and 2020.

Photos 1. Photographs upstream (top) and downstream (bottom) of the Tote Road crossing CV-106: (A,D) looking upstream; (B,E) looking downstream; and (C,F) looking across.

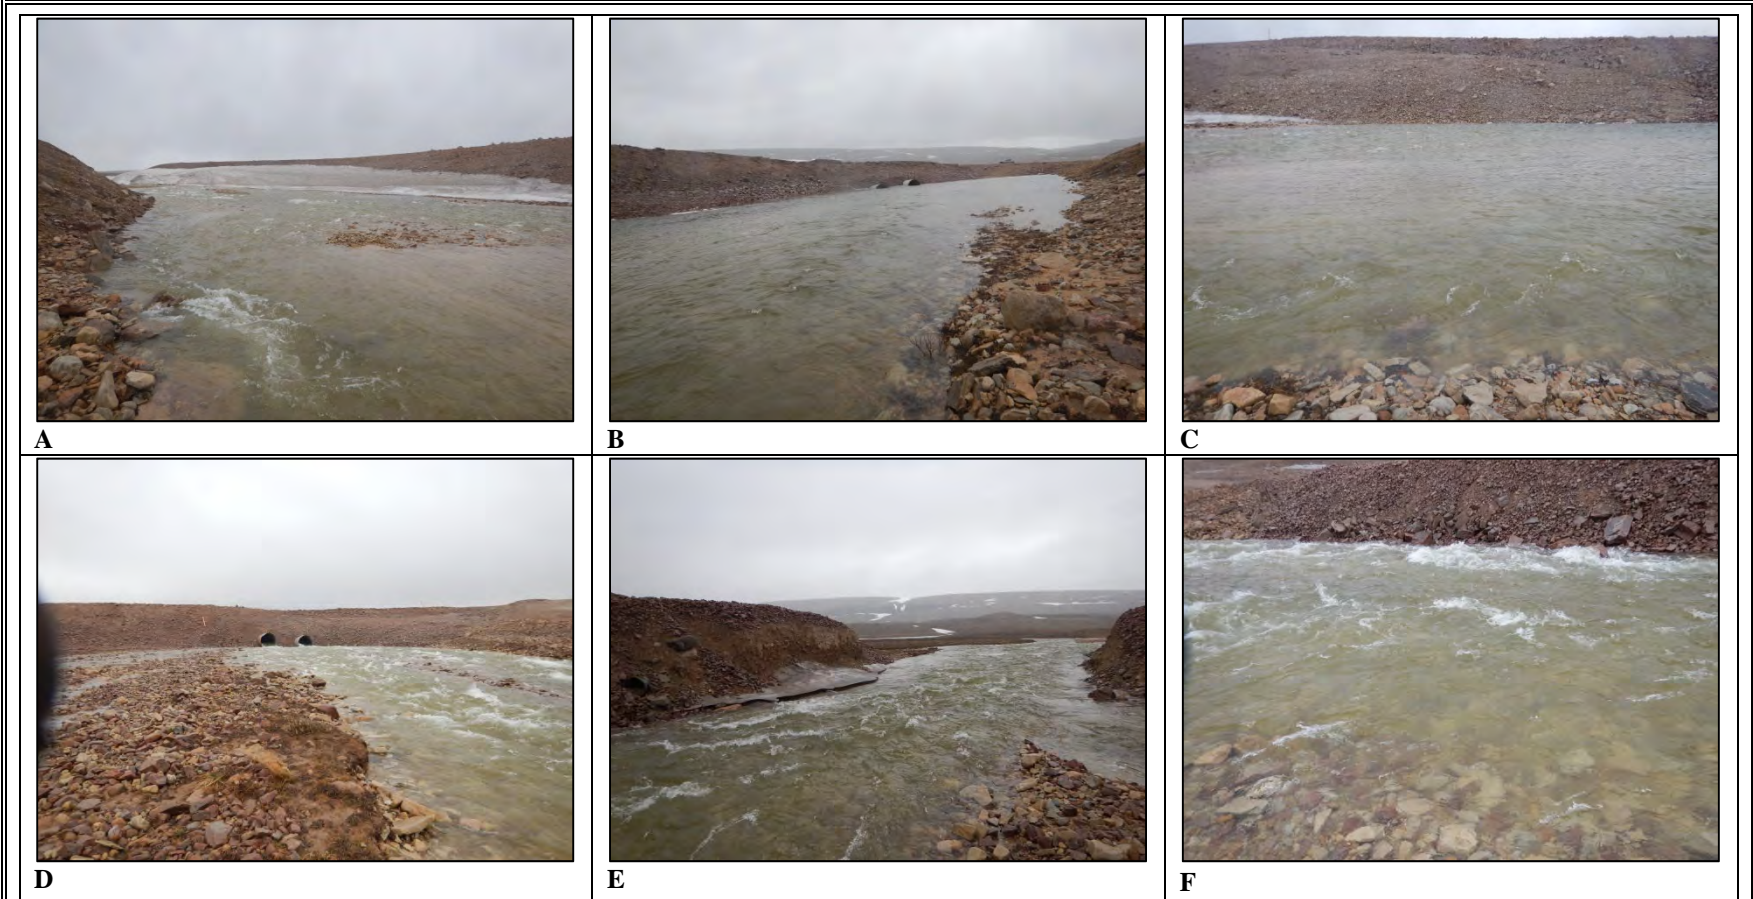
Summary: A large stream with abundant fish habitat. During high flows, water velocities in the culverts can be sufficiently high to restrict upstream access to larger juvenile char. Electrofishing could not be safely conducted in this stream during peak freshet in 2020 due to high flows. Fish use was not assessed for CV-099, but other streams in the study area showed minimal fish use during this period.

Photos 1. Photographs upstream (top) and downstream (bottom) of the Tote Road crossing CV-099: (A,D) looking upstream; (B,E) looking downstream; and (C,F) looking across.

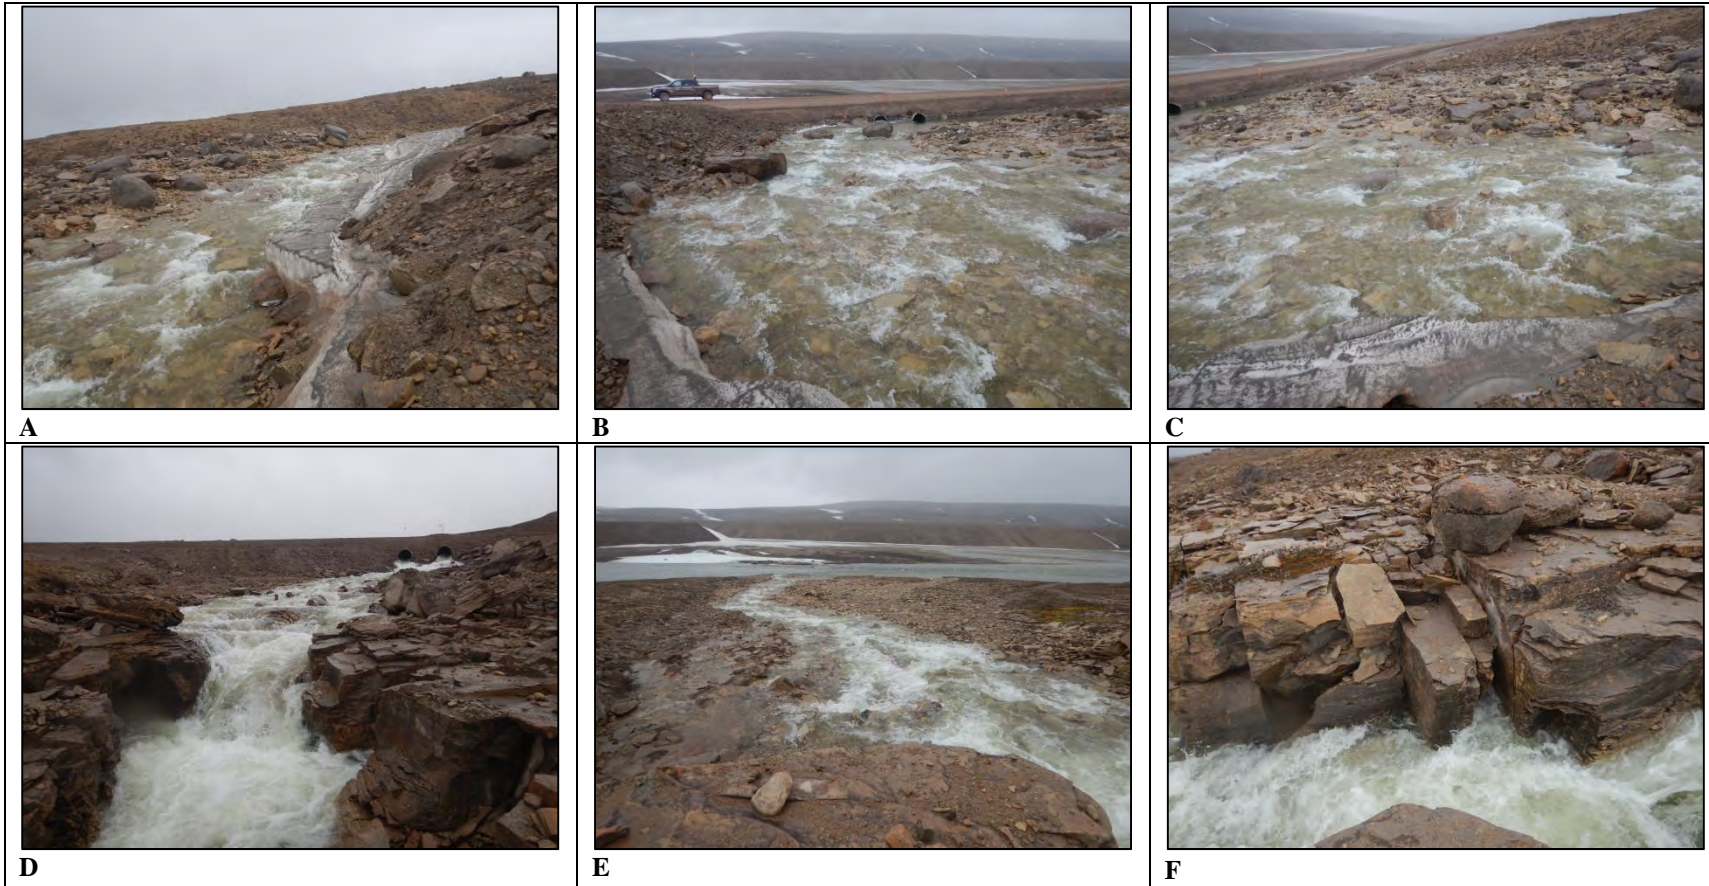
Summary: Site provides good quality summer rearing habitat for juvenile Arctic Char, but a natural downstream vertical barrier prevents access from overwintering habitat. Fish cannot naturally access the crossing or farther upstream habitat.

Photos 1. Photographs upstream (top) and downstream (bottom) of the Tote Road crossing CV-094: (A,D) looking upstream; (B,E) looking downstream; and (C,F) looking across.

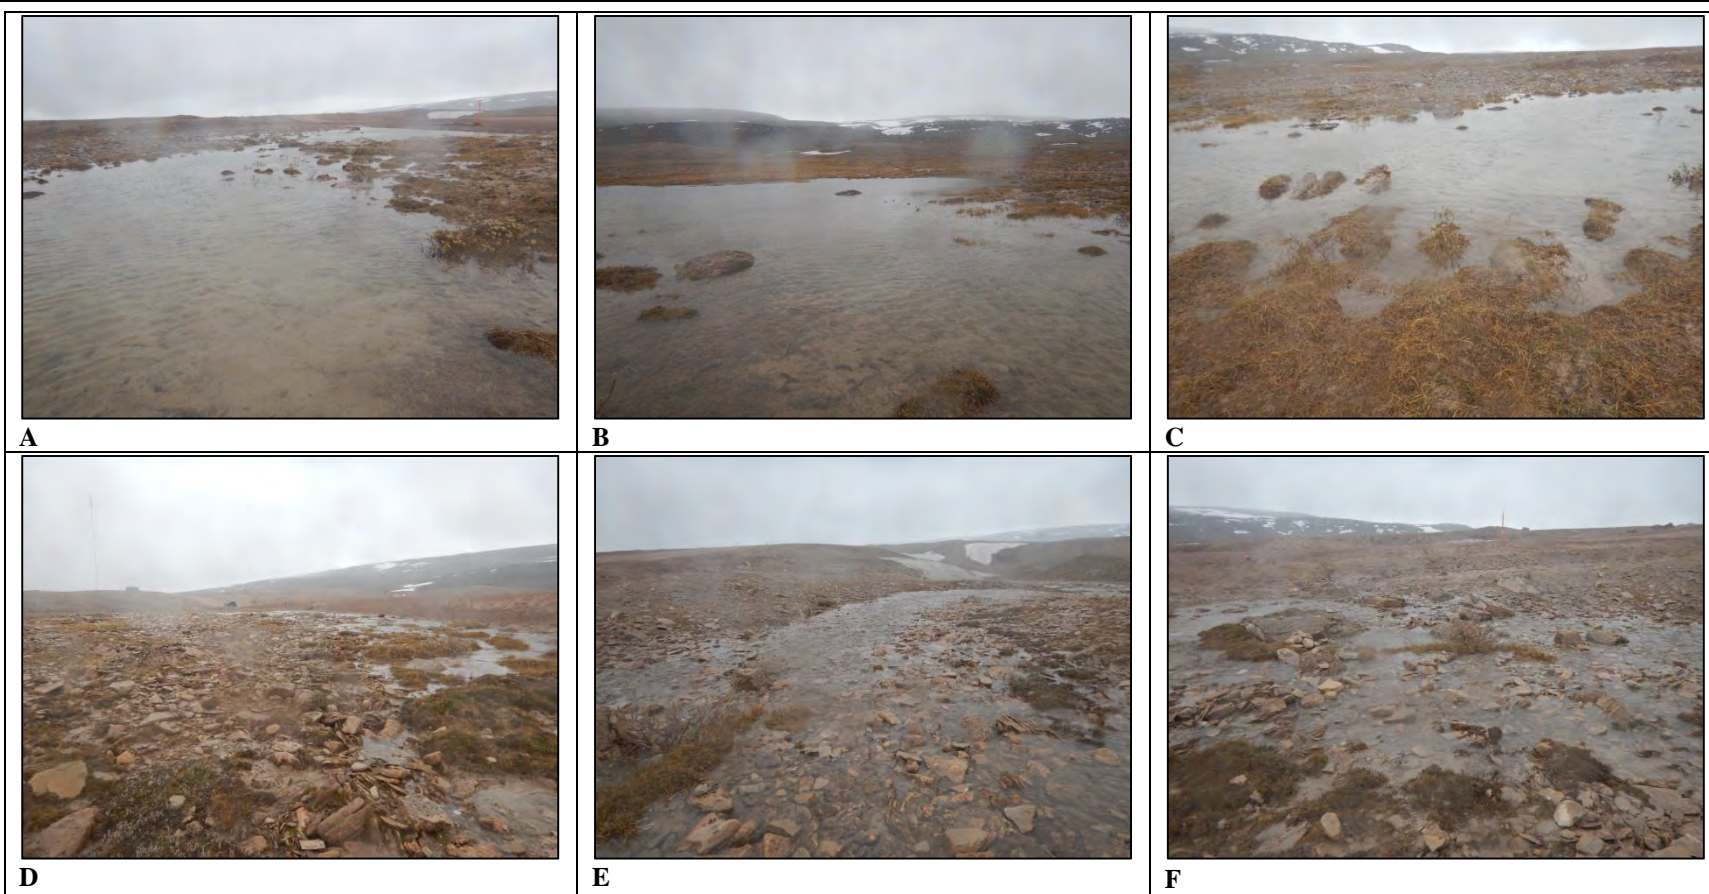
Summary: No natural channel upstream from the road where meltwater pools on terrestrial habitat and subsequently dries up shortly after peak freshet. There is also a steep gradient downstream from the road and the crossing lacks connectivity to overwintering habitat.

Photos 1. Photographs upstream (top) and downstream (bottom) of the Tote Road crossing CV-082: (A,D) looking upstream; (B,E) looking downstream; and (C,F) looking across.

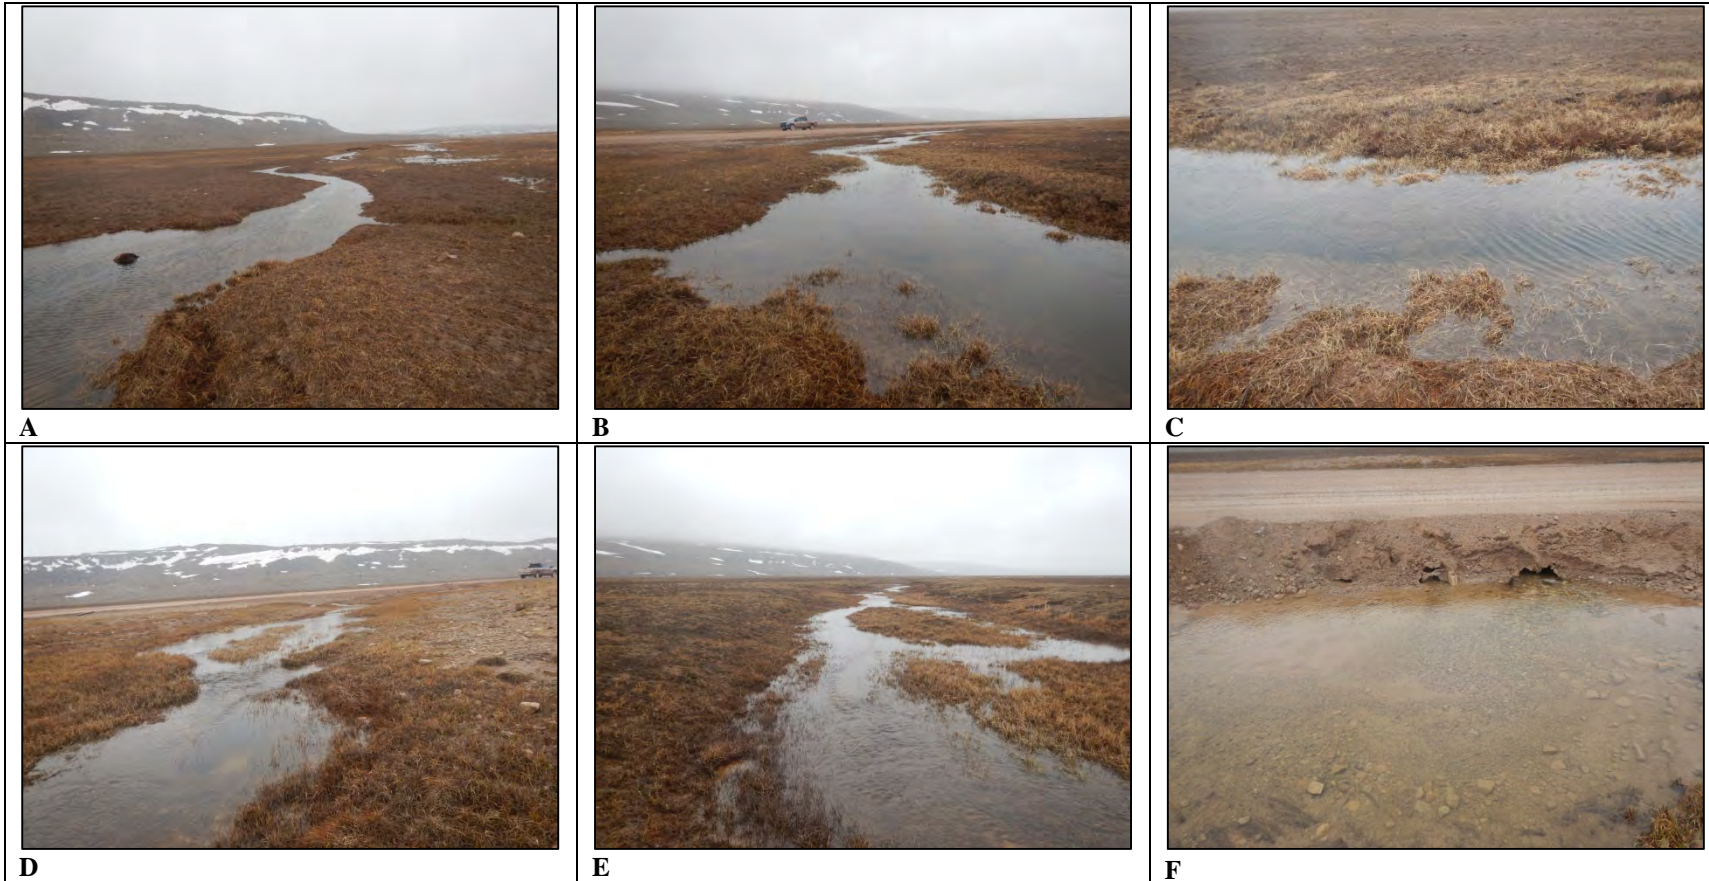
The spring 2020 survey identified that culverts at CV-057 were nearly completely buried by sediment, which is a recurring problem at this site. The ongoing sedimentation at CV-057 is potentially caused by erosion of the road embankment and/or elevated sediment transport due to erosion of fine-grained glaciofluvial deposits upstream of the crossing during spring freshet conditions. Baffinland will remove the accumulated sediment during non-flowing winter months. This work was not completed during the open-water season to prevent mobilization of sediment in the stream. Larger culverts, improved armouring of the road embankments, and implementation of upstream sediment control measures at locations where sediment enters the water body may also be required to prevent ongoing infilling of the culverts. Options for addressing the sedimentation at CV-057 will be discussed with the DFO prior to remediation work proceeding during non-flowing winter conditions. During the 2021 open-water season, Baffinland will monitor turbidity upstream and downstream of this crossing and inspect the road embankment and upstream sections of the stream to identify and address potential sources of sedimentation with control measures if required.

Photos 1. Photographs upstream (top) and downstream (bottom) of the Tote Road crossing CV-057: (A,D) looking upstream; (B,E) looking downstream; (C) looking across; and (F) sediment-filled culverts.

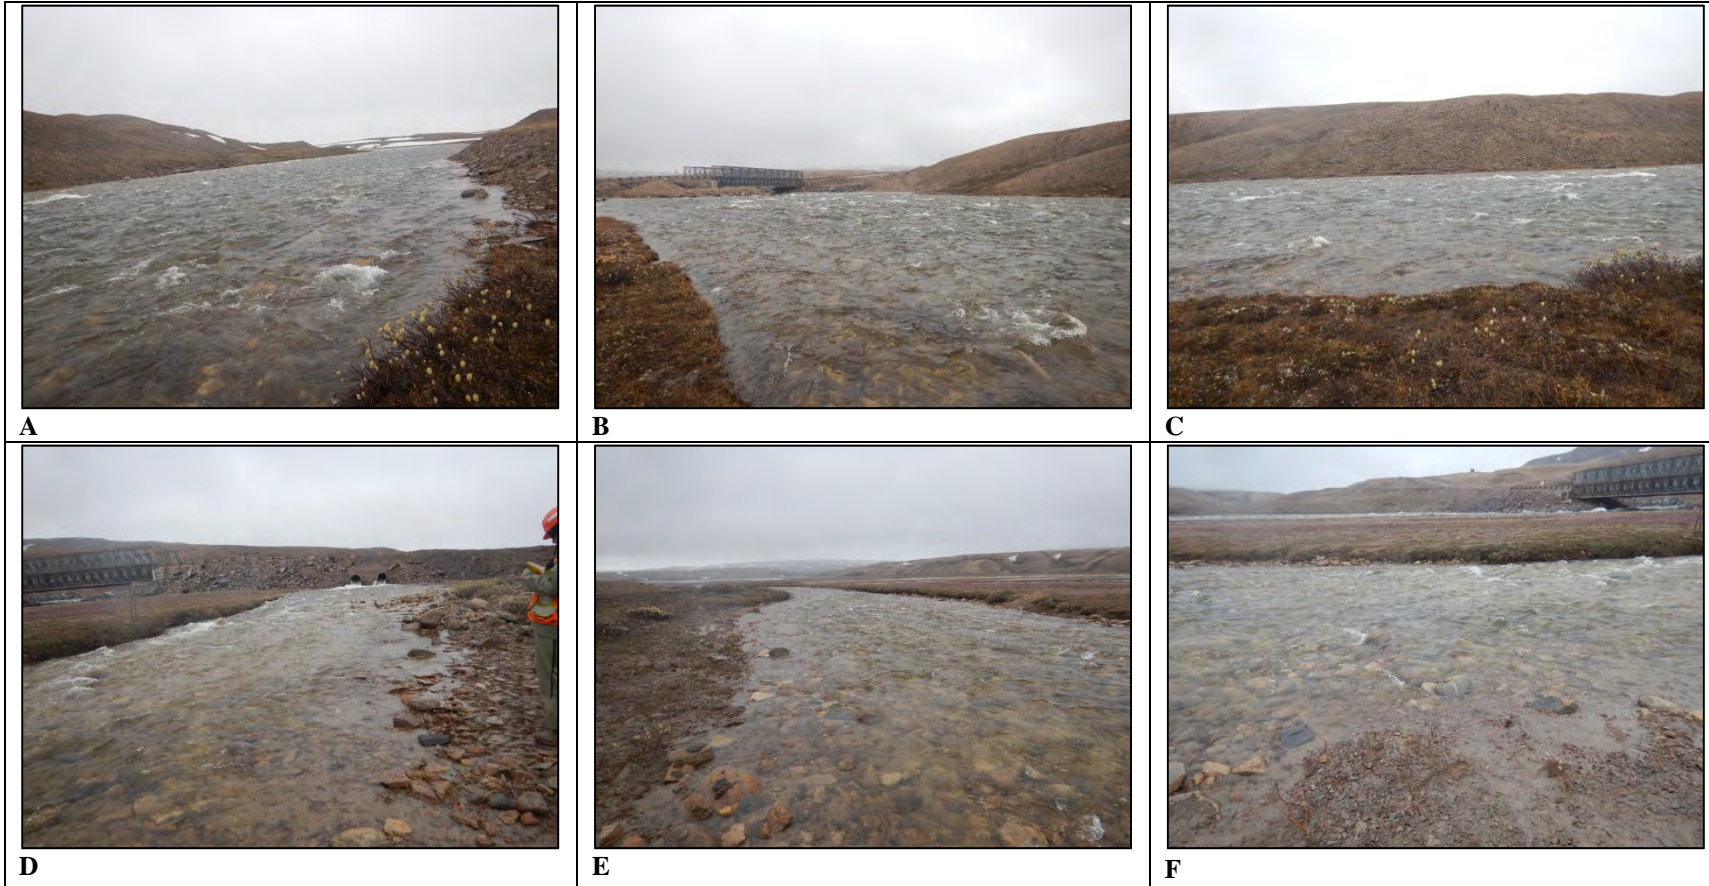
Photos 1. Photographs upstream (top) downstream (bottom) of the Tote Road crossing BG-50: (A,D) looking upstream; (B,E) looking downstream; and (C,F) looking across.

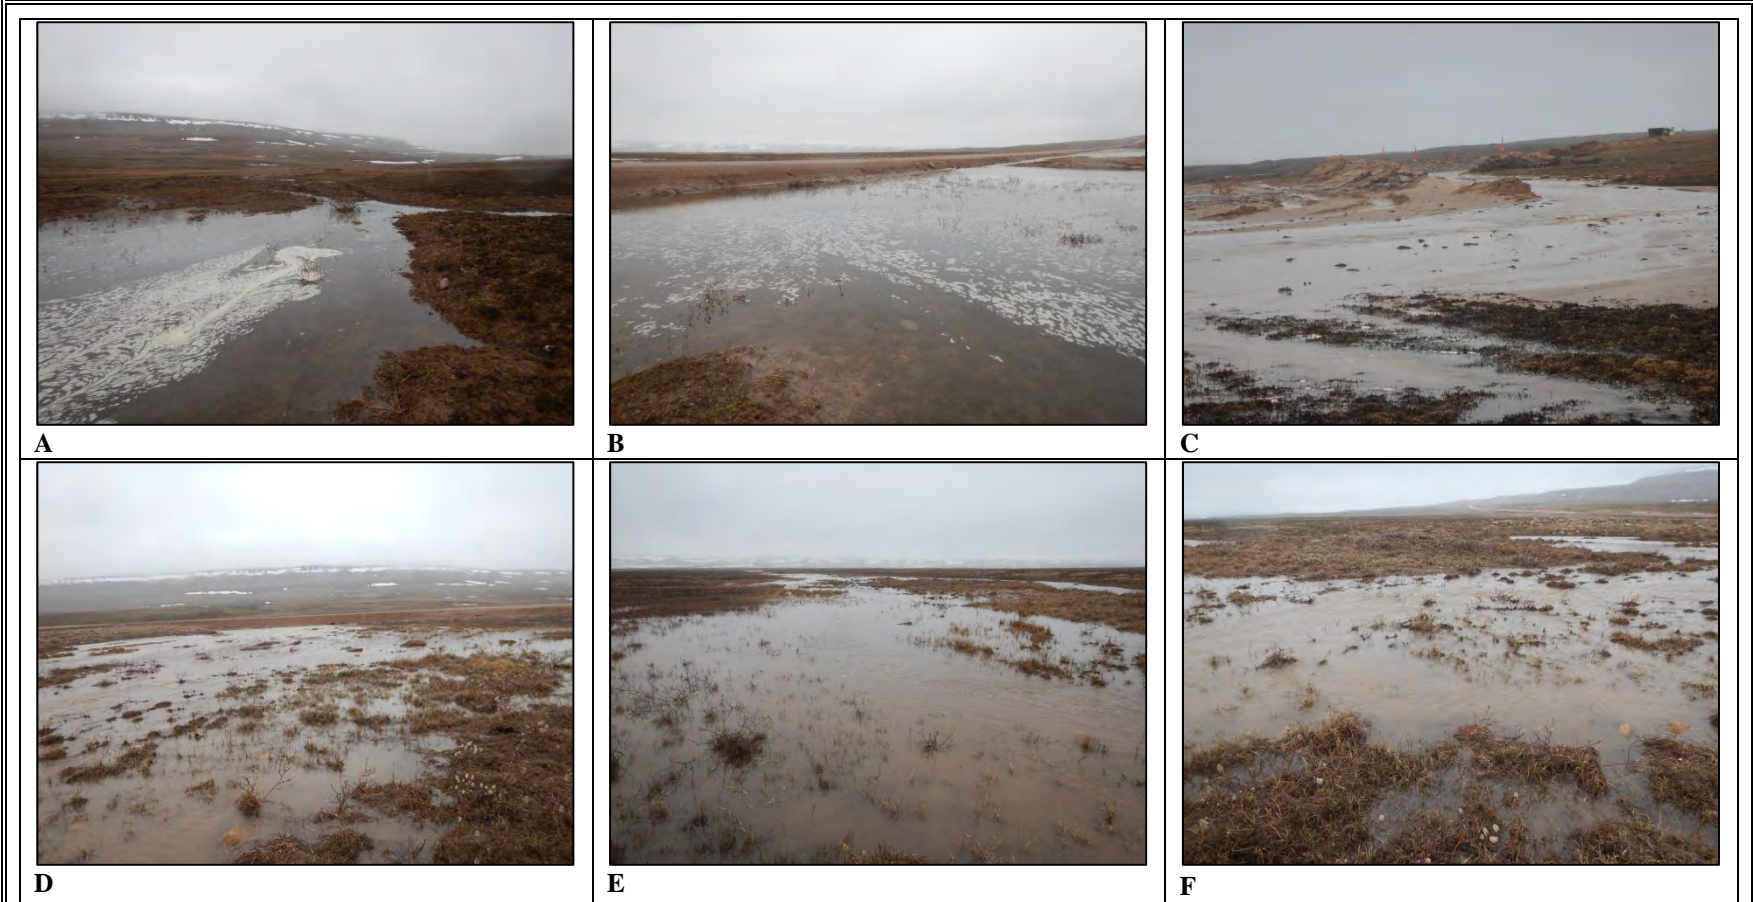
During spring 2020, water was diverted from non fish-bearing crossing (CV-031), due to a frozen culvert, which caused ponding upstream of the crossing. The flow was diverted to a fish-bearing crossing (CV-030) to alleviate potential flooding of the road. Diverting stream flow was done as a safety and environmental measure to prevent washing out of the road embankment and resulting greater sedimentation of downstream fish bearing waters at the Muriel Lake outfall. This diversion caused flooding, erosion, and increased turbidity in the area of the stream at crossing CV-030. Water diversion was ceased after alleviation of flooding upstream of CV-031 shortly after peak freshet.

Photos 1. Photographs upstream (top) and downstream (bottom) of the Tote Road crossing CV-030: (A,D) looking upstream; (B,E) looking downstream; (C) diversion flow from CV-031; and (F) looking across flooded terrestrial vegetation downstream.

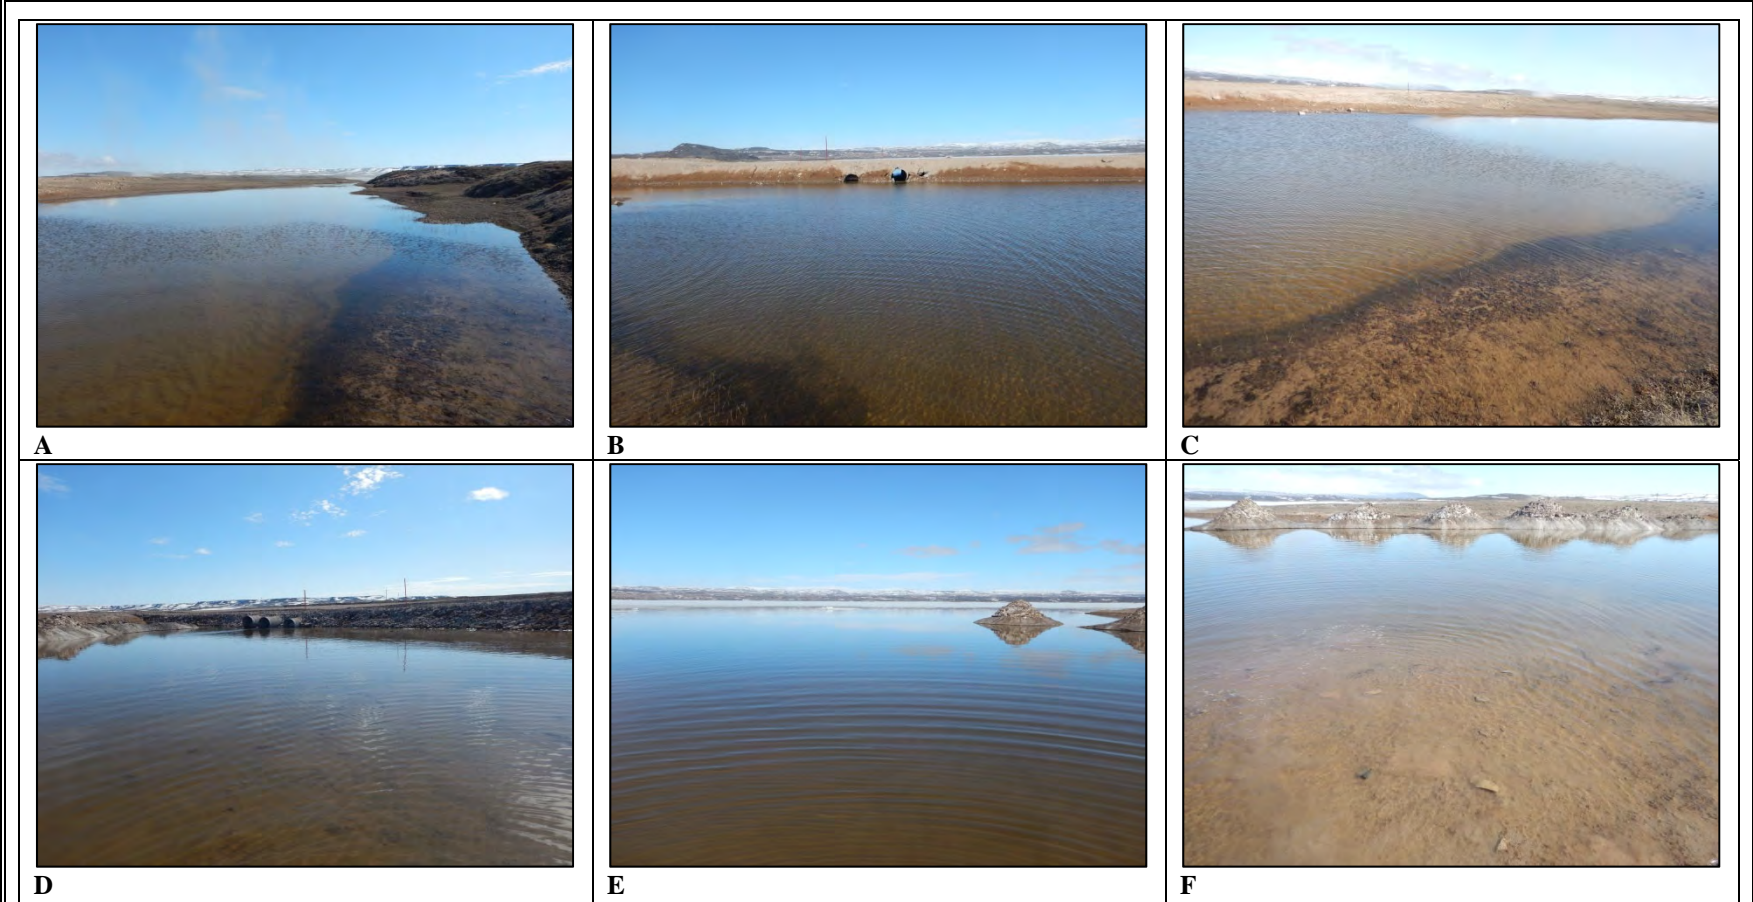
Photos 1. Photographs upstream of the Tote Road crossing CV-216: (A) looking upstream; (B) looking downstream; (C) looking across; and photographs downstream of the Tote Road: (D) looking upstream; (E) looking downstream; and (F) looking across (with snow stockpile visible in the channel).
