**BAFFINLAND IRON MINES CORPORATION
MARY RIVER PROJECT**

**TOTE ROAD FISH HABITAT MONITORING
2020 ANNUAL REPORT
EARLY REVENUE PHASE - TOTE ROAD UPGRADES**

2020-12-29	0

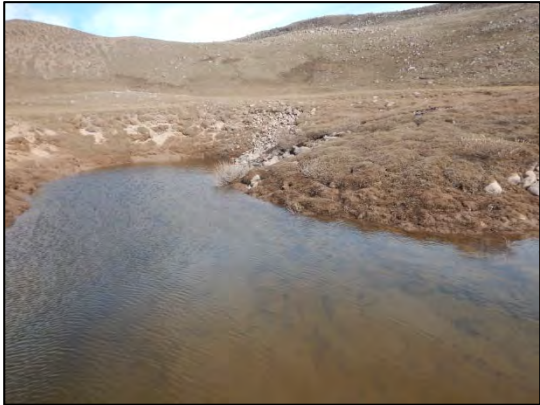
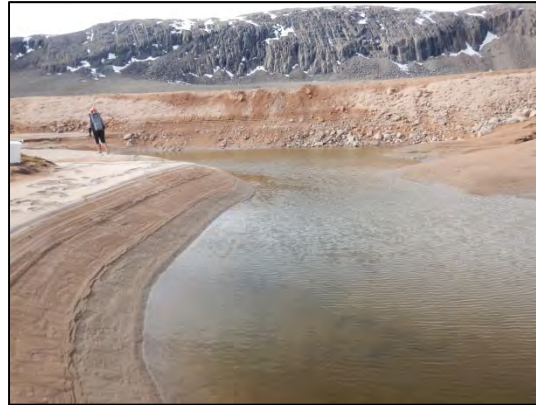
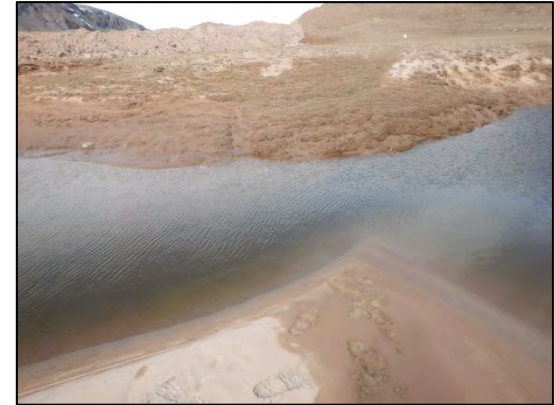
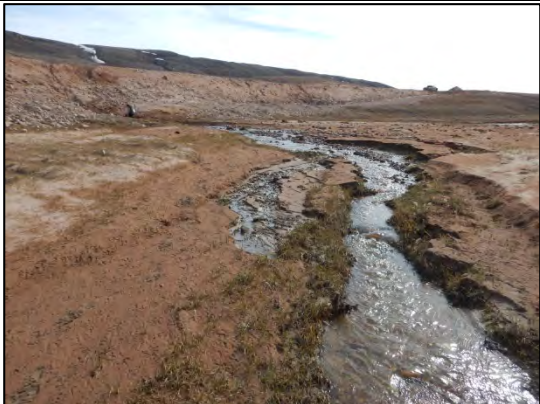
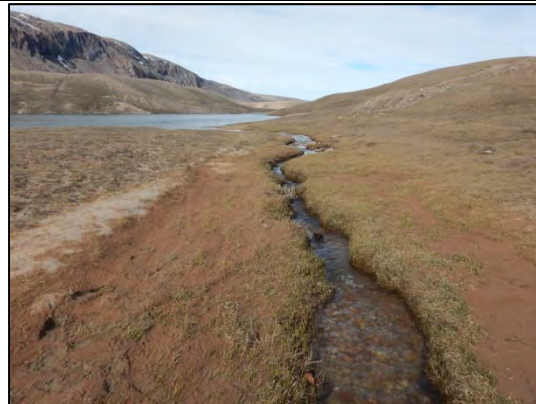
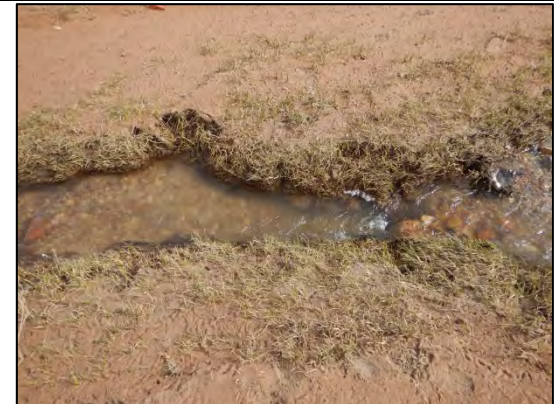
Summary: This small stream has several natural steep gradient and vertical drop barriers downstream that prevent fish access to the crossing area from Phillips Creek. There is no upstream overwintering habitat.

Photos 1. Photographs upstream (top) and downstream (bottom) of the Tote Road crossing CV-159: (A,D) looking upstream; (B,E) looking downstream; and (C,F) looking across.

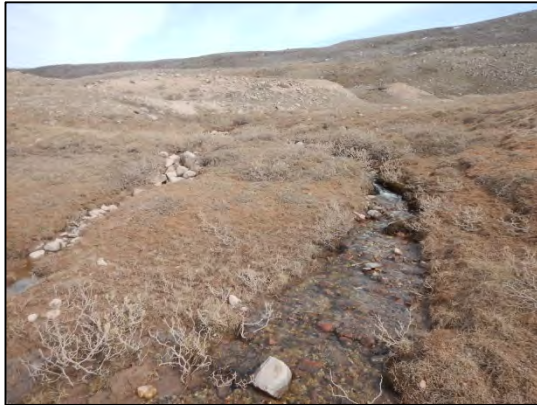
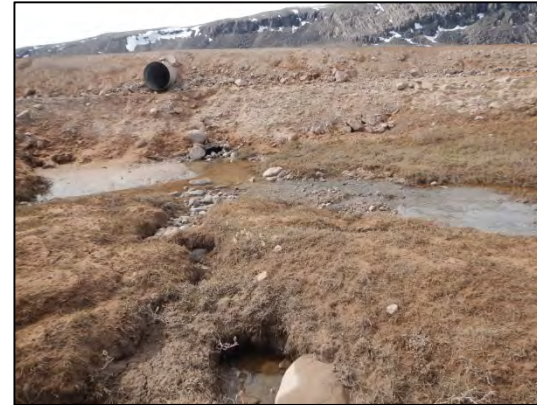
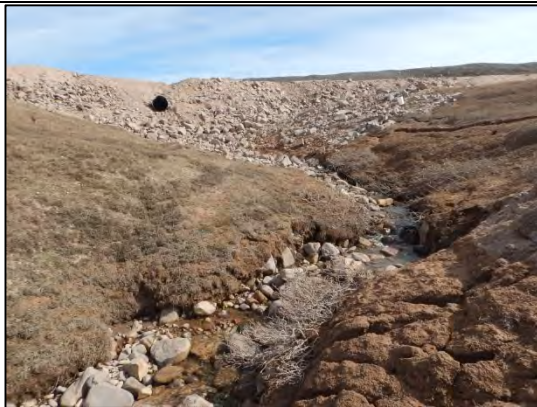
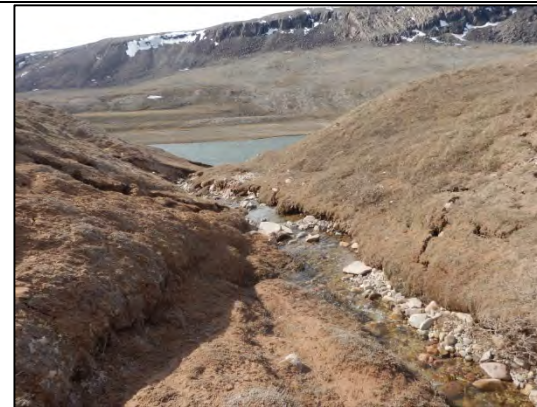
Summary: This small stream has several natural steep gradient and vertical drop barriers downstream that prevent fish access to the crossing area from Phillips Creek. There is no upstream overwintering habitat.

Photos 1. Photographs upstream (top) and downstream (bottom) of the Tote Road crossing CV-157: (A,C) looking upstream; and (B,D) looking downstream.

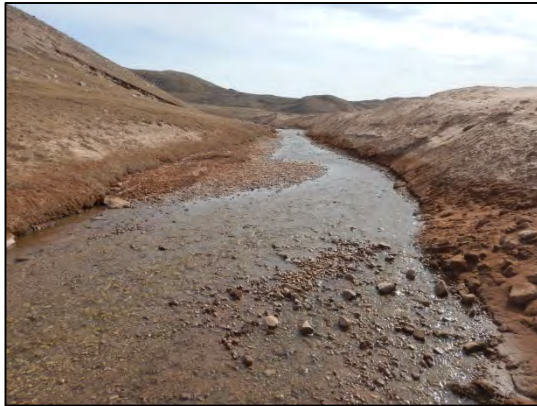
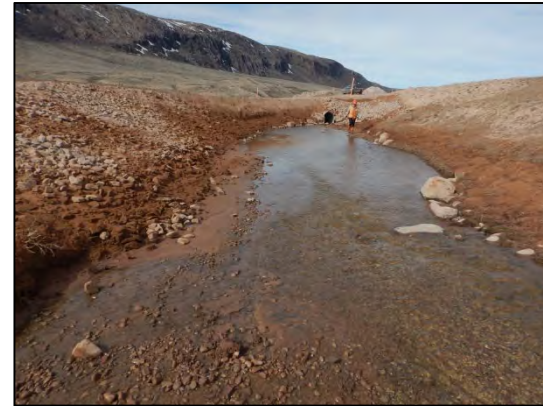
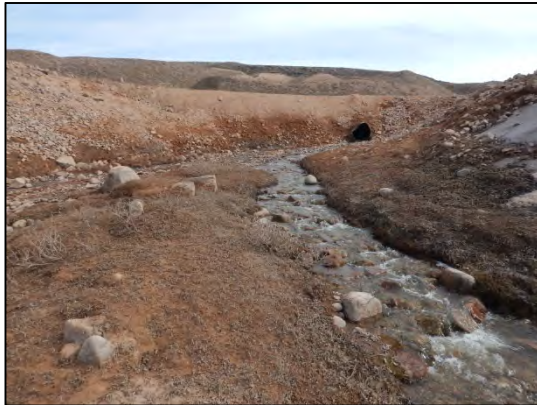
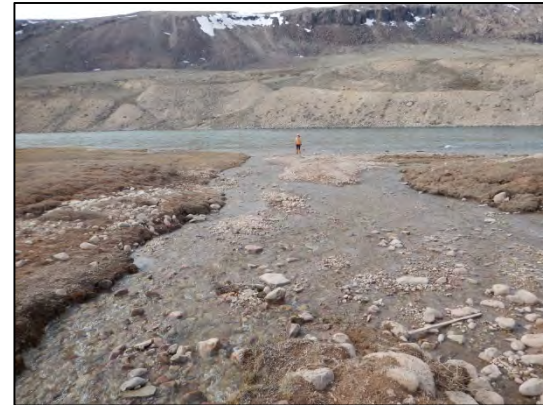
Summary: This small stream typically has low water levels and lacks connectivity at the confluence with Phillips Creek, preventing fish access to the crossing. There is no upstream overwintering habitat.

Photos 1. Photographs upstream (top) and downstream (bottom) of the Tote Road crossing CV-154: (A,C) looking upstream; and (B,D) looking downstream.

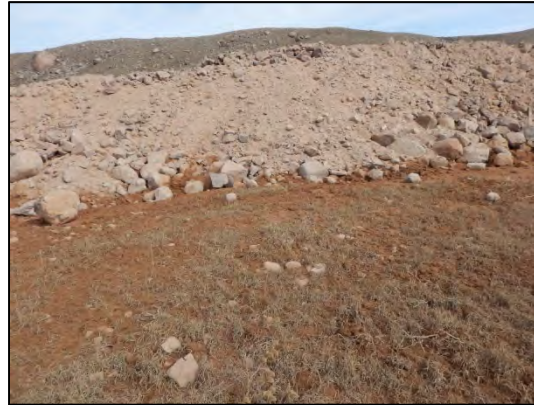
Summary: This small runoff area has no channel and is typically dry with several natural steep gradient and vertical drop barriers downstream that prevent fish access to the crossing area from Phillips Creek. There is no longer a culvert at this location on the Tote Road.

Photos 1. Photograph of the Tote Road crossing CV-153 from downstream.

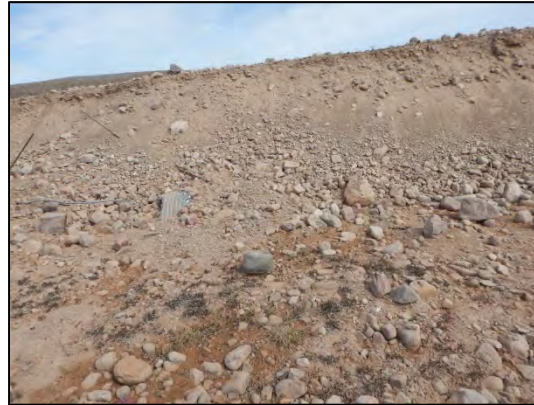
Summary: This small runoff area has no channel and is typically dry with several natural steep gradient and vertical drop barriers downstream that prevent fish access to the crossing area from Phillips Creek. There is no longer a culvert at this location on the Tote Road.

Photos 1. Photograph of the Tote Road crossing CV-152 from downstream.

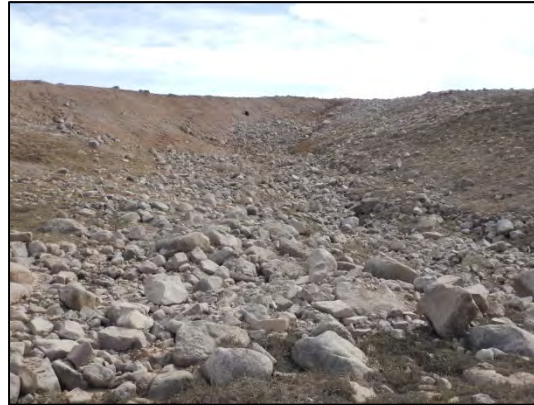
Summary: This small runoff area has a poorly defined channel and is typically dry with several natural steep gradient and vertical drop barriers downstream that prevent fish access to the crossing area from Phillips Creek.

Photos 1. Photograph of the Tote Road crossing CV-151 from downstream.

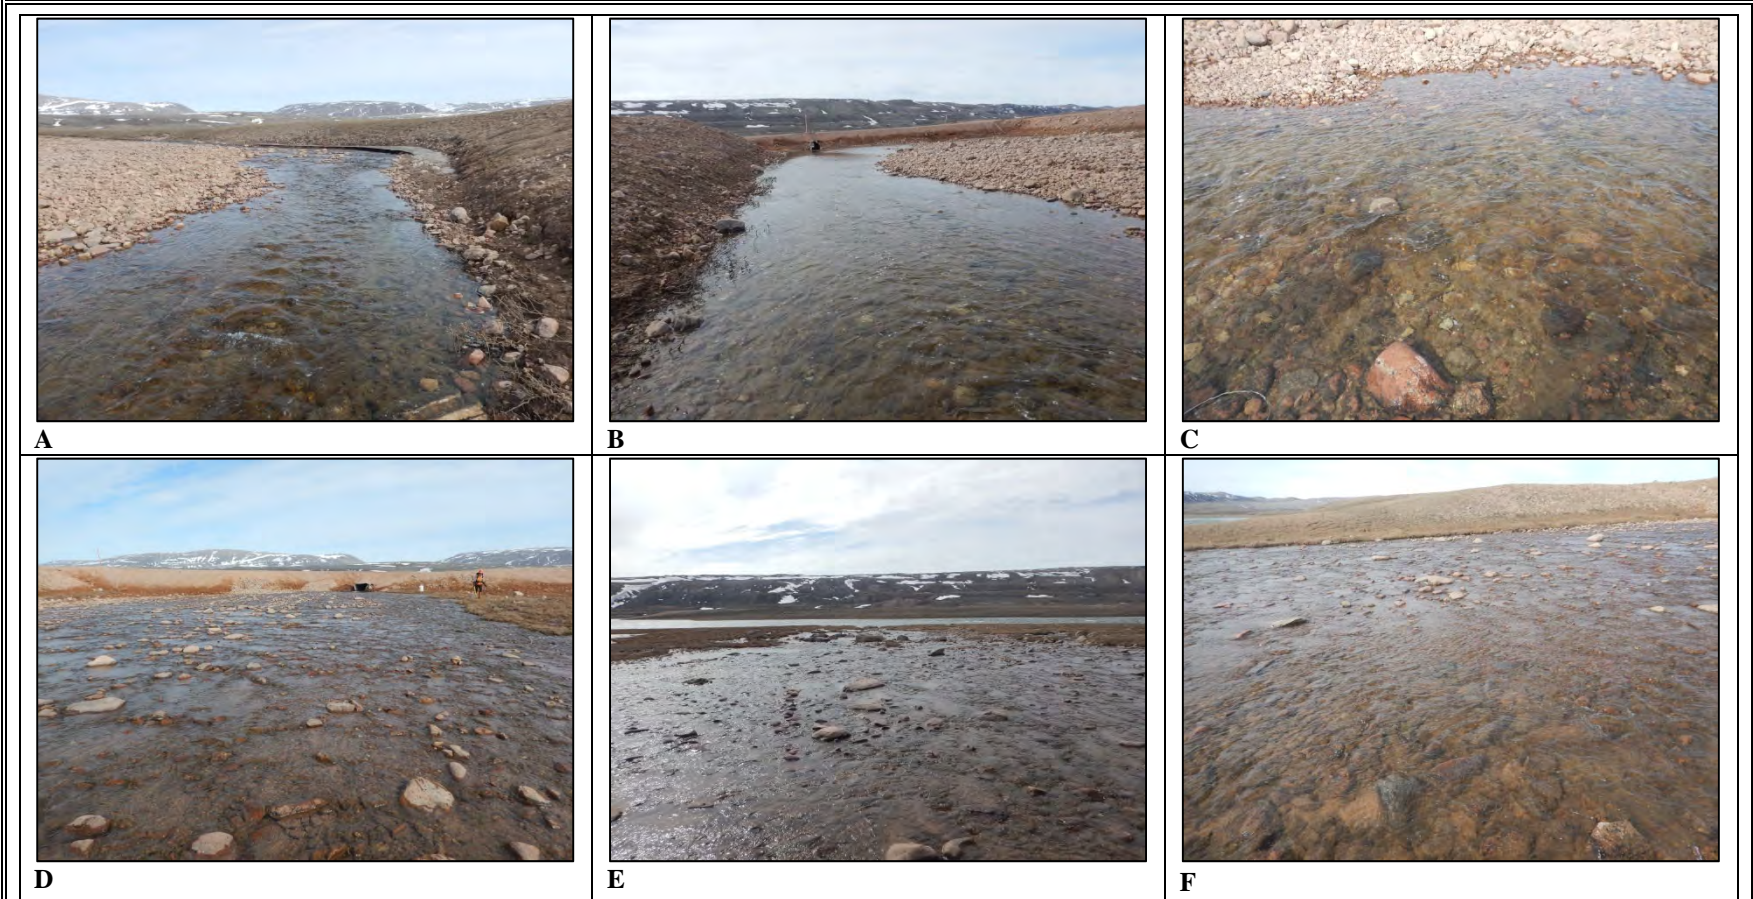
Summary: This site has consistently provided good quality summer rearing habitat for juvenile Arctic Char and is the first large tributary upstream of the impassable falls on Phillips Creek (i.e., fish use is restricted to land-locked Arctic Char). A small culvert perch was remediated in fall 2019 and minor repairs to the remediation works were conducted in fall 2020. An upstream overwintering lake provides additional habitat.

Photos 1. Photographs upstream (top) and downstream (bottom) of the Tote Road crossing CV-129: (A,D) looking upstream; (B,E) looking downstream; and (C,F) looking across.

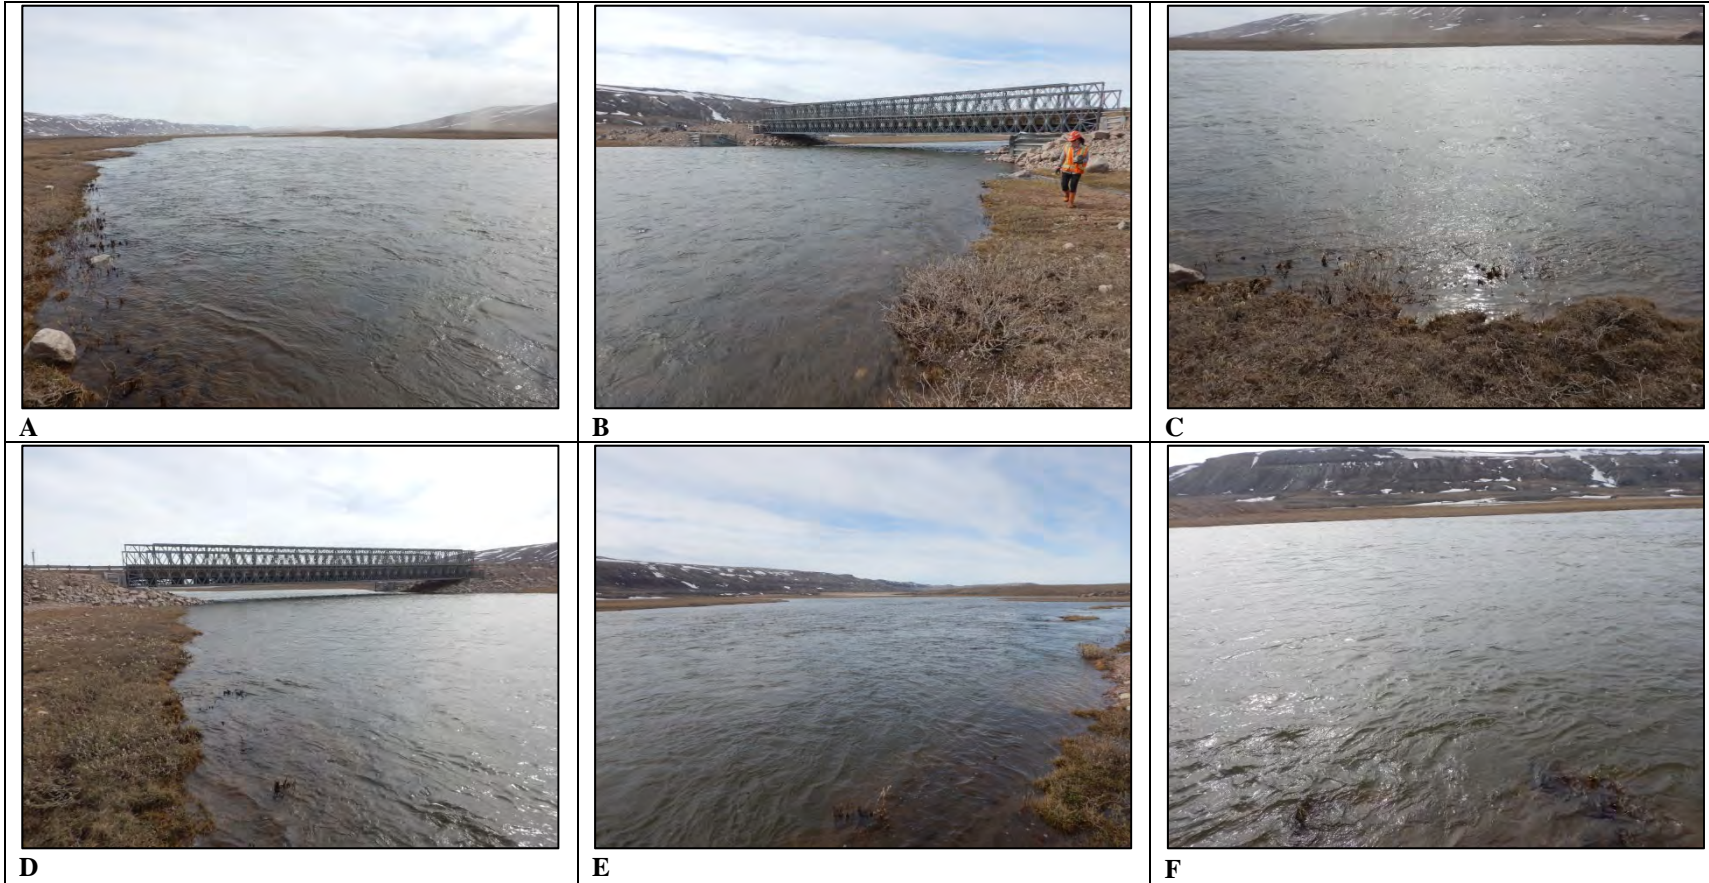
Summary: A bridge crossing of a major river that has consistently provided abundant fish habitat with no passage issues identified.

Photos 1. Photographs upstream (top) and downstream (bottom) of the Tote Road crossing CV-128: (A,D) looking upstream; (B,E) looking downstream; and (C,F) looking across.

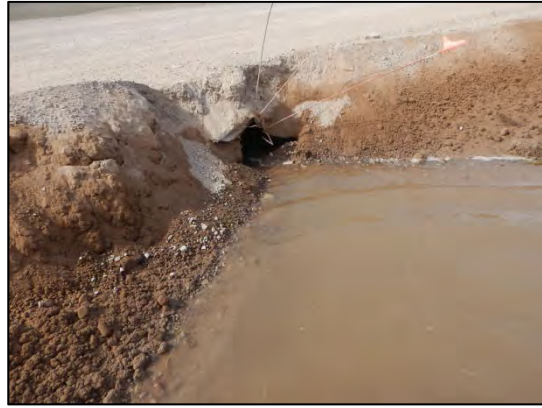
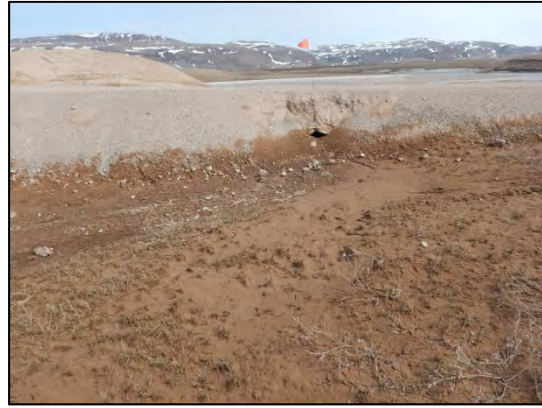
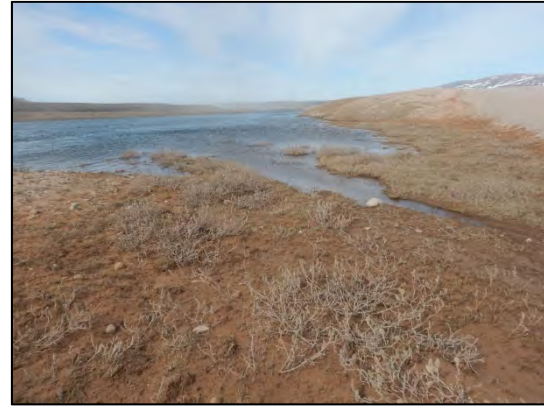
Summary: Some ponding occurs upstream of the Tote Road culvert, but there is no channel or surface water downstream of the road. There is no fish access to the site from Phillips Creek.

Photos 1. Photograph upstream of the Tote Road crossing CV-125 looking downstream (A); and photographs downstream of the Tote Road crossing CV-125 (B) looking upstream; and (C) looking downstream.

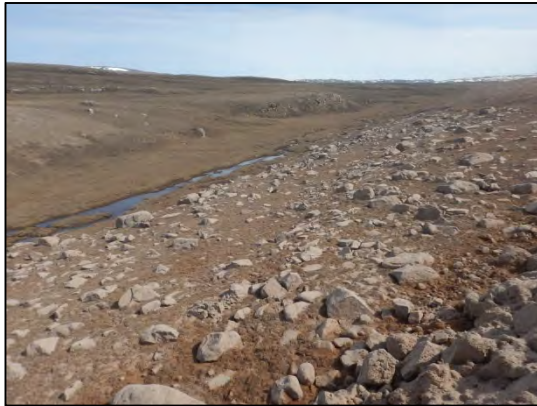
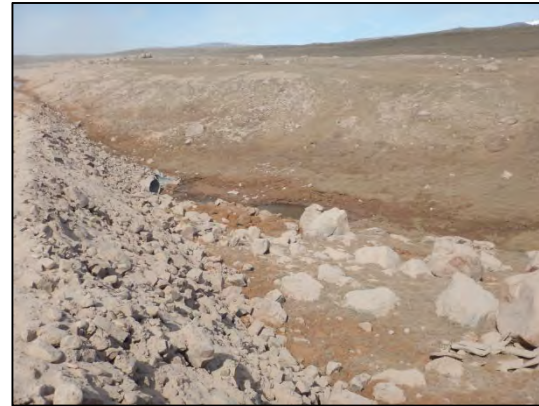
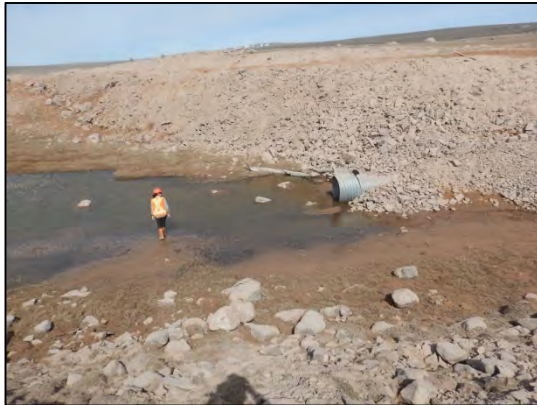
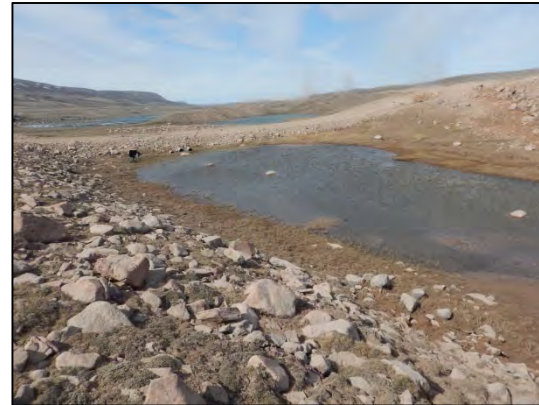
Summary: Some ponding occurs upstream of the Tote Road culvert, but there is no channel or surface water downstream of the road. There is no connection to or access from Phillips Creek for fish.

Photos 1. Photographs upstream (top) and downstream (bottom) of the Tote Road crossing CV-120; (A,C) looking upstream; and (B,D) looking downstream.

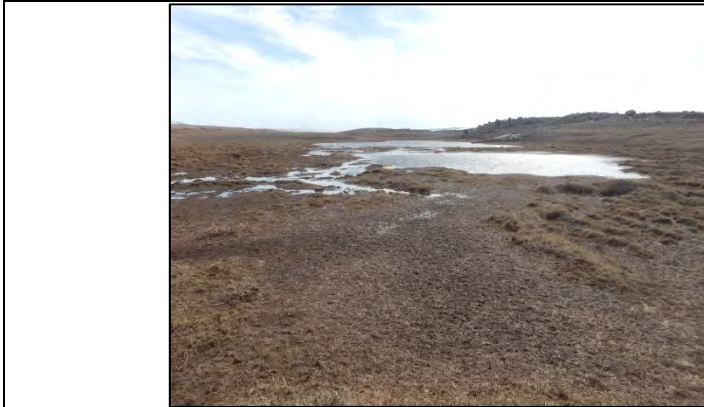
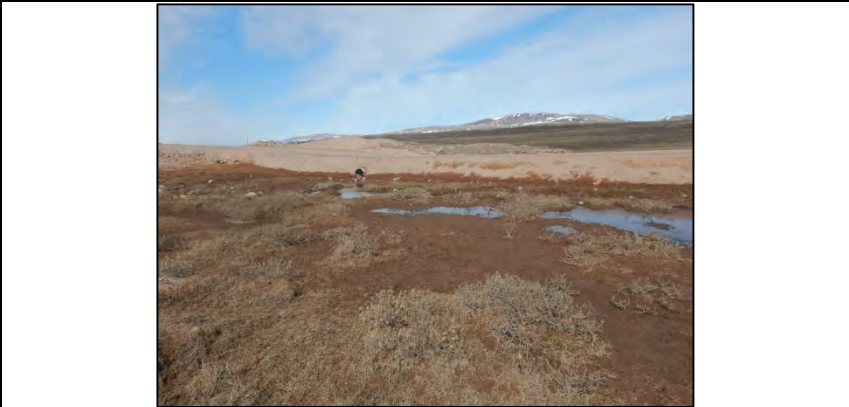
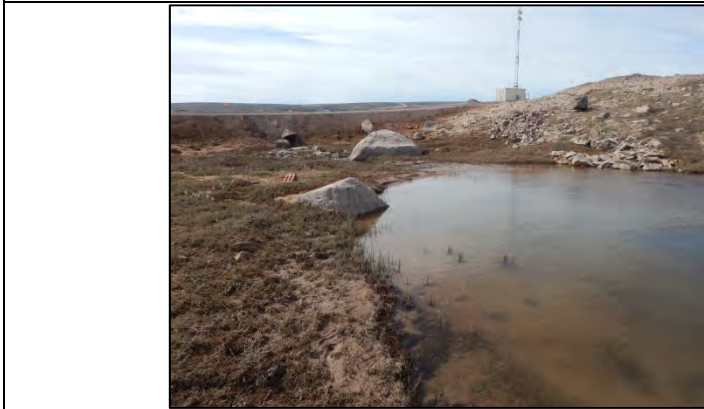
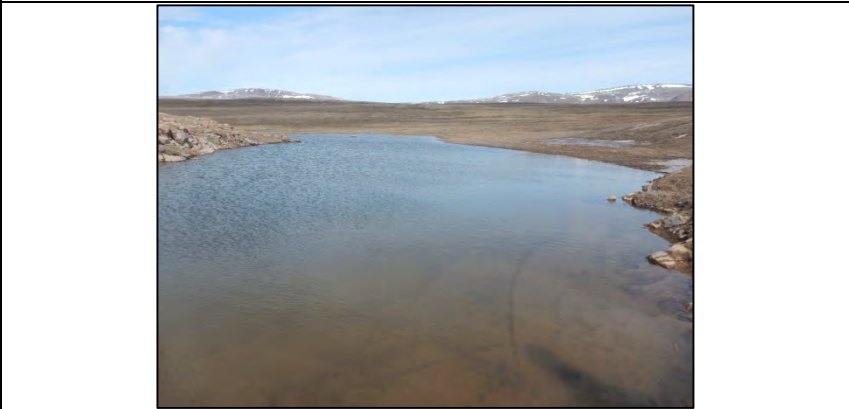
Summary: There is a shallow pond immediately downstream from the Tote Road culvert. Downstream from the pond, the channel disappears and surface water becomes patchy, shallow, and dispersed over terrestrial grasses as it flows towards the crossing at CV-120. There is no natural connectivity to Phillips Creek.

Photos 1. Photographs upstream of the Tote Road crossing CV-119: (A) looking upstream; (B) looking downstream; and photographs downstream of the Tote Road: (C) looking upstream; and (D) looking downstream.

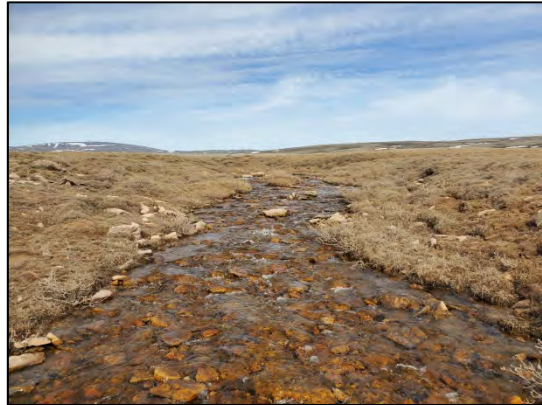
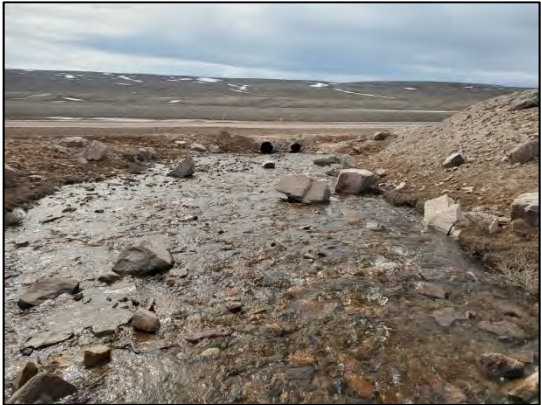
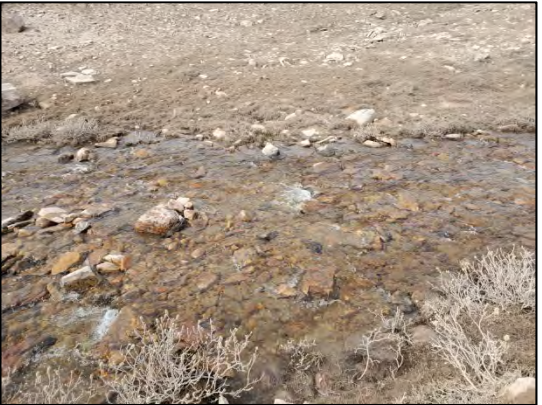
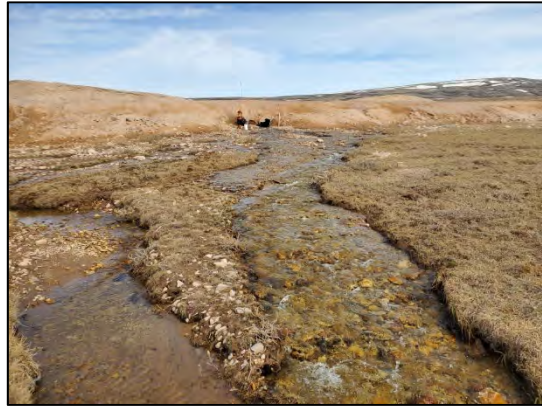
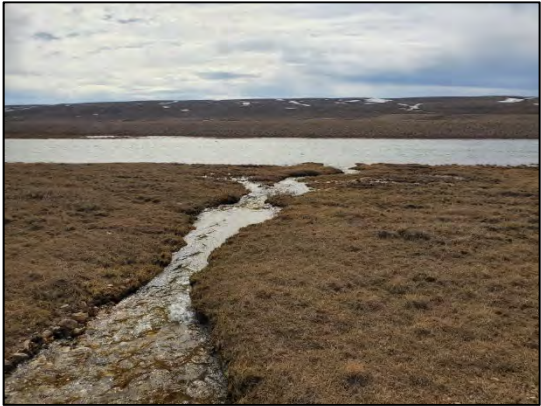
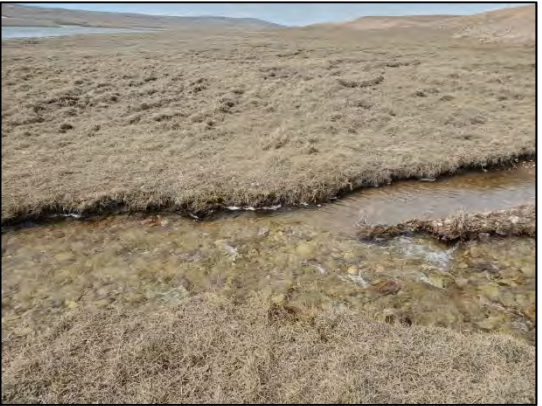
Summary: This stream provides habitat for juvenile Arctic Char. Perched culverts that may affect upstream access were remediated in fall 2019 and minor repairs to the works were completed in fall 2020.

Photos 1. Photographs upstream (top) and downstream (bottom) of the Tote Road crossing CV-114: (A,D) looking upstream; (B,E) looking downstream; and (C,F) looking across.

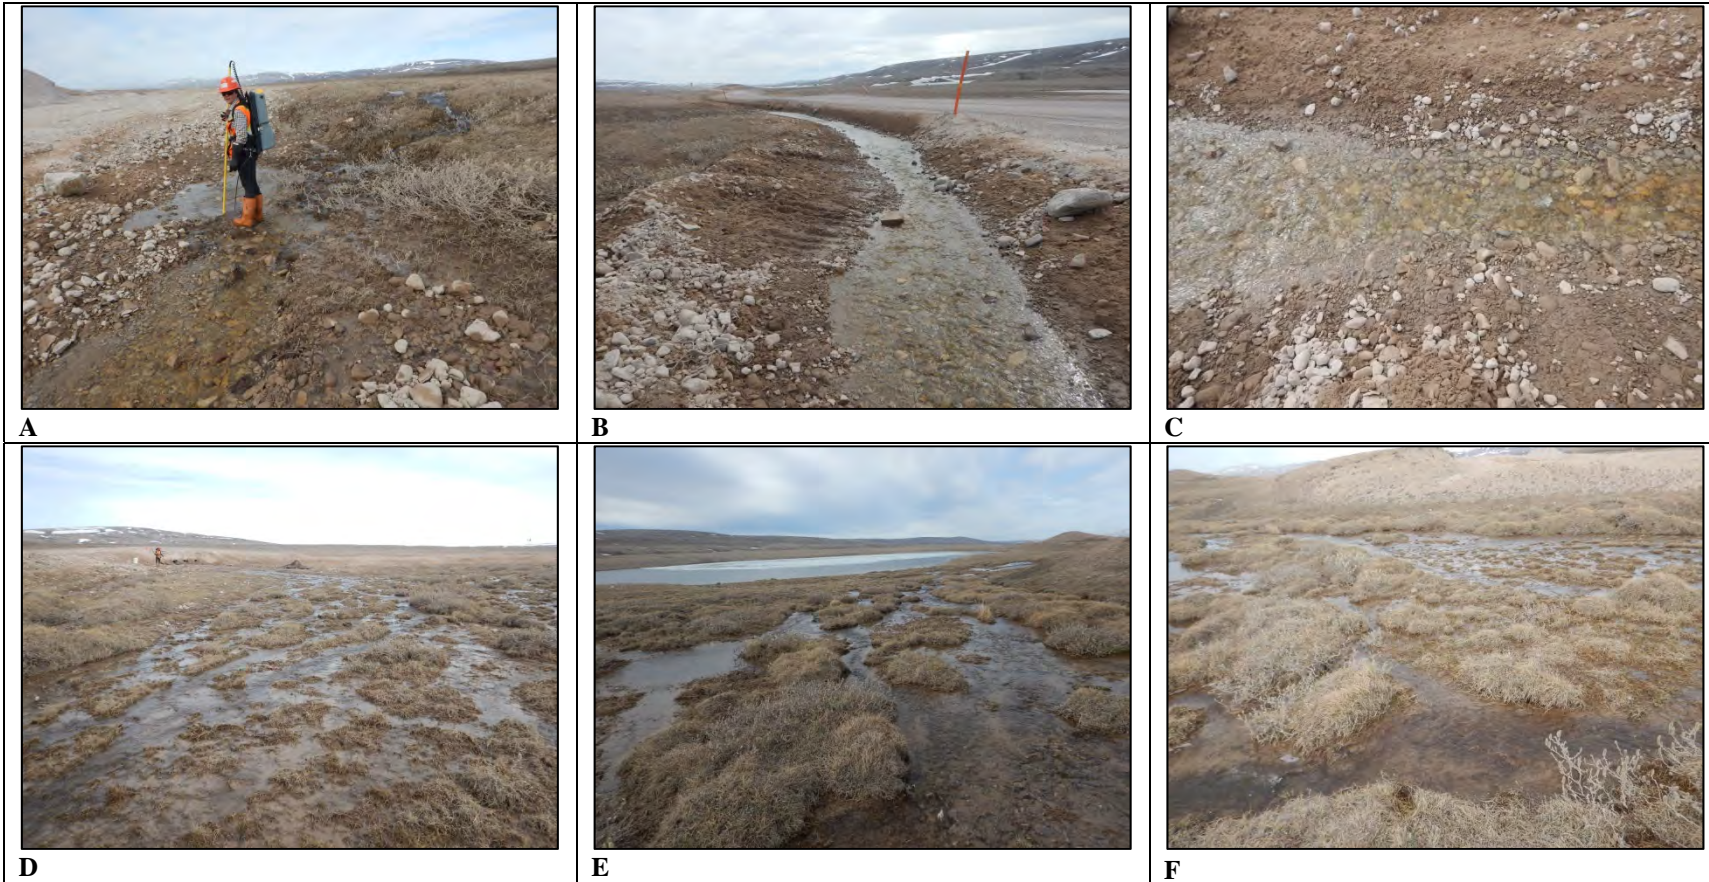
Summary: Site is dry most of the open-water season and lacks a defined channel and connectivity with Phillips Creek. Some surface melt was present during the freshet in spring 2020, but flows were dispersed over the tundra downstream of the road. The stream typically dries shortly after freshet.

Photos 1. Photographs upstream (top) and downstream (bottom) of the Tote Road crossing CV-113: (A,D) looking upstream; (B,E) looking downstream; and (C,F) looking across.

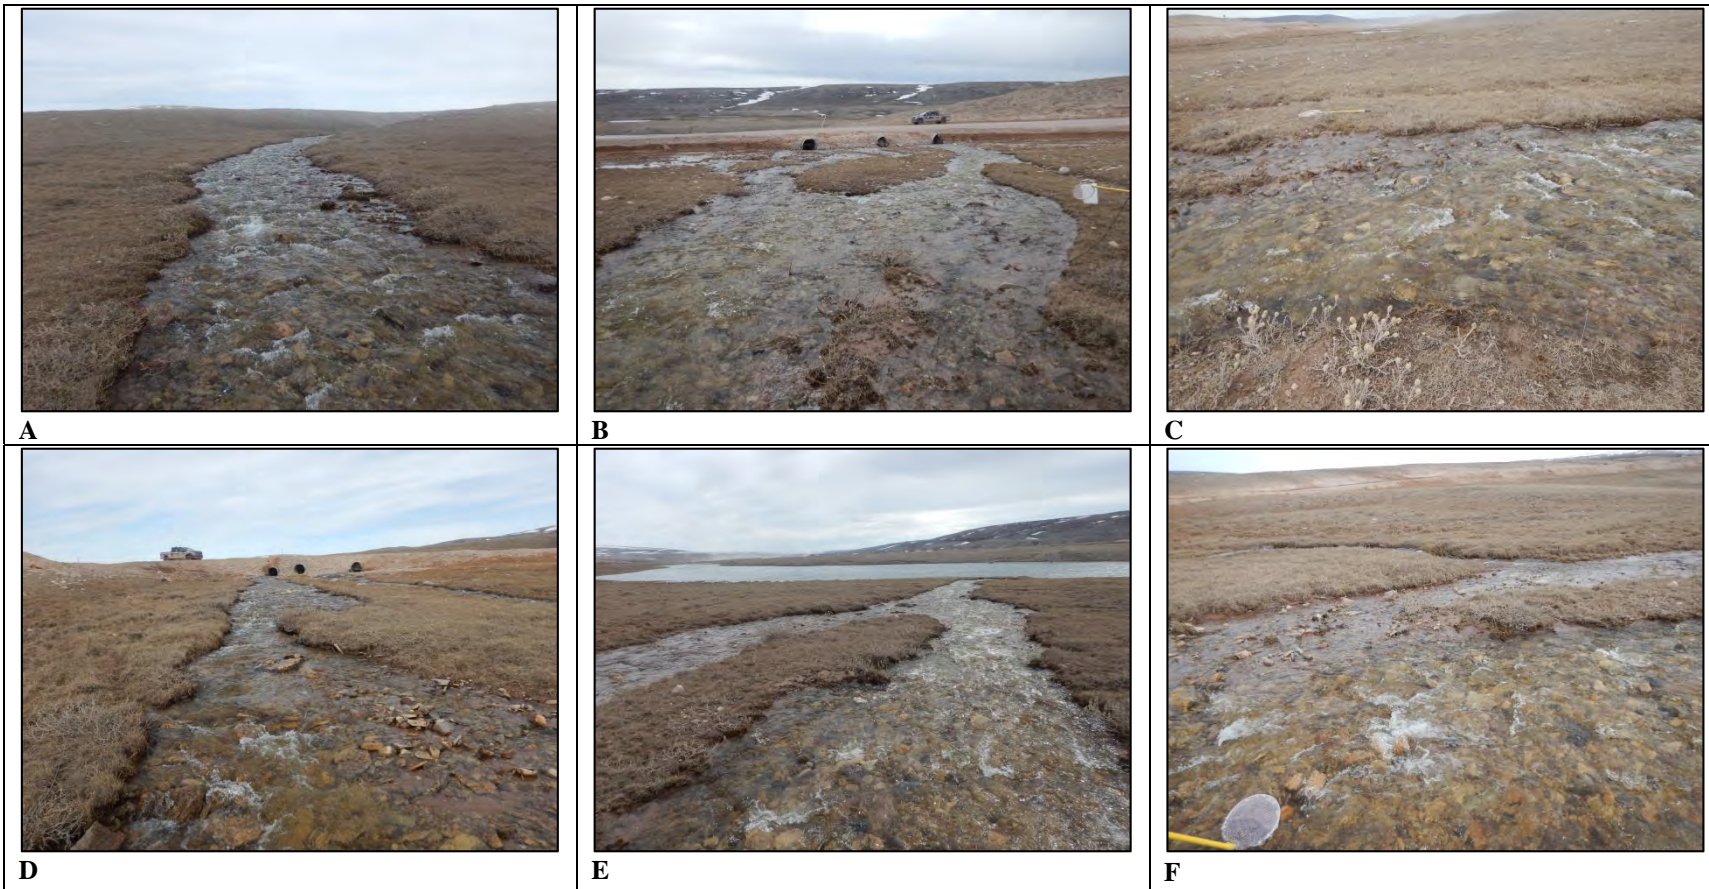
Summary: This stream provides summer rearing habitat for juvenile Arctic Char. There are no fish passage issues.

Photos 1. Photographs upstream (top) and downstream (bottom) of the Tote Road crossing CV-112: (A,D) looking upstream; (B,E) looking downstream; and (C,F) looking across.

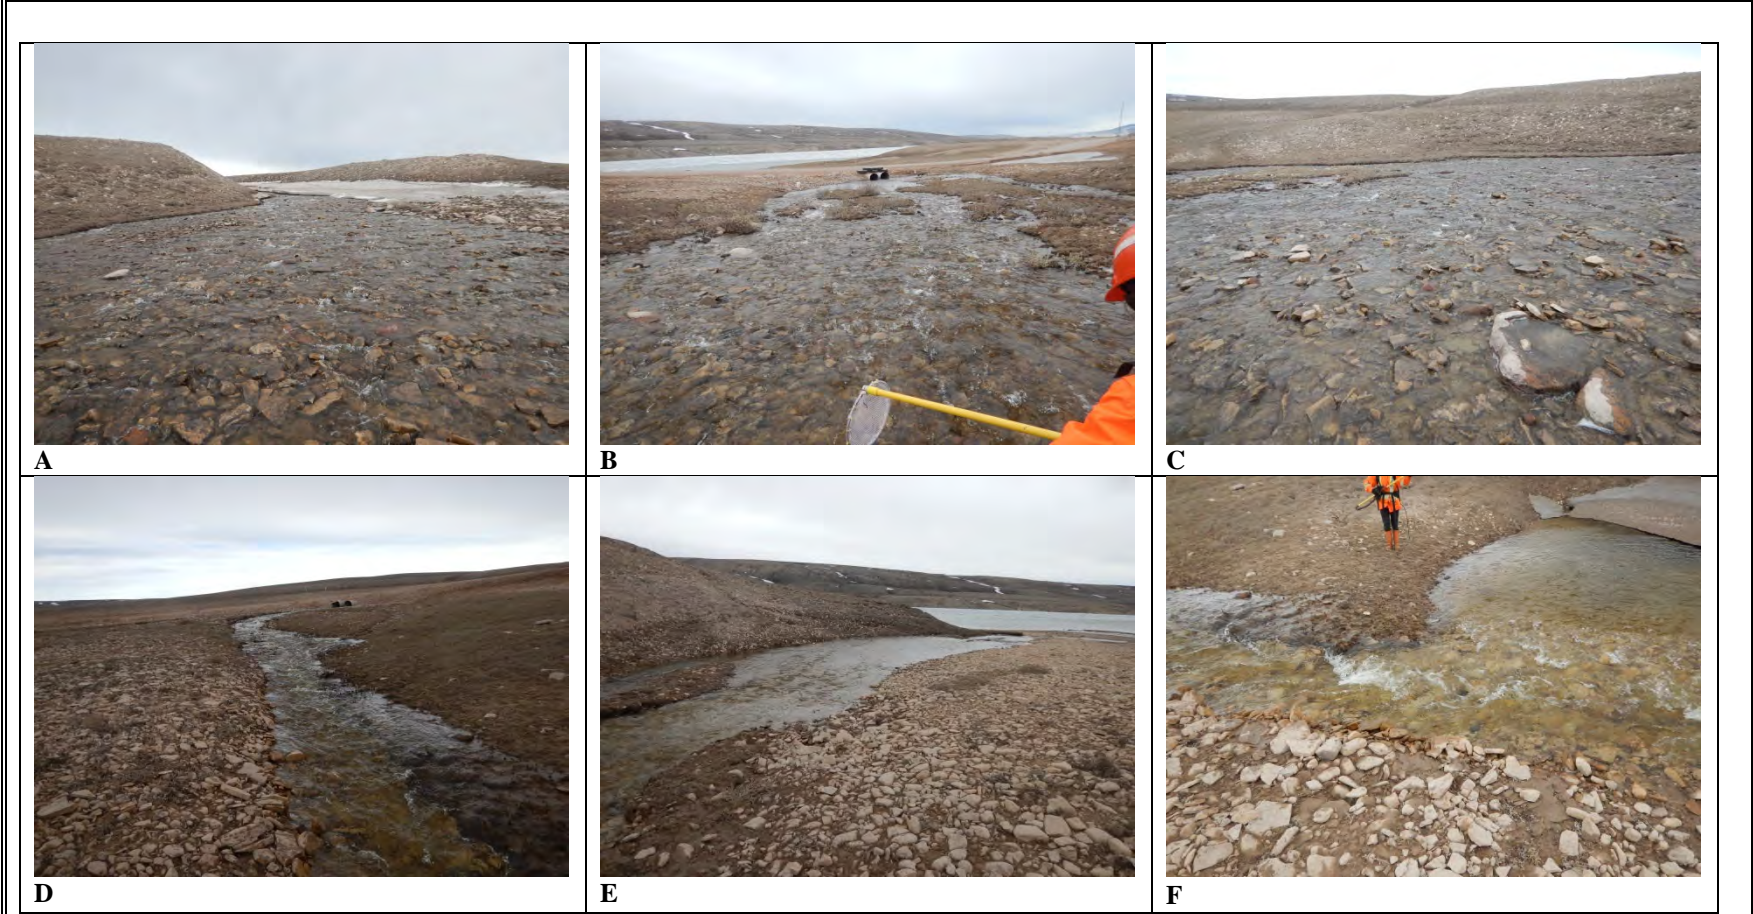
Summary: Though water levels are occasionally low (as in 2019), this stream typically provides summer rearing habitat for juvenile Arctic Char. There were no passage issues identified in 2020.

Photos 1. Photographs upstream (top) and downstream (bottom) of the Tote Road crossing CV-104: (A,D) looking upstream; (B,E) looking downstream; and (C,F) looking across.

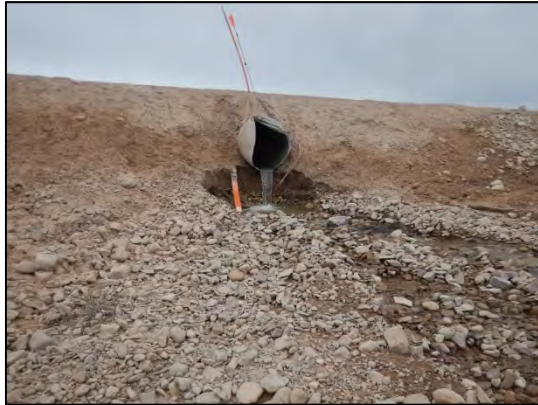
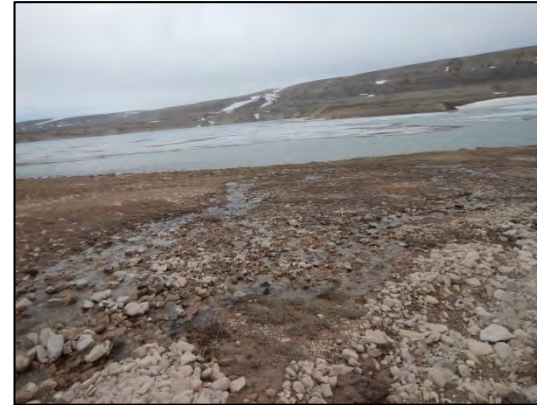
Summary: Stream is typically dry immediately after the freshet. Downstream of the crossing, the channel disappears over a steep gradient. There is no sustained connectivity to Phillips Creek.

Photos 1. Photographs downstream of the Tote Road crossing CV-203: (A) looking upstream; and (B) looking downstream towards Phillips Creek.

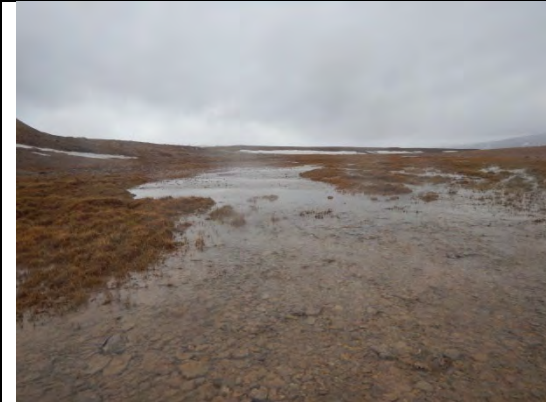
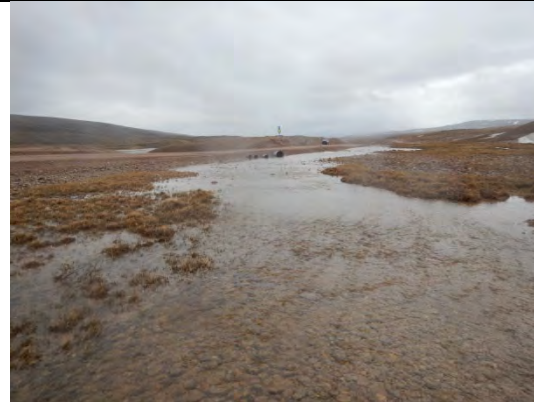
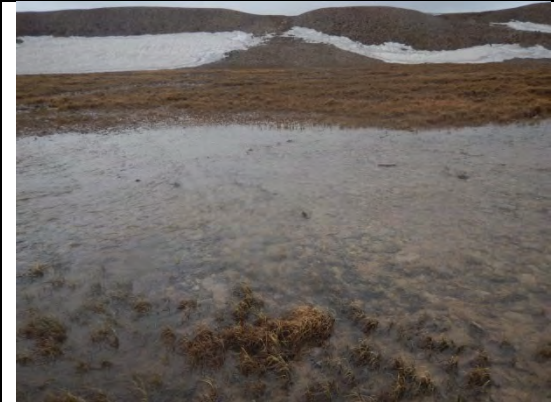
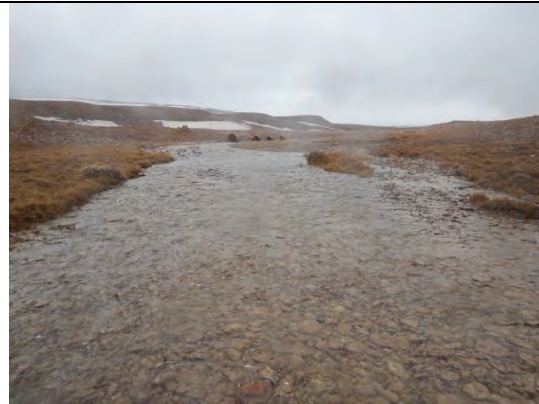
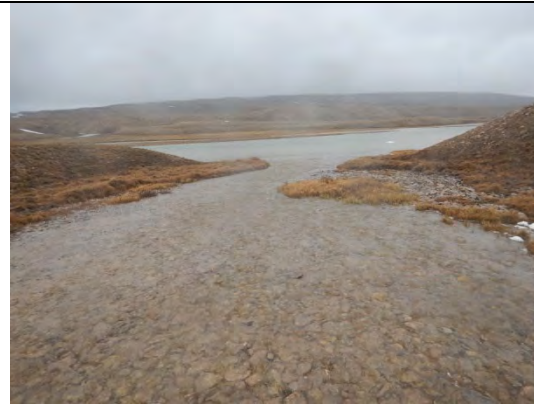
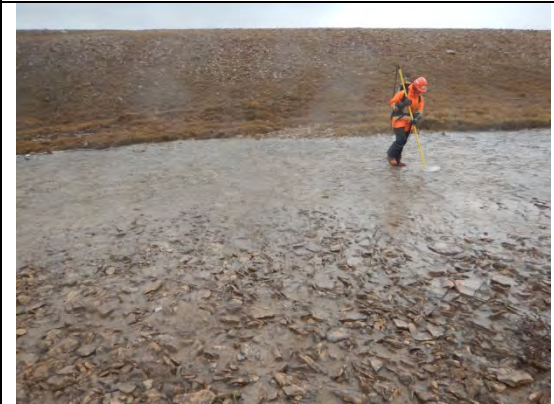
Summary: This stream typically provides summer rearing habitat for juvenile Arctic Char. There were no fish passage issues identified in 2020.

Photos 1. Photographs upstream (top) and downstream (bottom) of the Tote Road crossing CV-102: (A,D) looking upstream; (B,E) looking downstream; and (C,F) looking across.

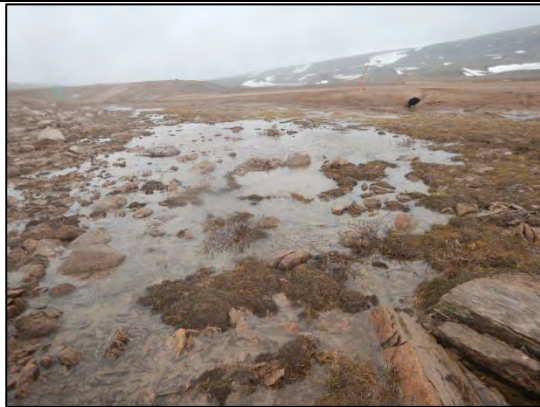
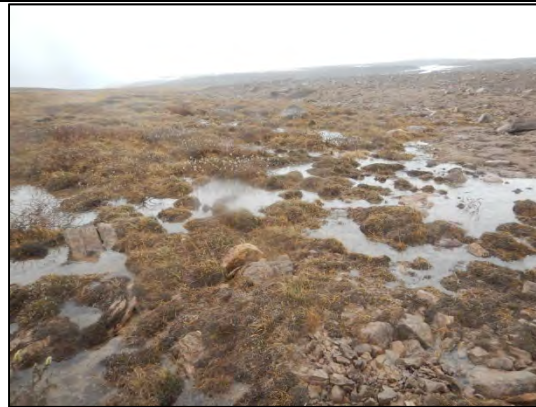
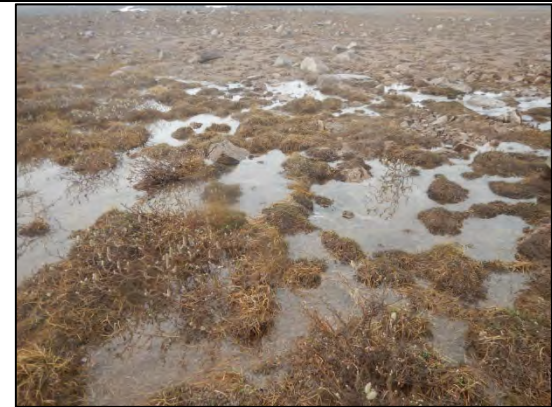
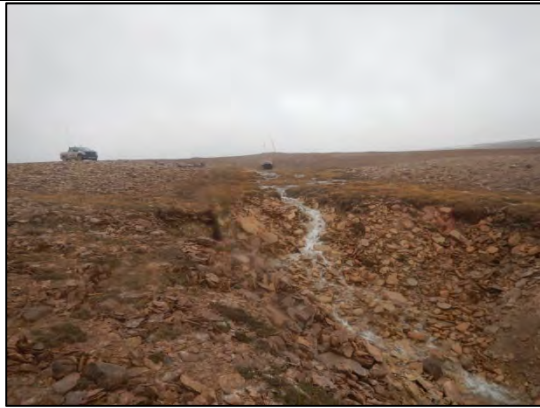
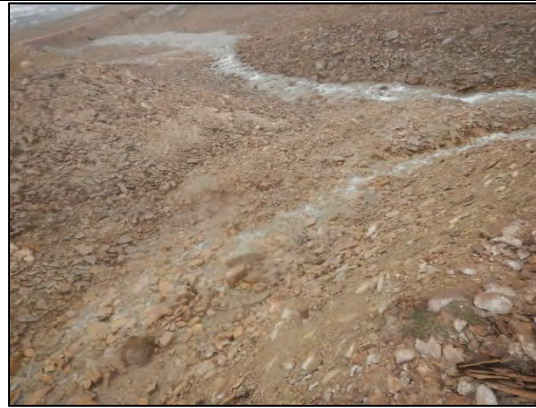
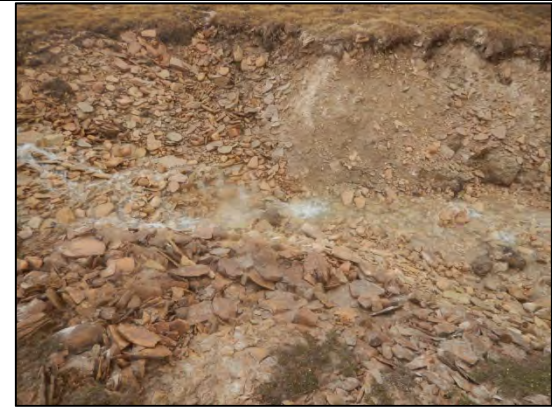
Summary: No natural channel and surface water dries up shortly after peak freshet. There is also a steep gradient downstream from the road that prevents fish access to the area and the crossing lacks connectivity to overwintering habitat.

Photos 1. Photographs upstream (top) and downstream (bottom) of the Tote Road crossing CV-086: (A,D) looking upstream; (B,E) looking downstream; and (C,F) looking across.

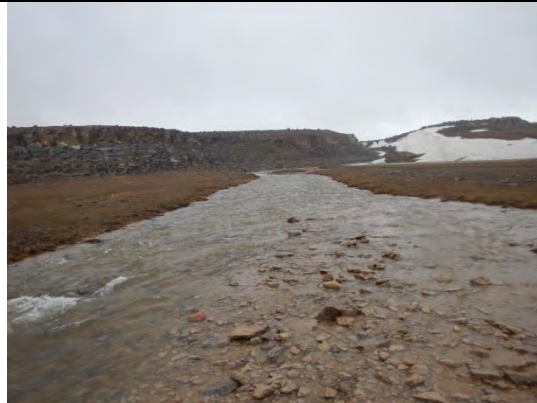
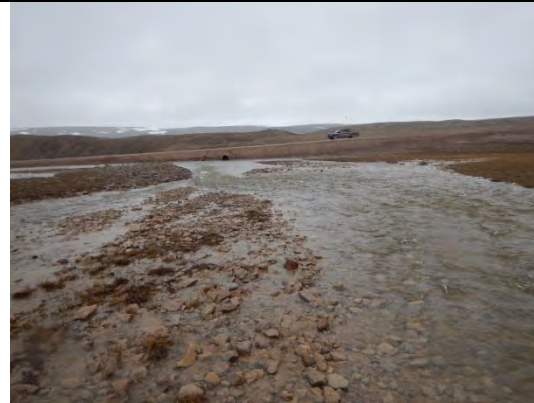
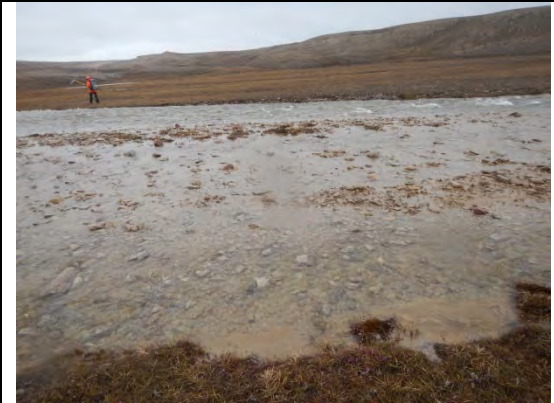
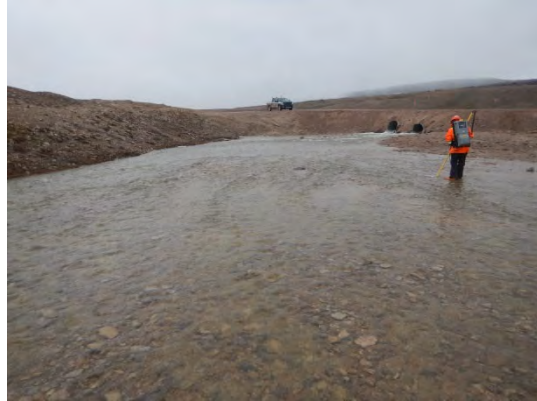
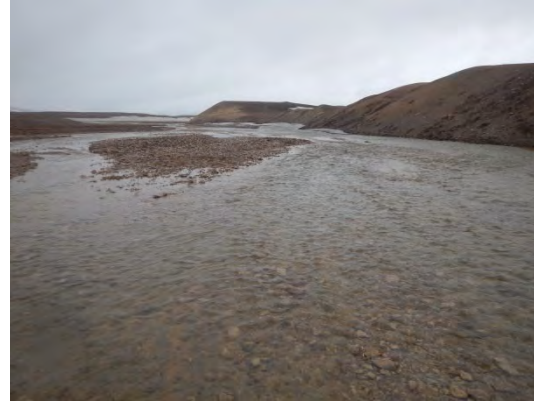
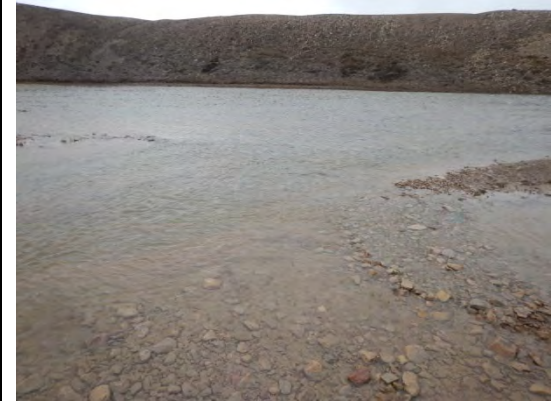
Summary: Site provides abundant summer rearing habitat for juvenile Arctic Char. There were no fish passage issues identified in 2020.

Photos 1. Photographs upstream (top) and downstream (bottom) of the Tote Road crossing CV-079: (A,D) looking upstream; (B,E) looking downstream; and (C,F) looking across.
