**BAFFINLAND IRON MINES CORPORATION
MARY RIVER PROJECT**

**TOTE ROAD FISH HABITAT MONITORING
2020 ANNUAL REPORT
EARLY REVENUE PHASE - TOTE ROAD UPGRADES**

2020-12-29	0

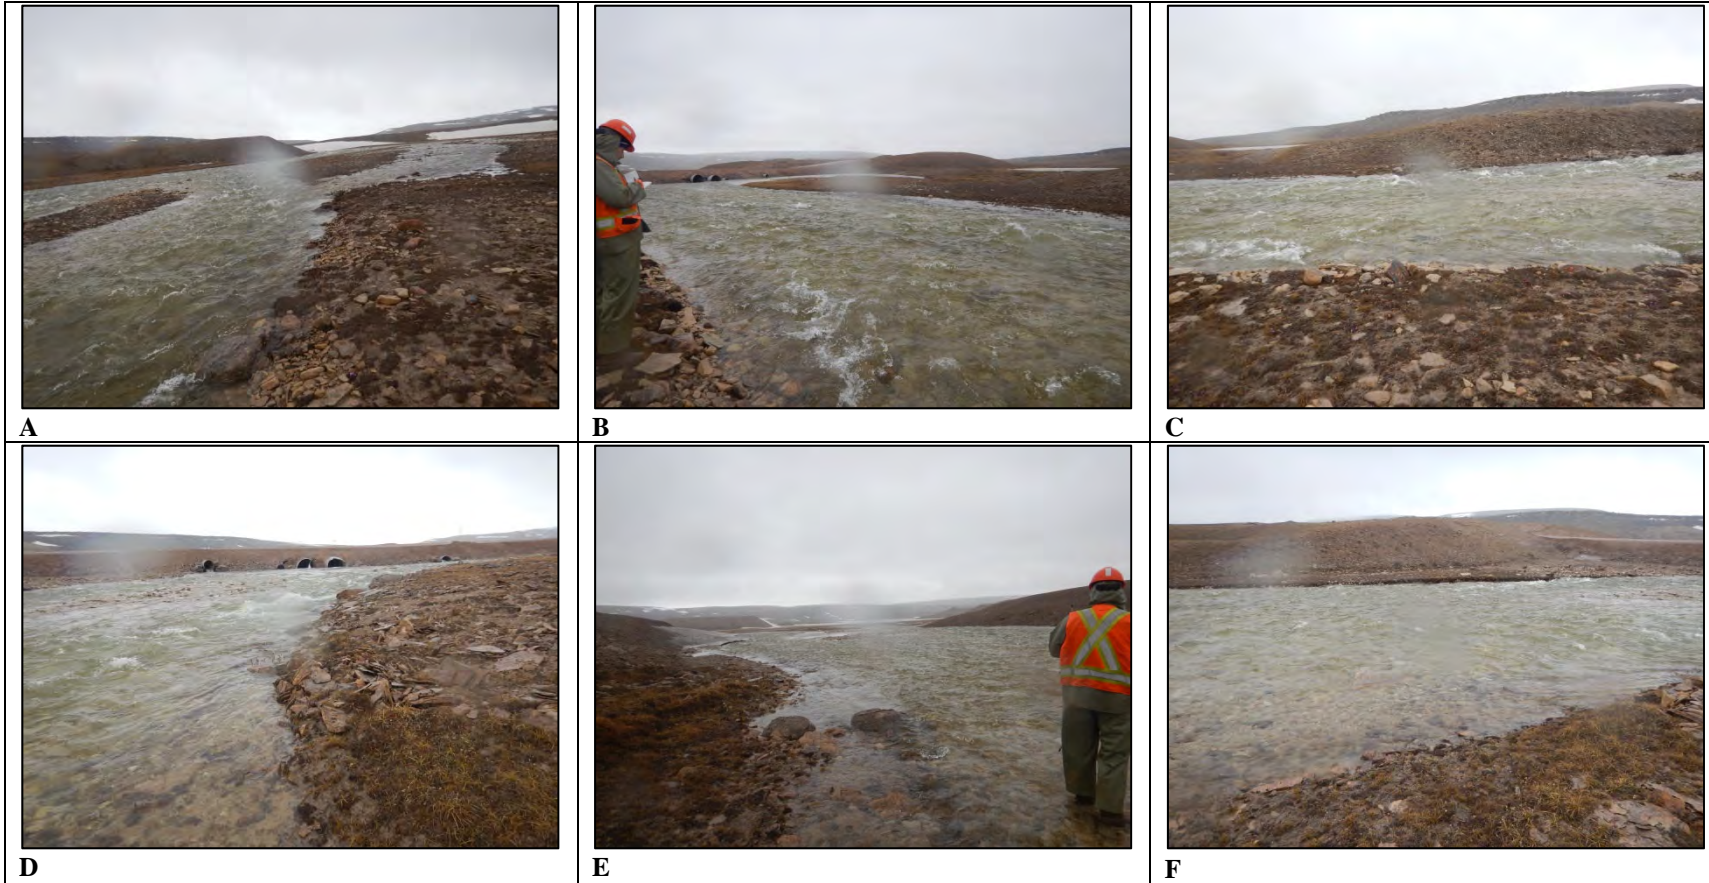
Summary: Site provides abundant summer rearing habitat for juvenile Arctic Char. There were no fish passage issues identified in 2020.

Photos 1. Photographs upstream (top) and downstream (bottom) of the Tote Road crossing CV-078: (A,D) looking upstream; (B,E) looking downstream; and (C,F) looking across.

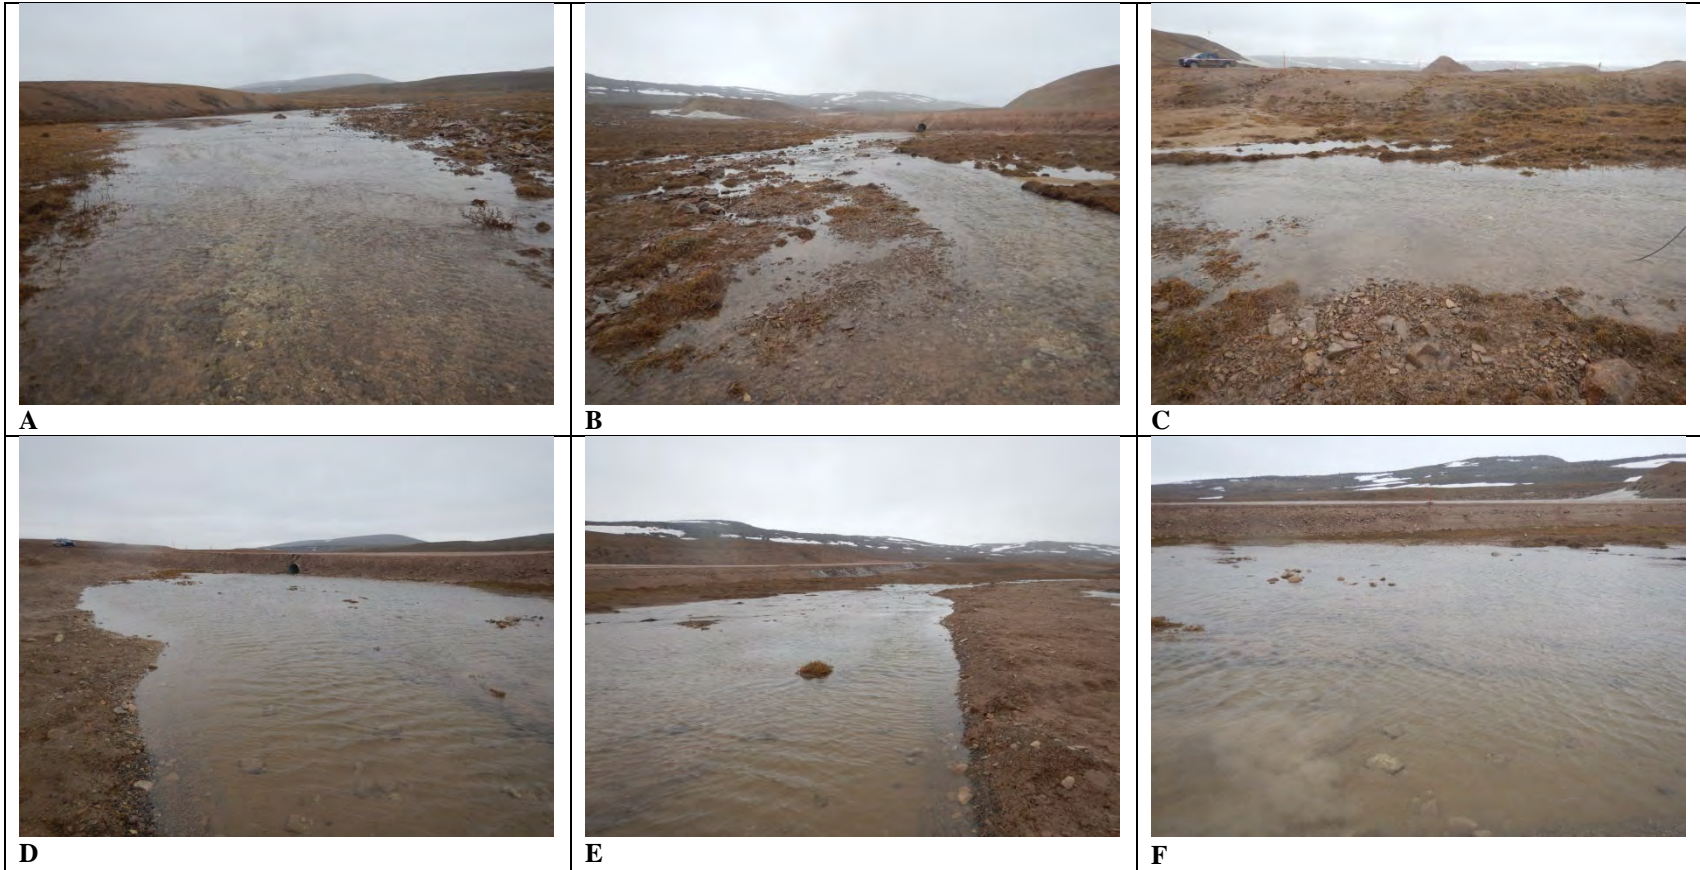
Summary: Small stream providing summer rearing habitat for juvenile Arctic Char. There was some flow observed underneath the road 5 m south of the culvert. This has not been previously observed and likely only occurs during peak freshet. There were no issues affecting fish passage in 2020.

Photos 1. Photographs upstream (top) and downstream (bottom) of the Tote Road crossing CV-076: (A,D) looking upstream; (B,E) looking downstream; and (C,F) looking across.

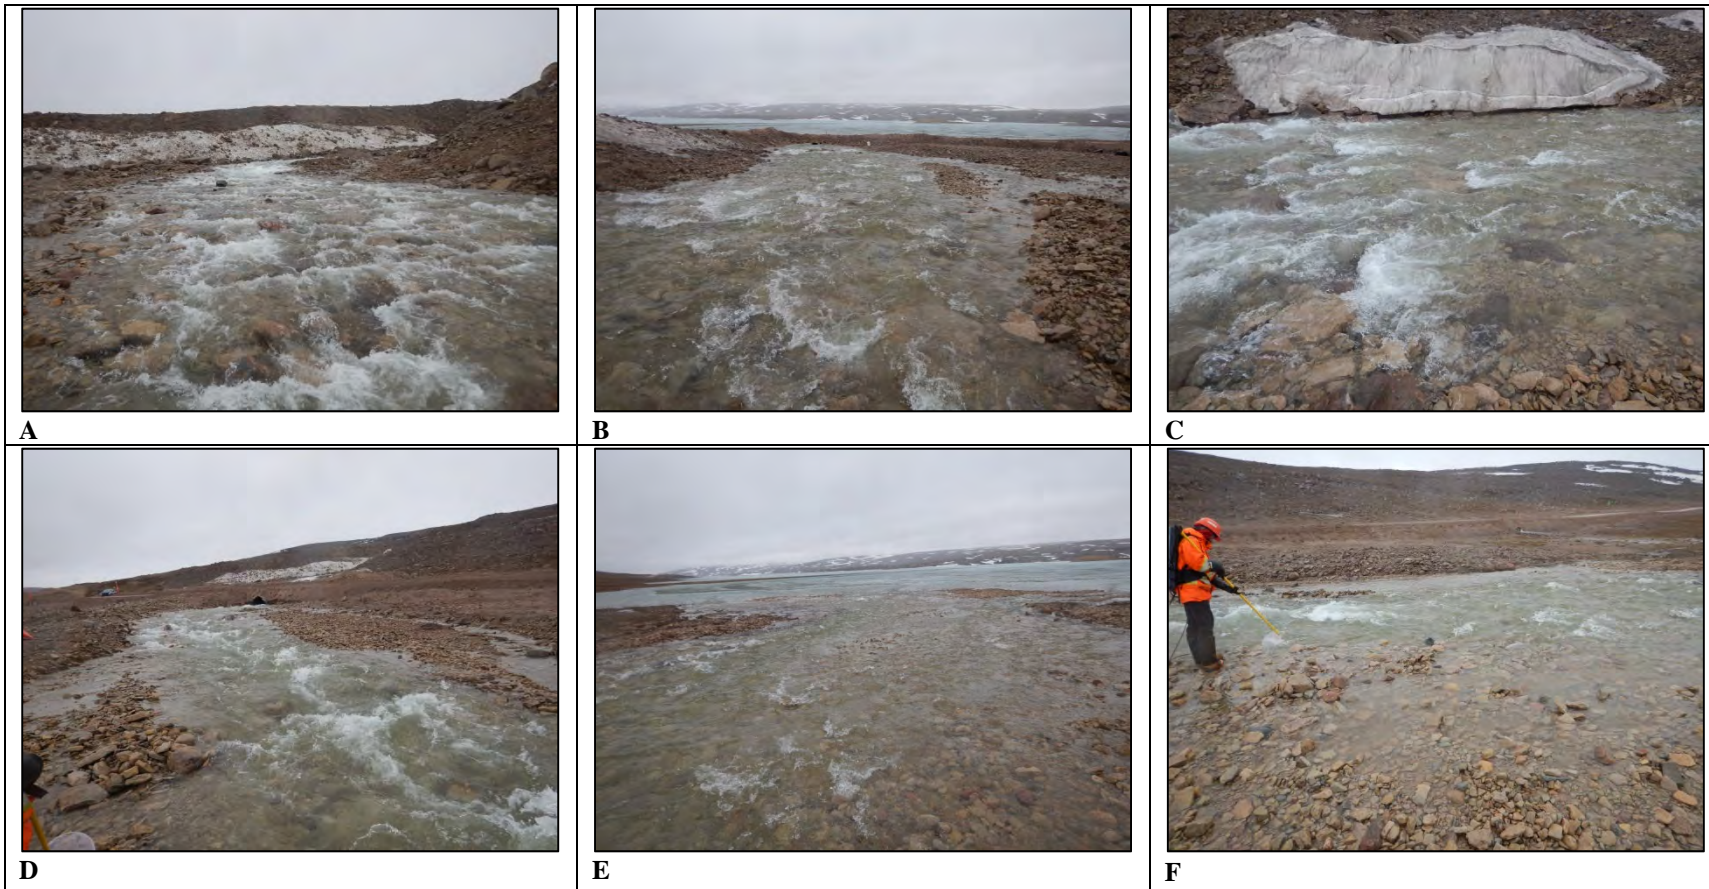
Summary: Site provides abundant summer rearing habitat for juvenile Arctic Char. There were no fish passage issues identified in 2020.

Photos 1. Photographs upstream (top) and downstream (bottom) of the Tote Road crossing CV-072: (A,D) looking upstream; (B,E) looking downstream; and (C,F) looking across.

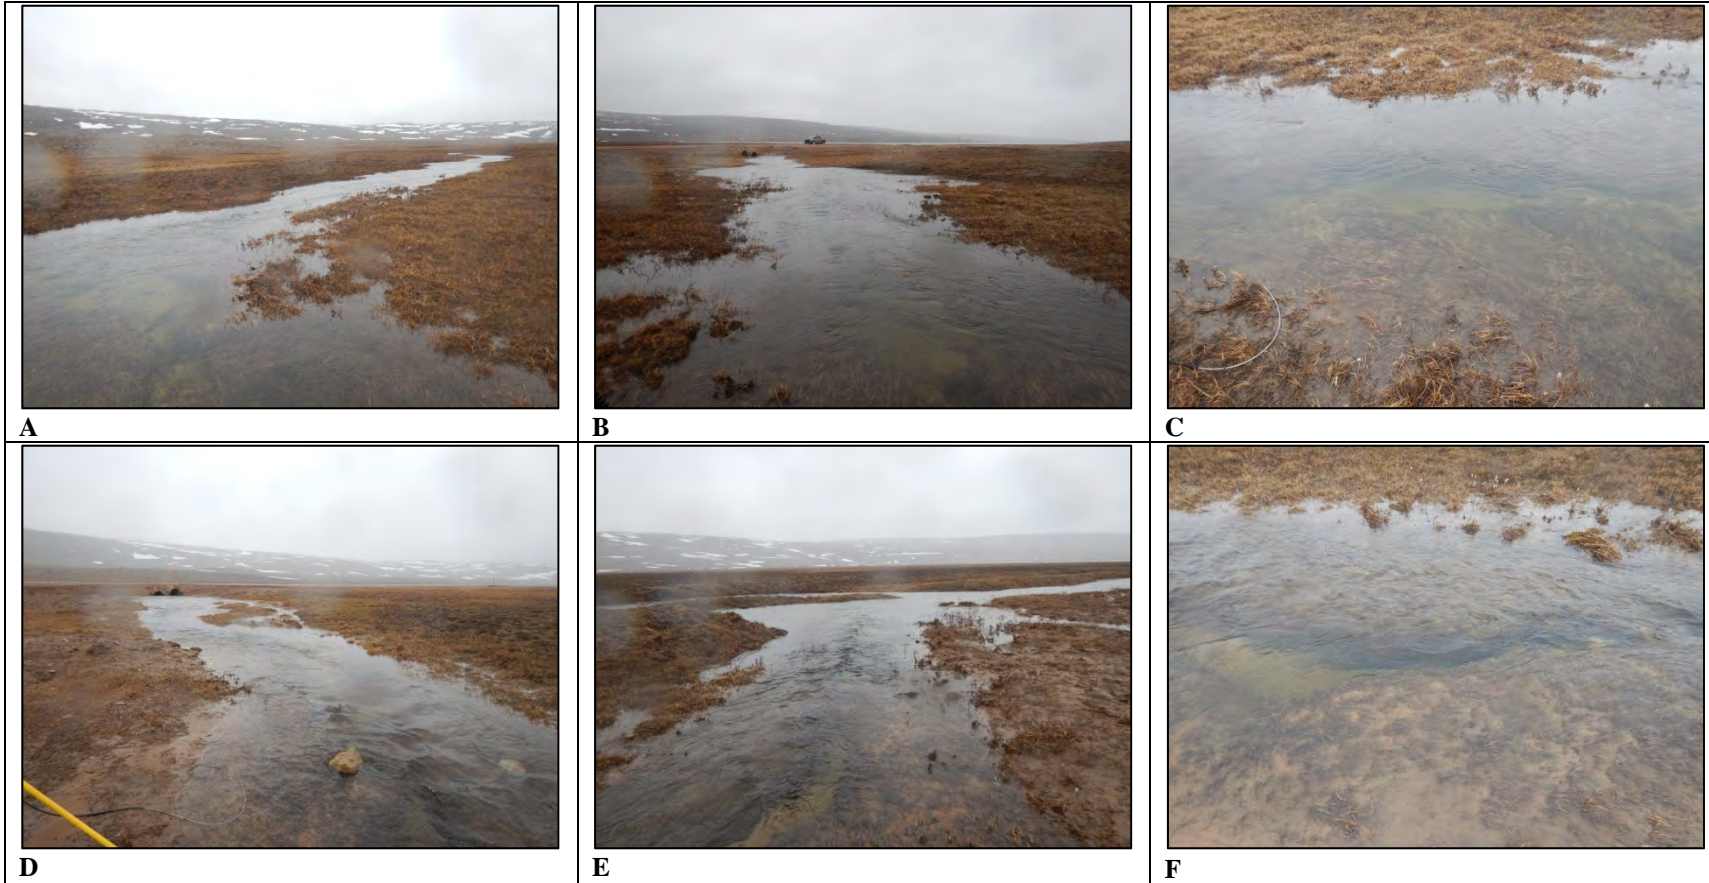
Summary: Site provides abundant summer rearing habitat for juvenile Arctic Char. There were no fish passage issues identified in 2020.

Photos 1. Photographs upstream (top) and downstream (bottom) of the Tote Road crossing CV-060: (A,D) looking upstream; (B,E) looking downstream; and (C,F) looking across.

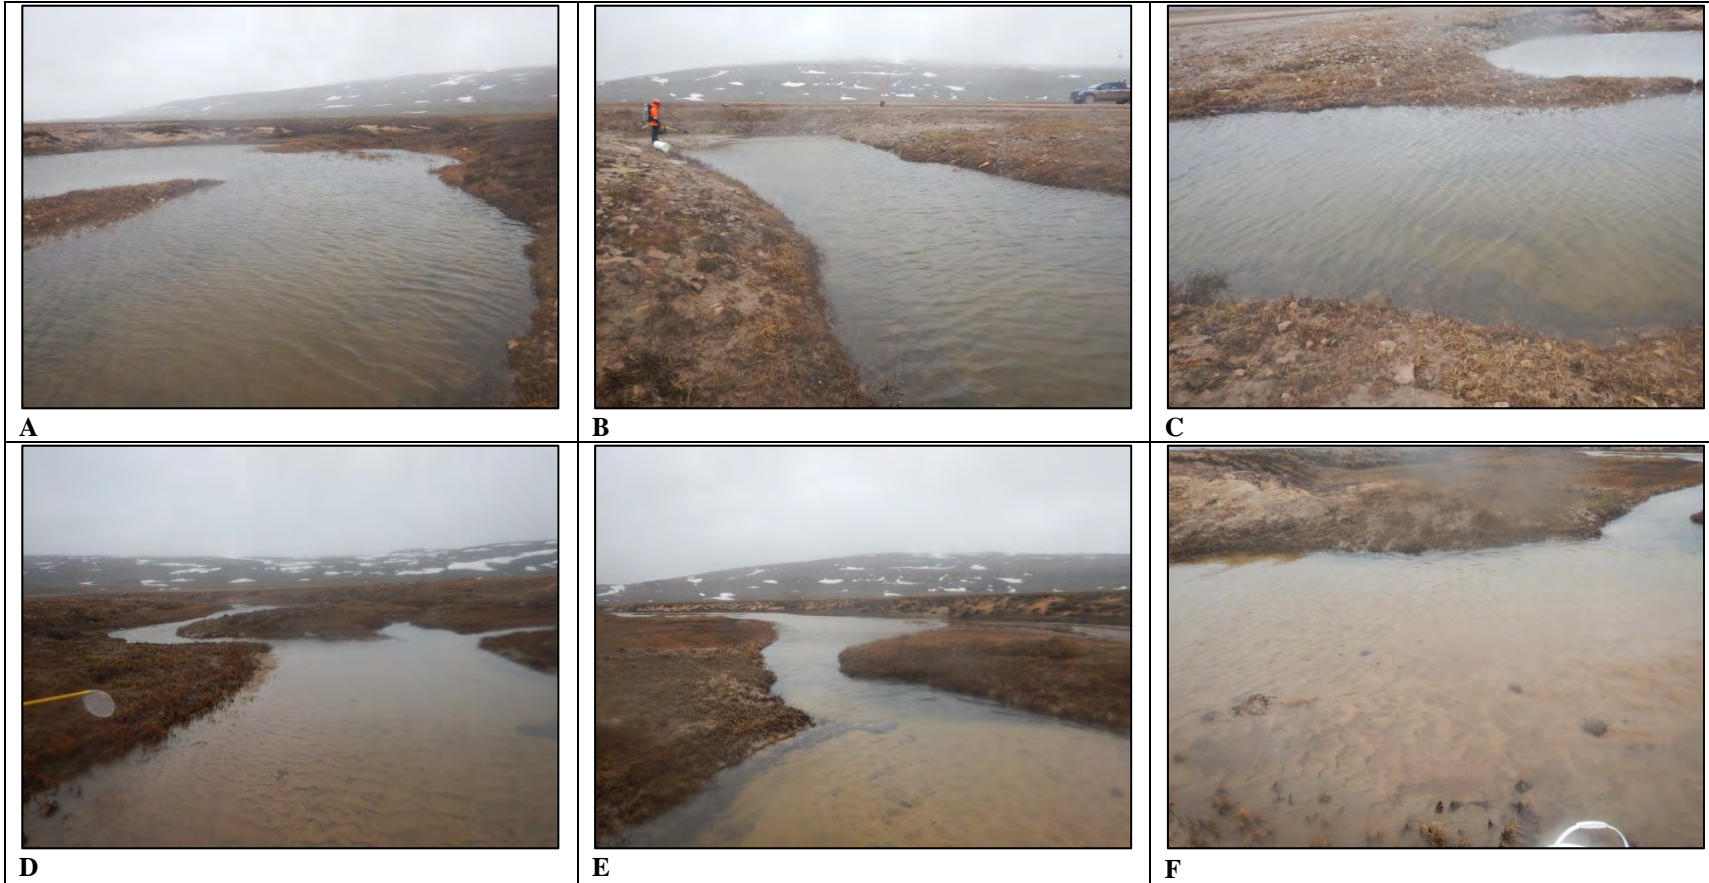
Summary: Site provides abundant summer rearing habitat for juvenile Arctic Char. There were no fish passage issues identified in 2020.

Photos 1. Photographs upstream (top) and downstream (bottom) of the Tote Road crossing CV-059: (A,D) looking upstream; (B,E) looking downstream; and (C,F) looking across.

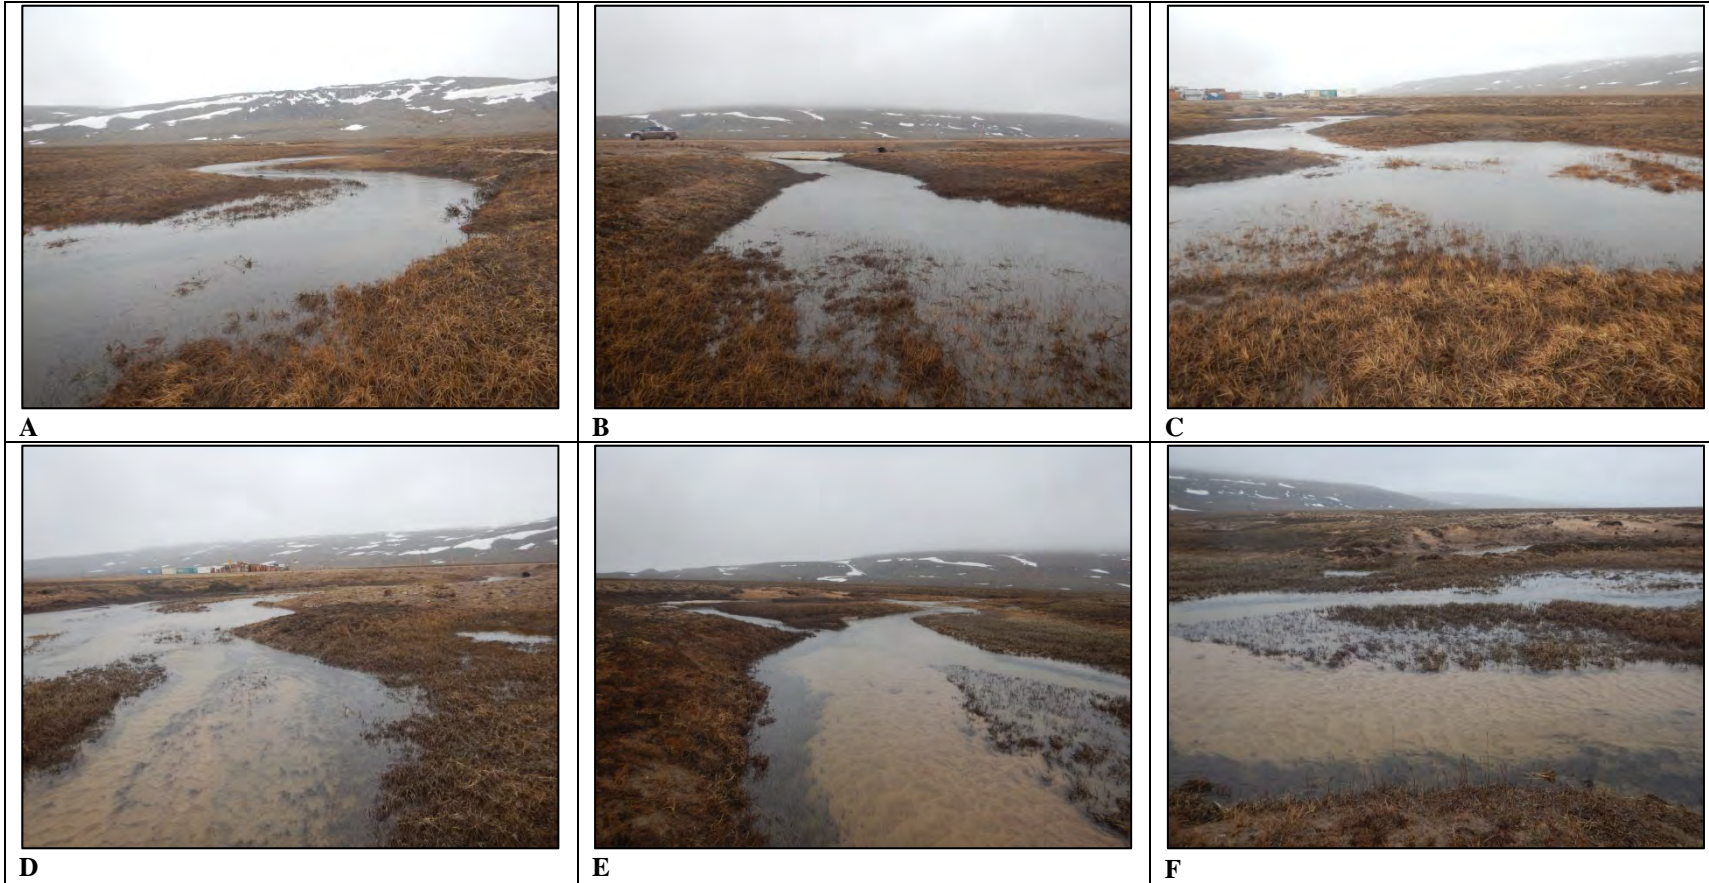
Summary: Site provides abundant summer rearing habitat for juvenile Arctic Char. There were no fish passage issues identified in 2020.

Photos 1. Photographs upstream (top) and downstream (bottom) of the Tote Road crossing CV-058: (A,D) looking upstream; (B,E) looking downstream; and (C,F) looking across.

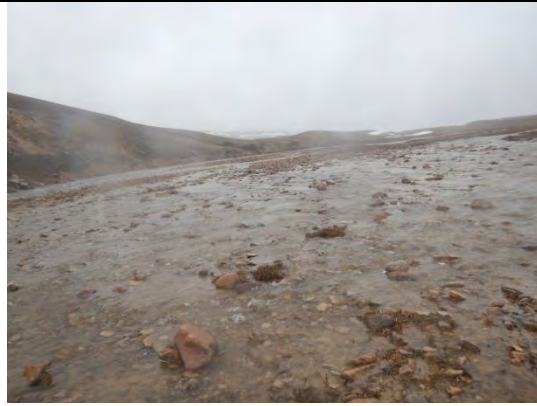
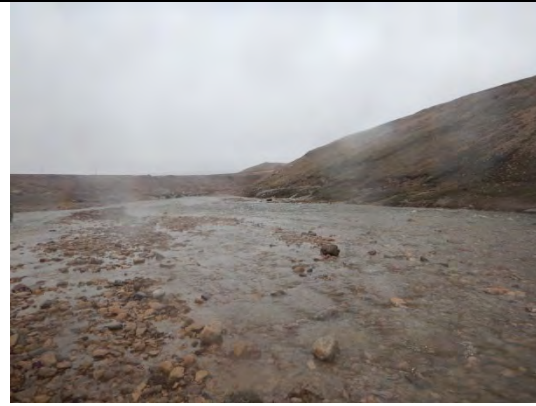
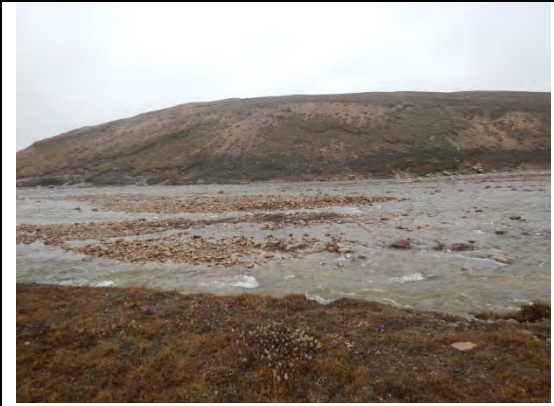
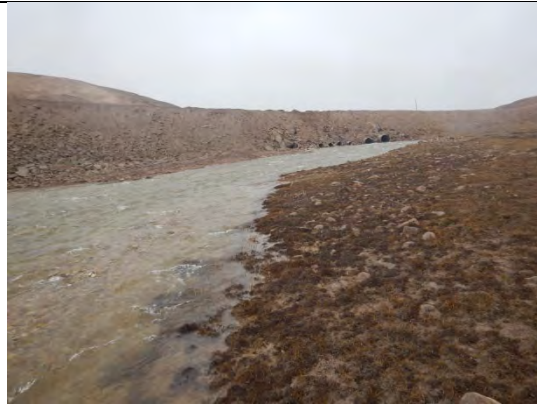
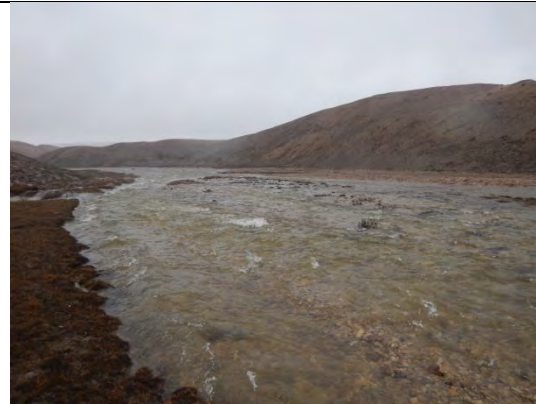
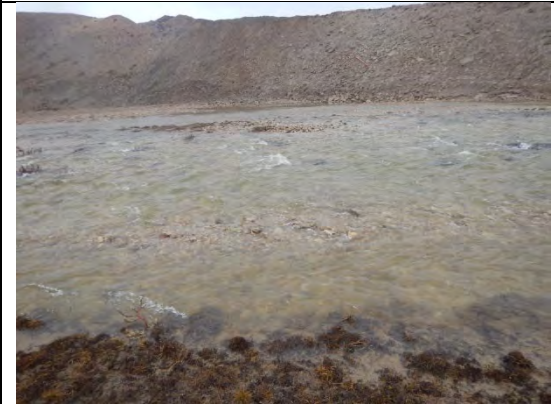
Summary: Site provides abundant summer rearing habitat for juvenile Arctic Char. There were no fish passage issues identified in 2020.

Photos 1. Photographs upstream (top) and downstream (bottom) of the Tote Road crossing CV-049: (A,D) looking upstream; (B,E) looking downstream; (C,F) looking across.

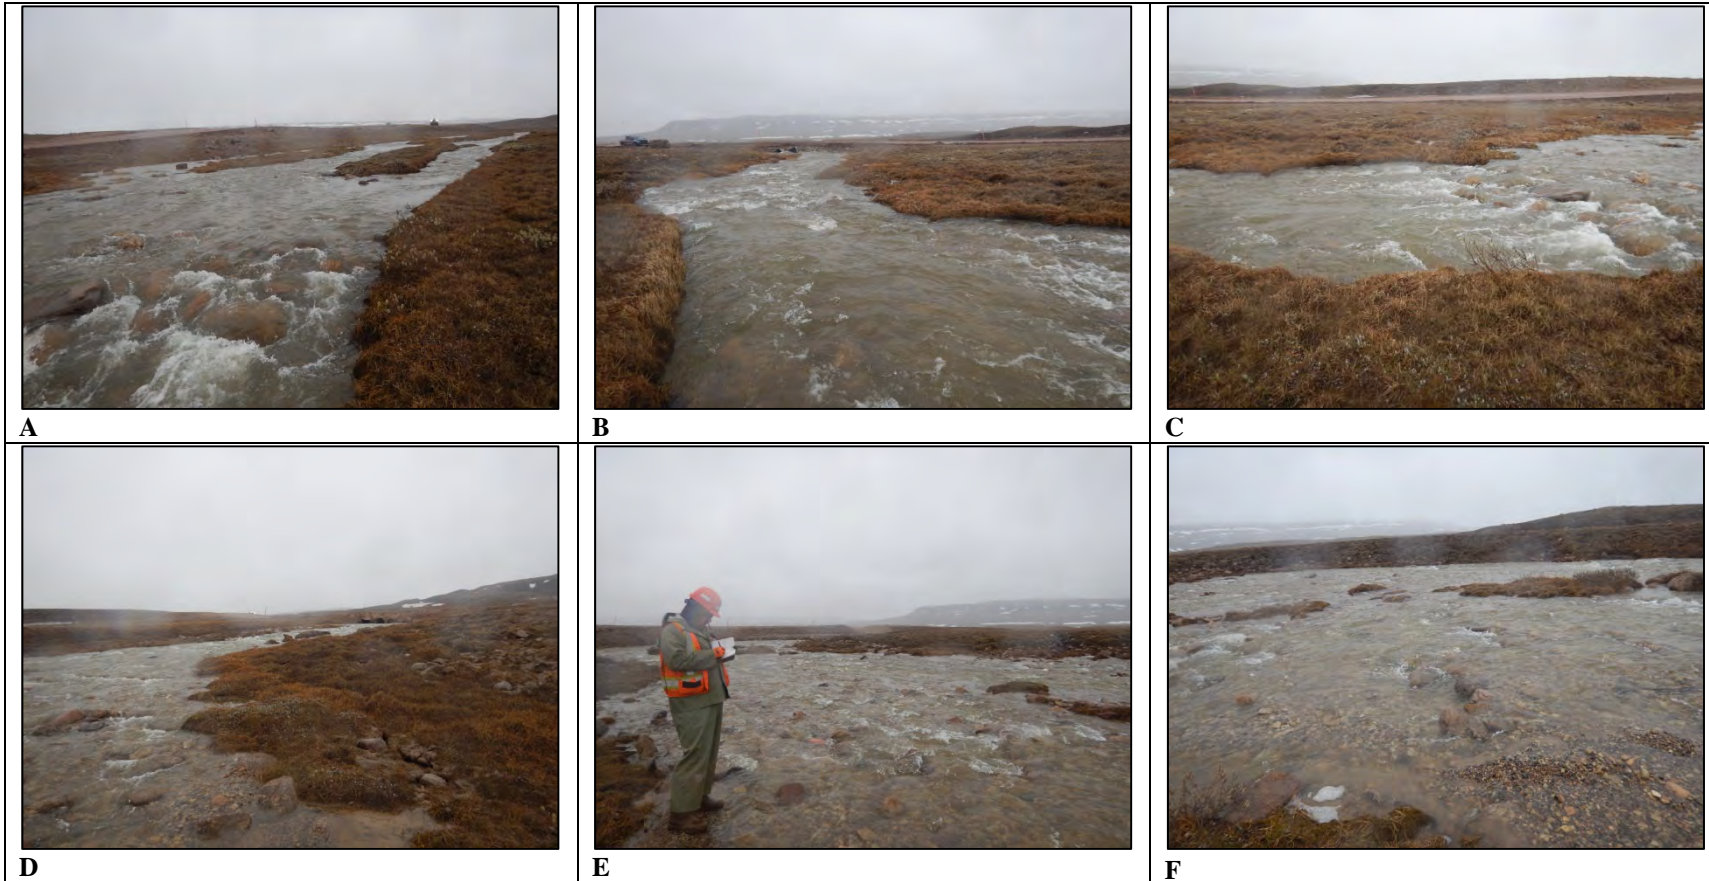
Summary: A persistent natural downstream subsurface flow barrier near the confluence with crossing CV-049 prevents fish access from downstream overwintering lakes.

Photos 1. Photographs upstream (top) and downstream (bottom) of the Tote Road crossing CV-048: (A,D) looking upstream; (B,E) looking downstream; and (C,F) looking across.

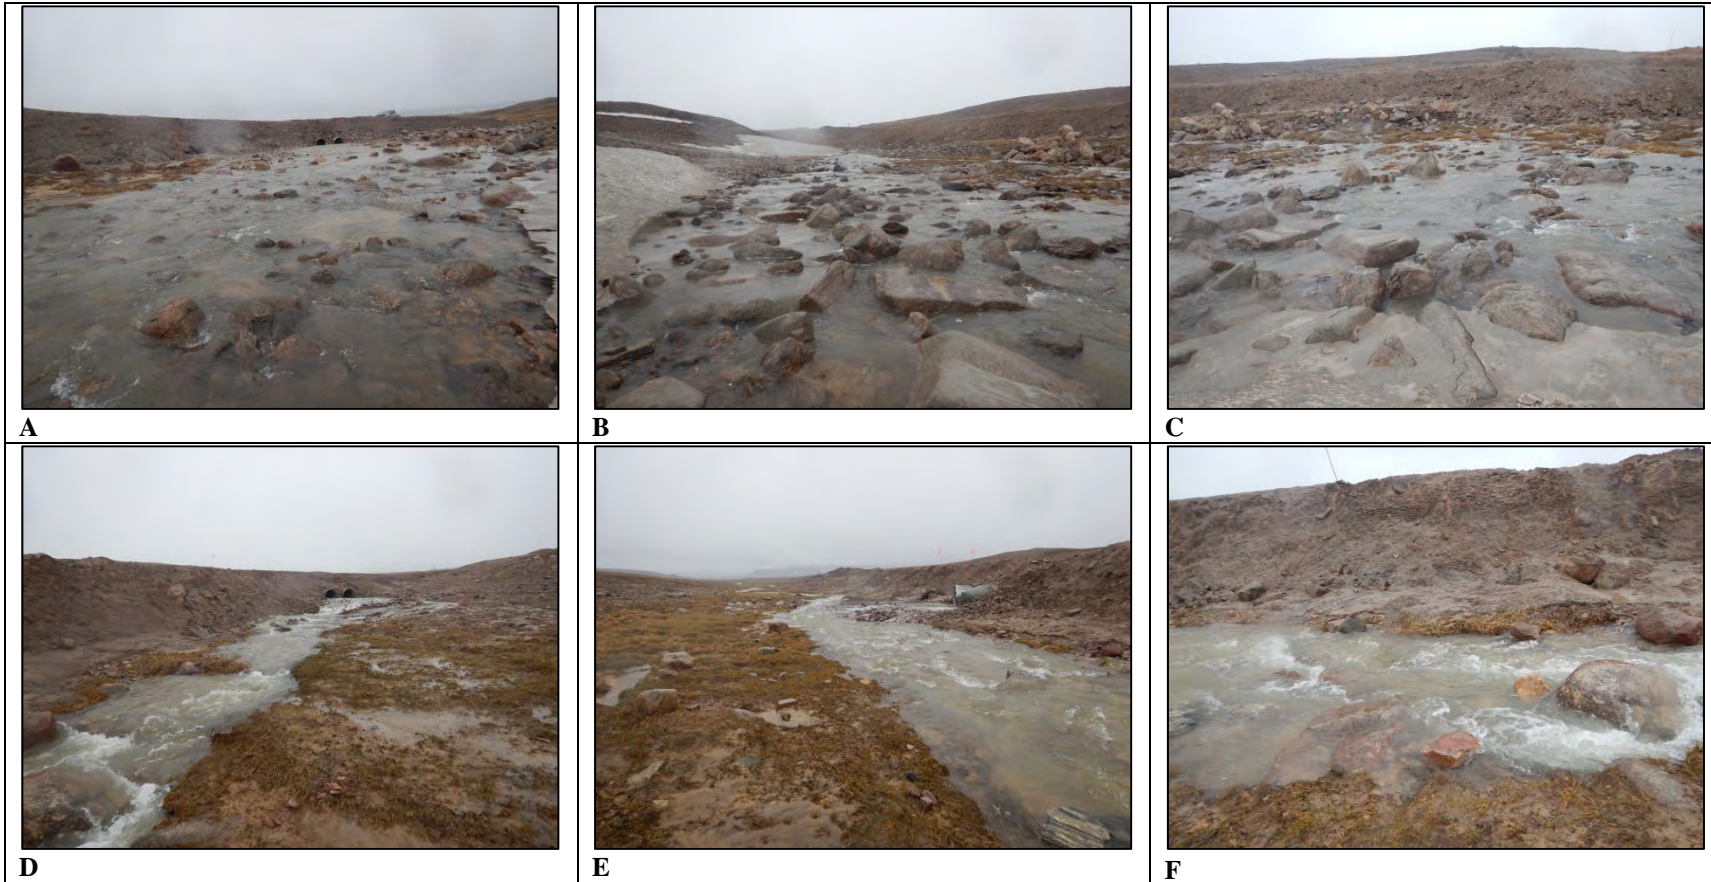
Tote Road Site CV-046

Summary: A persistent natural downstream subsurface flow barrier near the confluence with crossing CV-049 prevents fish access from downstream overwintering lakes.

Photos 1. Photographs upstream (top) and downstream (bottom) of the Tote Road crossing CV-046: (A,D) looking upstream; (B,E) looking downstream; (C,F) looking across.

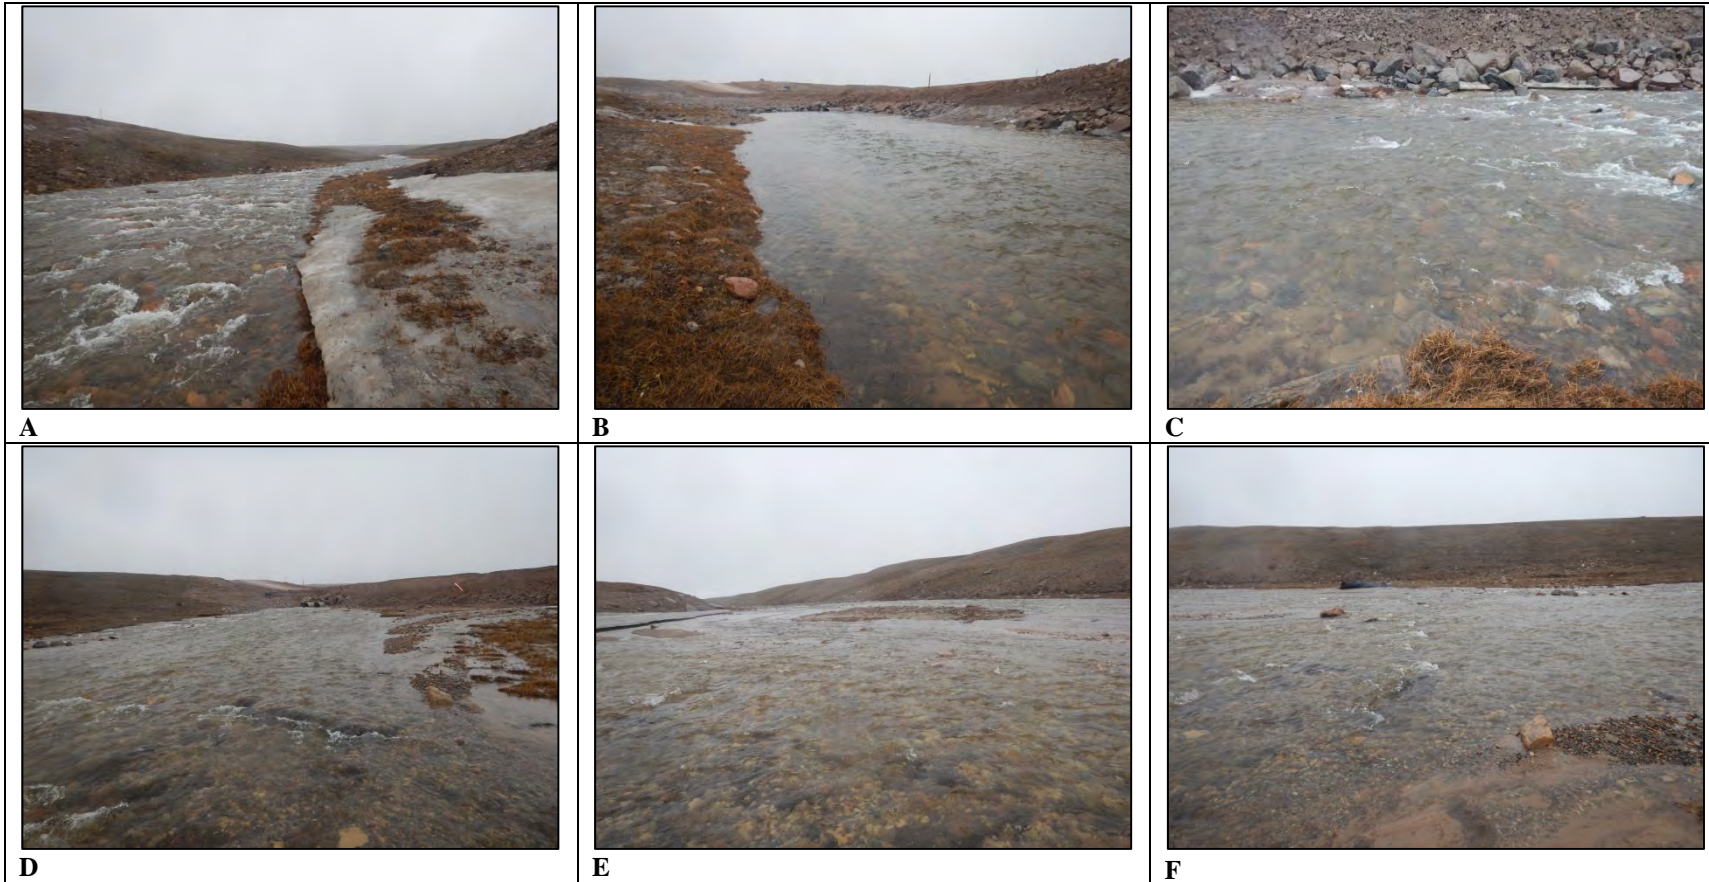
Summary: There is consistent surface flow at the crossing, but natural seasonal subsurface flows (during spring) several hundred metres downstream combined with great distance to overwintering habitat prevent fish access to the crossing.

Photos 1. Photographs upstream (top) and downstream (bottom) of the Tote Road crossing CV-040: (A,D) looking upstream; (B,E) looking downstream; (C,F) looking across.

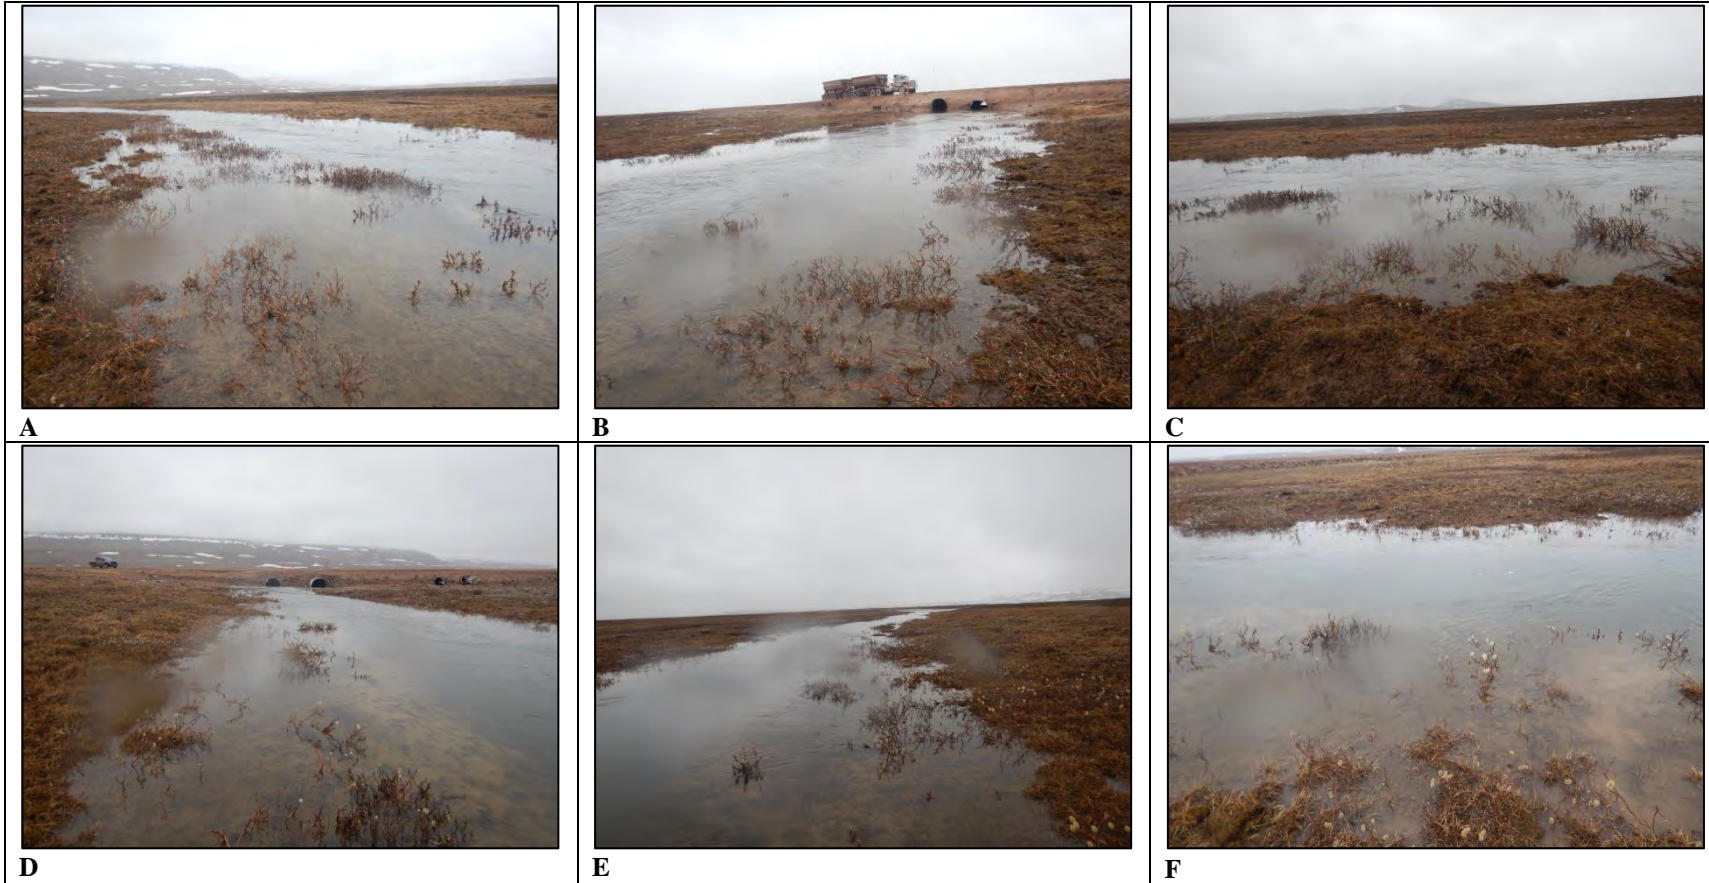
Summary: Consistently provides abundant, good quality rearing habitat for both species. No fish passage issues identified in 2020.

Photos 1. Photographs upstream (top) and downstream (bottom) of the Tote Road crossing BG-32 (A,D) looking upstream; (B,E) looking downstream; and (C,F) looking across.

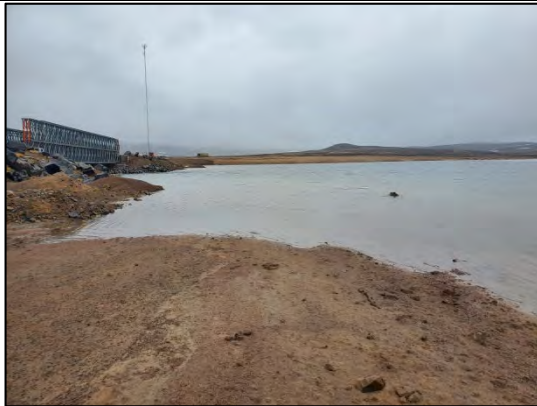
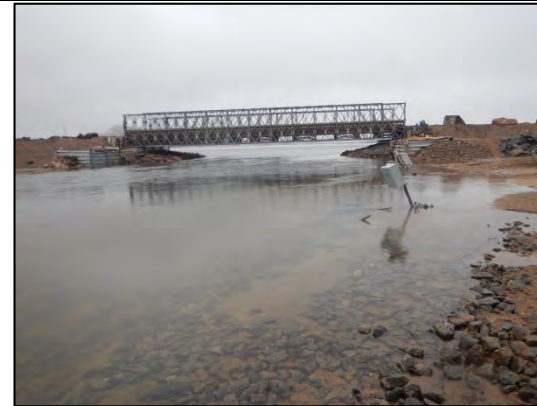
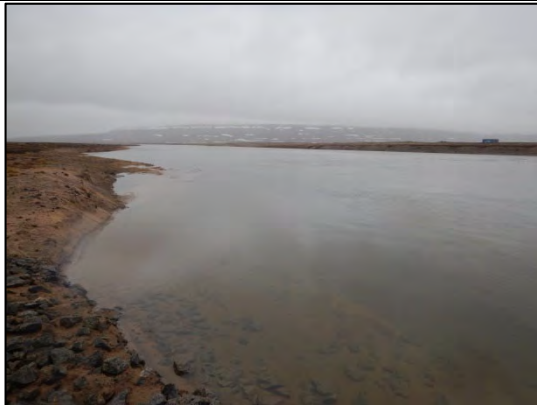
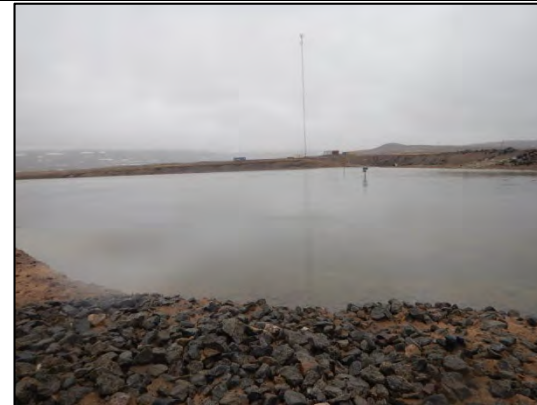
Summary: A bridge and culvert crossing with abundant habitat for both species and no passage issues identified in 2020.

Photos 1. Photograph upstream of the Tote Road crossing CV-217: (A) showing Muriel Lake; and photographs downstream of the Tote Road: (B) looking upstream; (C) looking downstream; and (D) looking across.

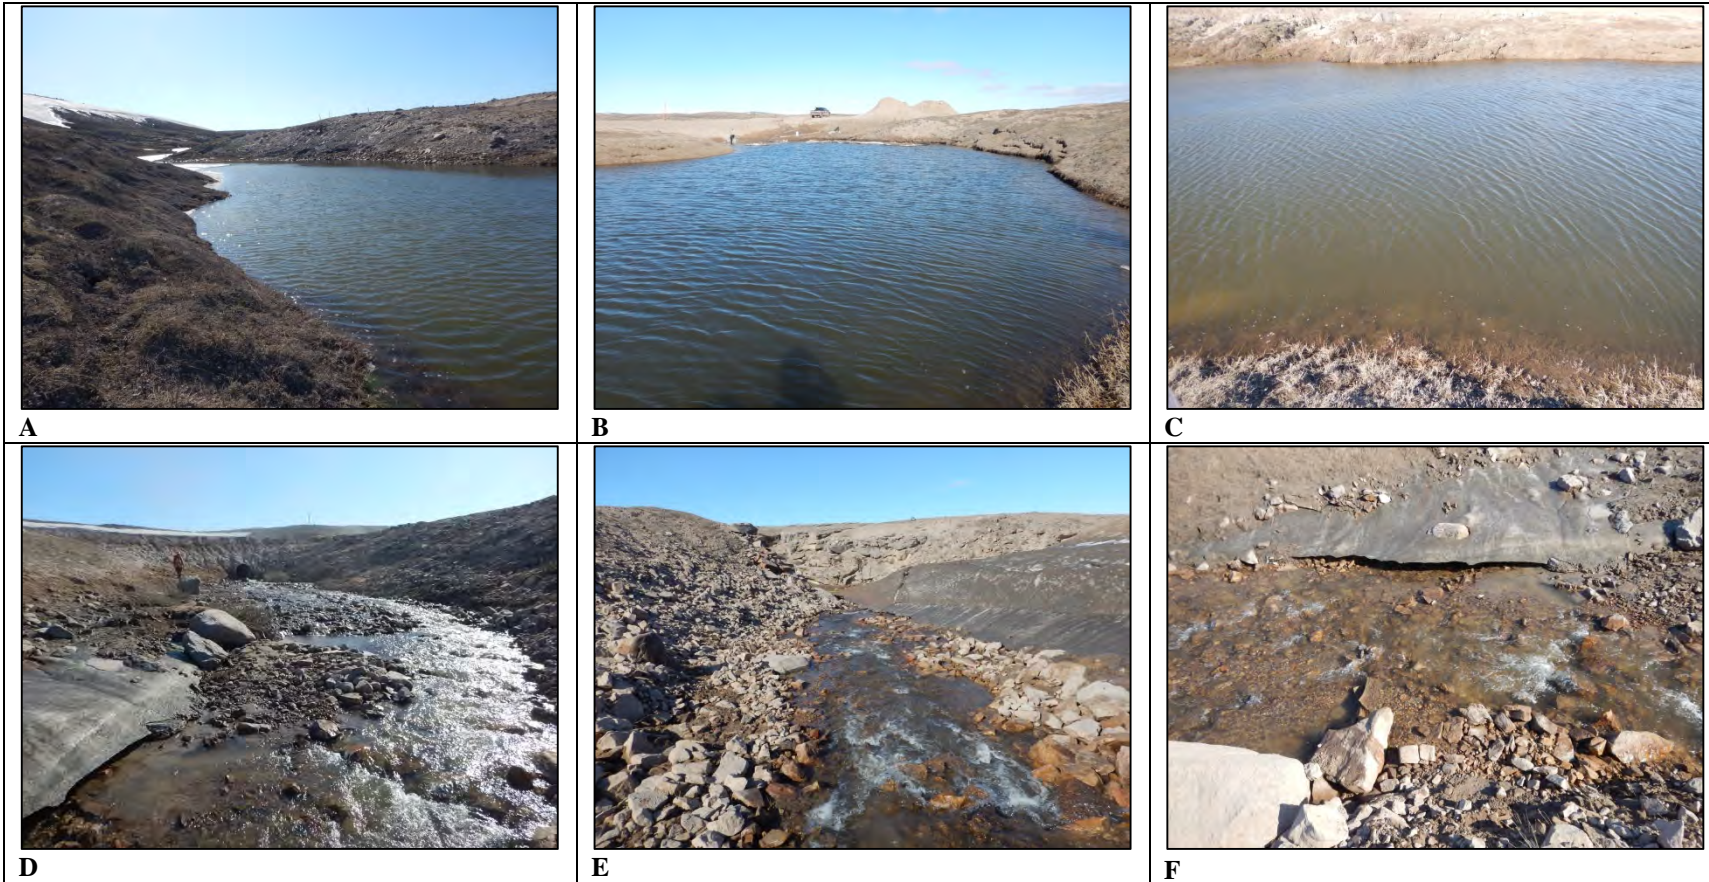
All compensation works completed prior to 2020 continued to be successful in 2020, including fish use of the rustic fishway installed at BG-30. For more details on habitat compensation activities, see Baffinland (2009 to 2019, incl.).

Summary: Stream provides abundant rearing habitat, particularly upstream of the road in a large pond. Access to the upstream pond was created with a rocky ramp as part of the Tote Road Compensation Plan. There were no fish access issues identified in 2020.

Photos 1. Photographs upstream of the Tote Road crossing BG-30: (A) looking upstream; (B) looking downstream; (C) looking across; and photographs downstream of the Tote Road: (D) looking upstream; (E) looking downstream; and (F) looking across.

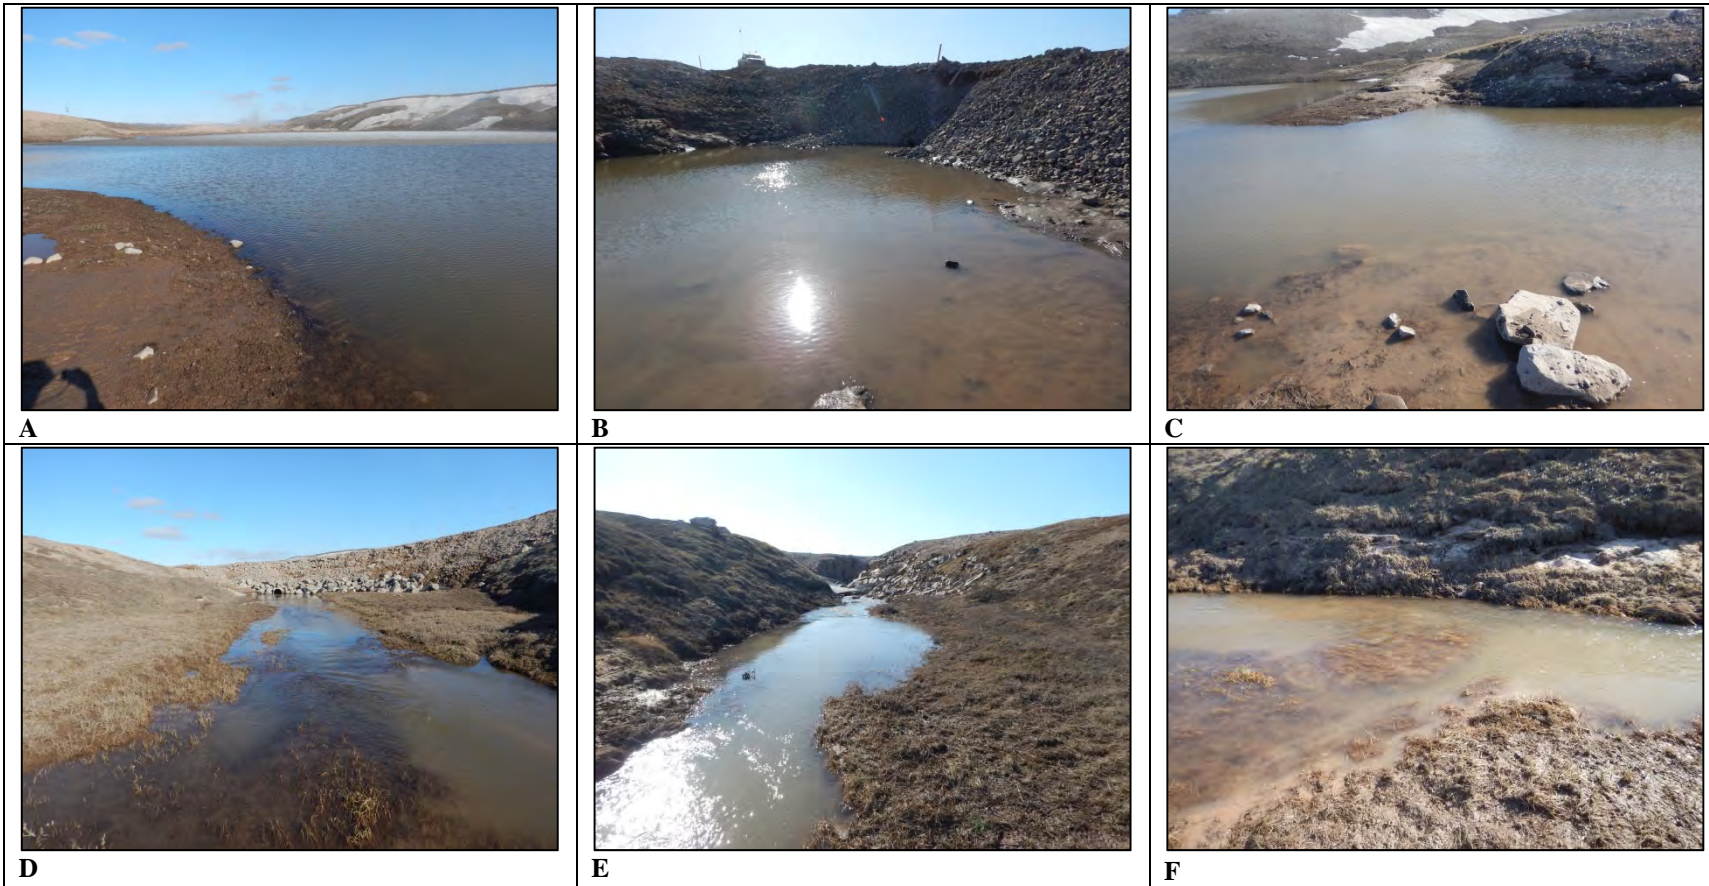
Tote Road Site BG-29

Summary: Stream provides abundant summer rearing habitat for both species. There were no fish access issues identified in 2020.

Photos 1. Photographs upstream of the Tote Road crossing BG-29: (A) looking upstream; (B) looking downstream; (C) looking across; and photographs downstream of the Tote Road: (D) looking upstream; (E) looking downstream; and (F) looking across.
