**BAFFINLAND IRON MINES CORPORATION
MARY RIVER PROJECT**

**TOTE ROAD FISH HABITAT MONITORING
2020 ANNUAL REPORT
EARLY REVENUE PHASE - TOTE ROAD UPGRADES**

2020-12-29	0

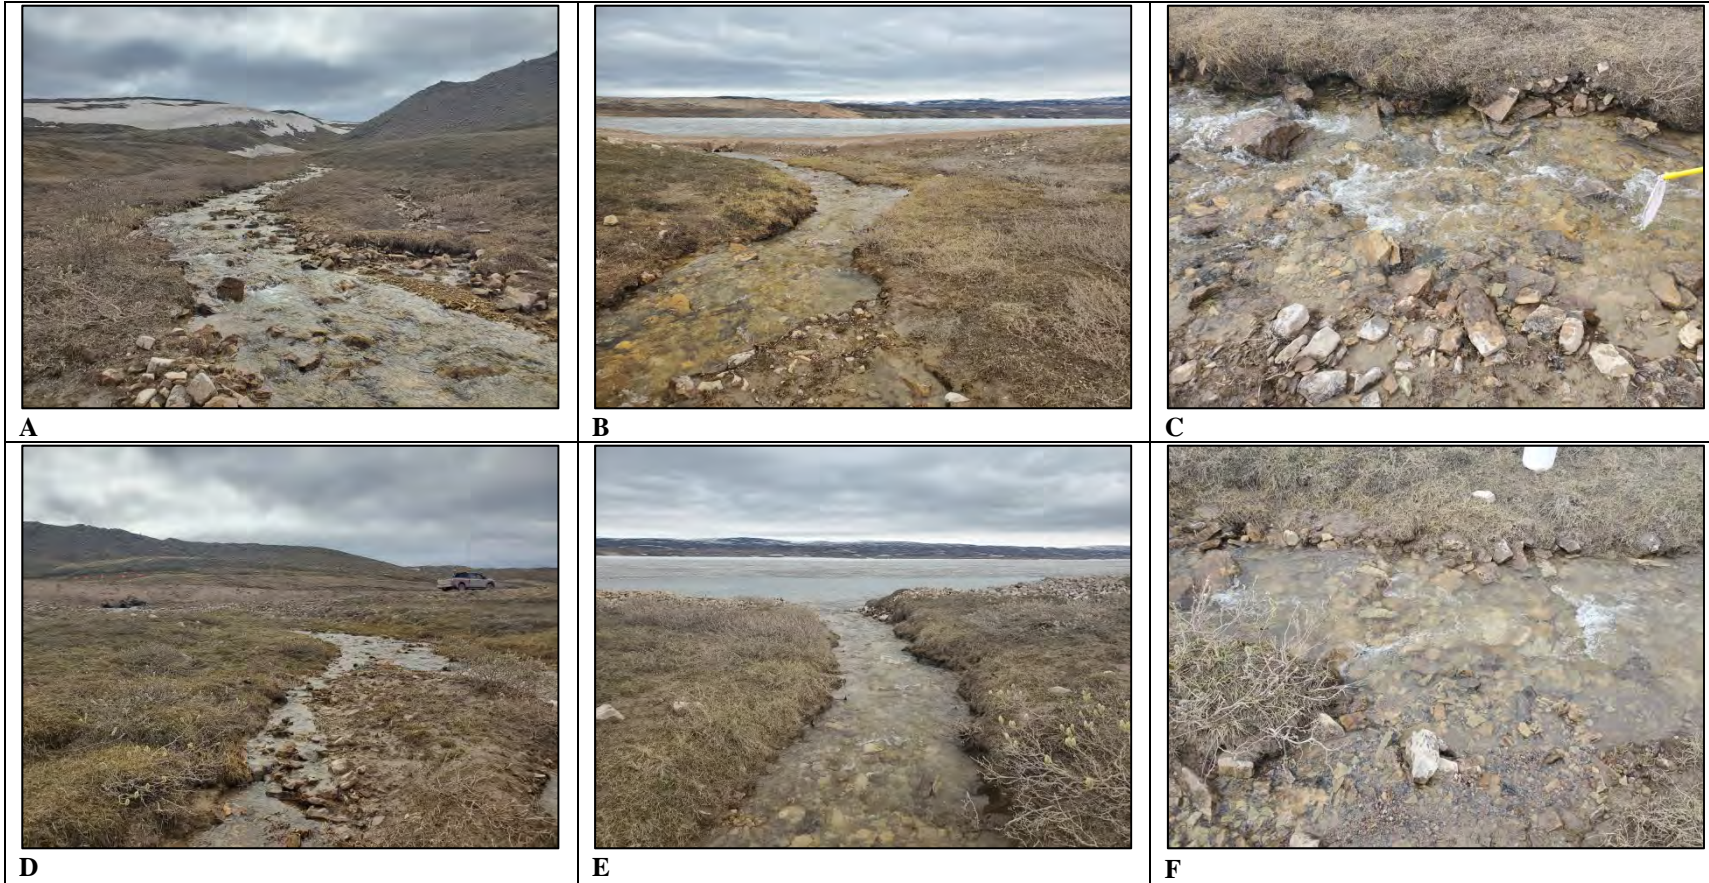
Summary: Site provides summer rearing habitat for juvenile Arctic Char. No fish passage issues were identified in 2020.

Photos 1. Photographs upstream (top) and downstream (bottom) of the Tote Road crossing BG-27: (A,D) looking upstream; (B,E) looking downstream; and (C,F) looking across.

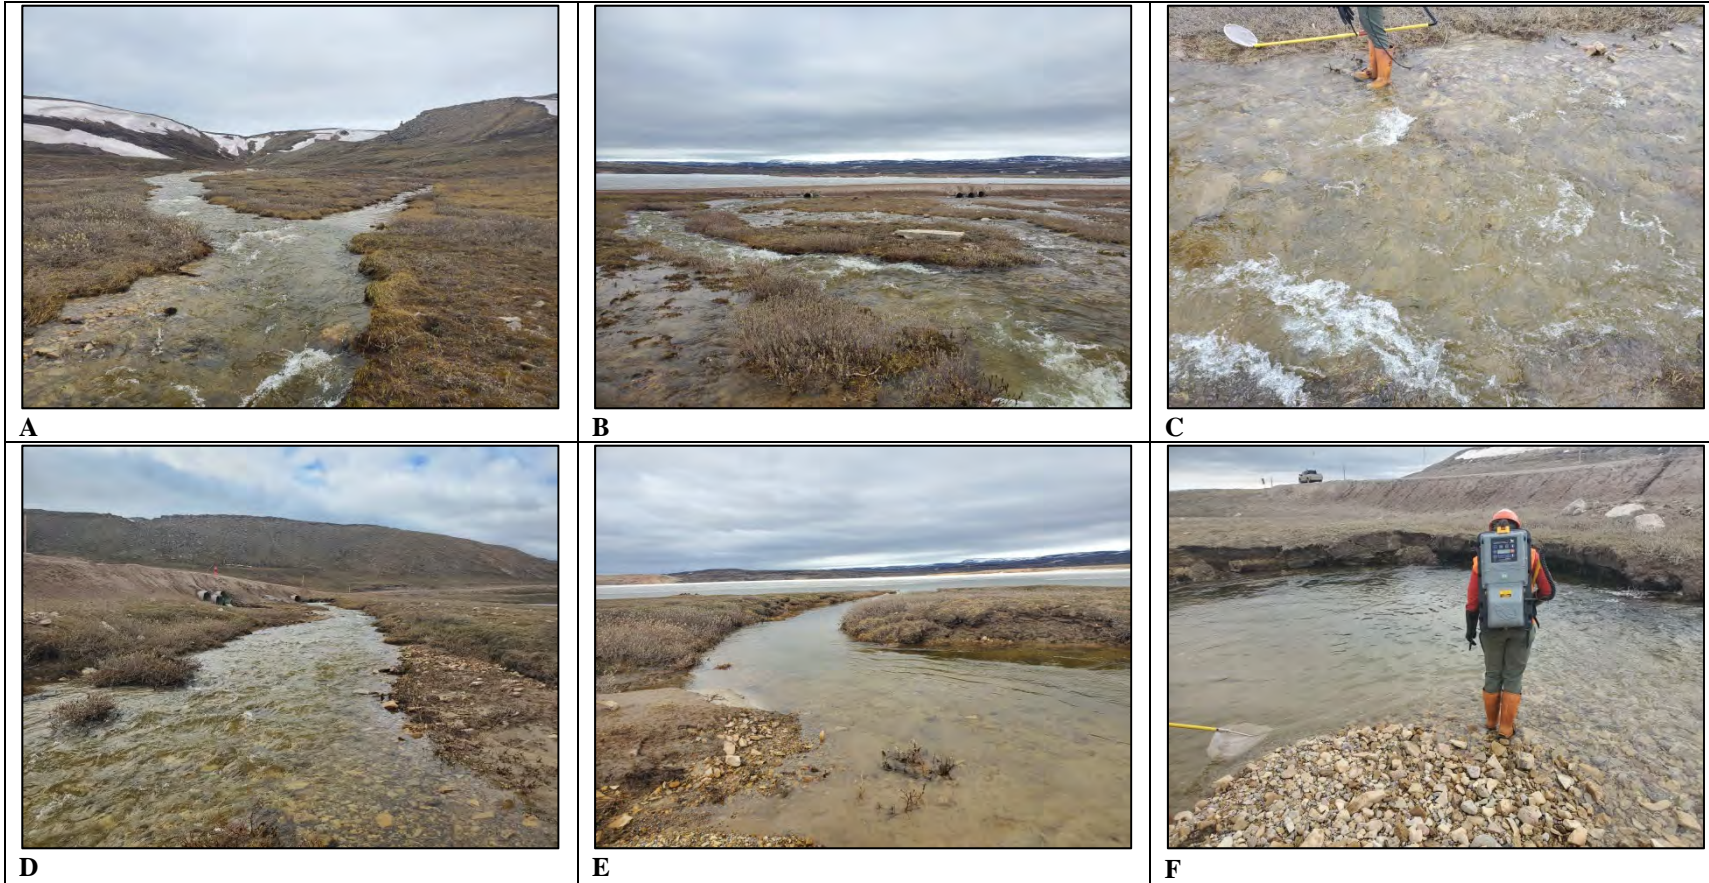
Summary: Site provides summer rearing habitat for juvenile Arctic Char. No fish passage issues were identified in 2020.

Photos 1. Photographs upstream (top) and downstream (bottom) of the Tote Road crossing BG-24: (A,D) looking upstream; (B,E) looking downstream; and (C,F) looking across.

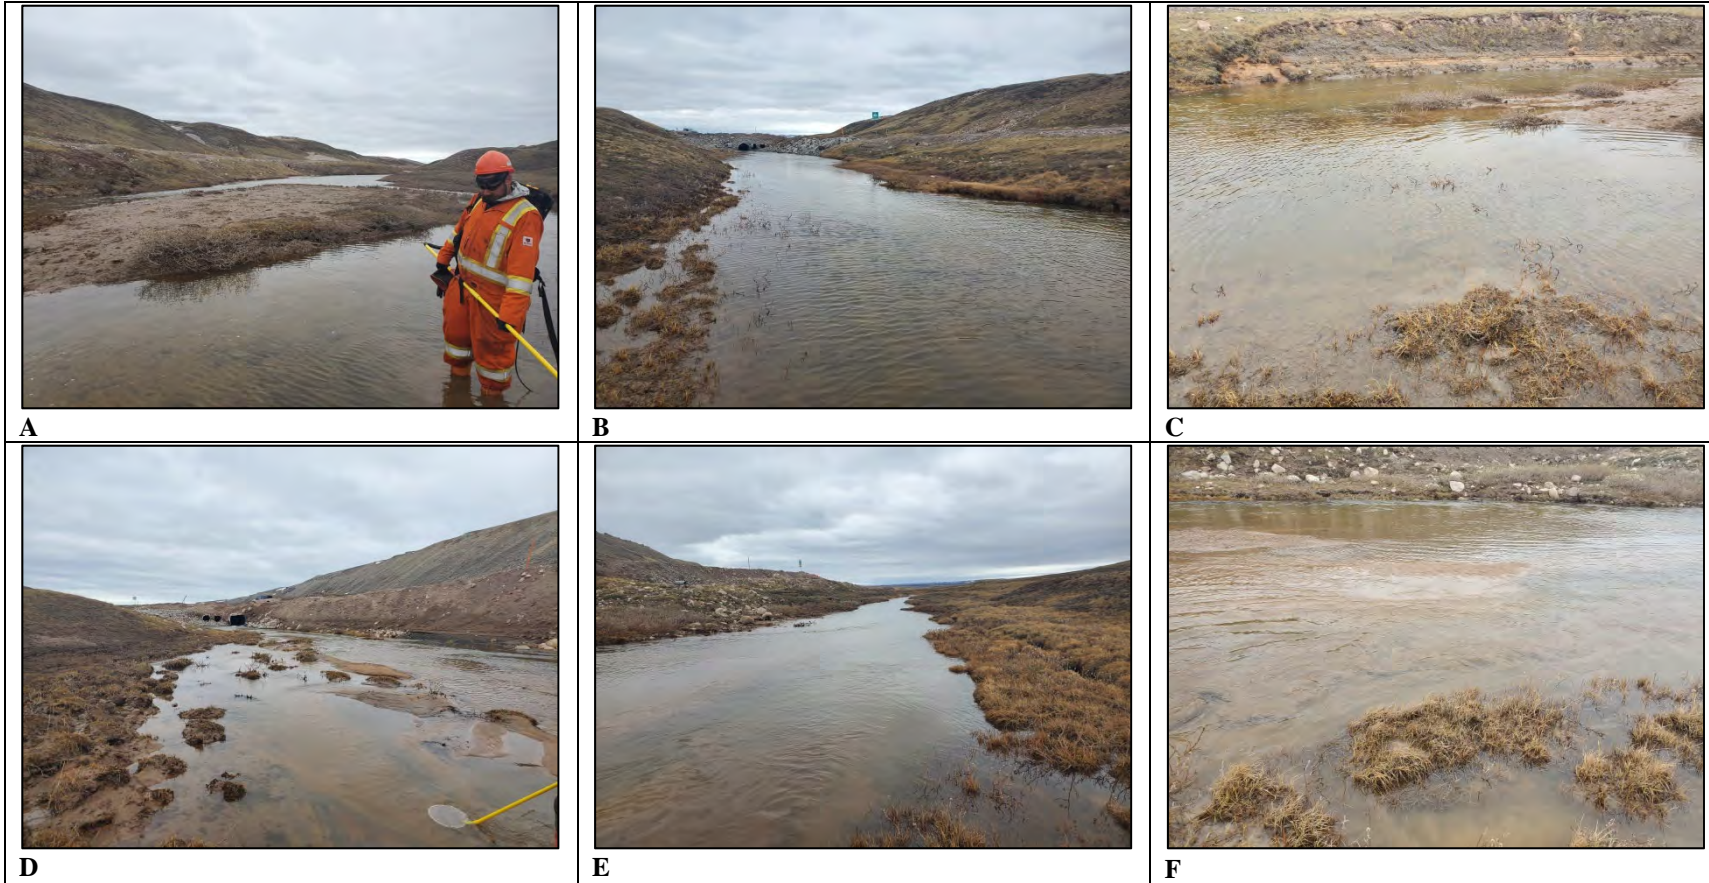
Summary: Site provides summer rearing habitat for both species. No fish passage issues were identified in 2020.

Photos 1. Photographs upstream (top) and downstream (bottom) of the Tote Road crossing BG-17: (A,D) looking upstream; (B,E) looking downstream; and (C,F) looking across.

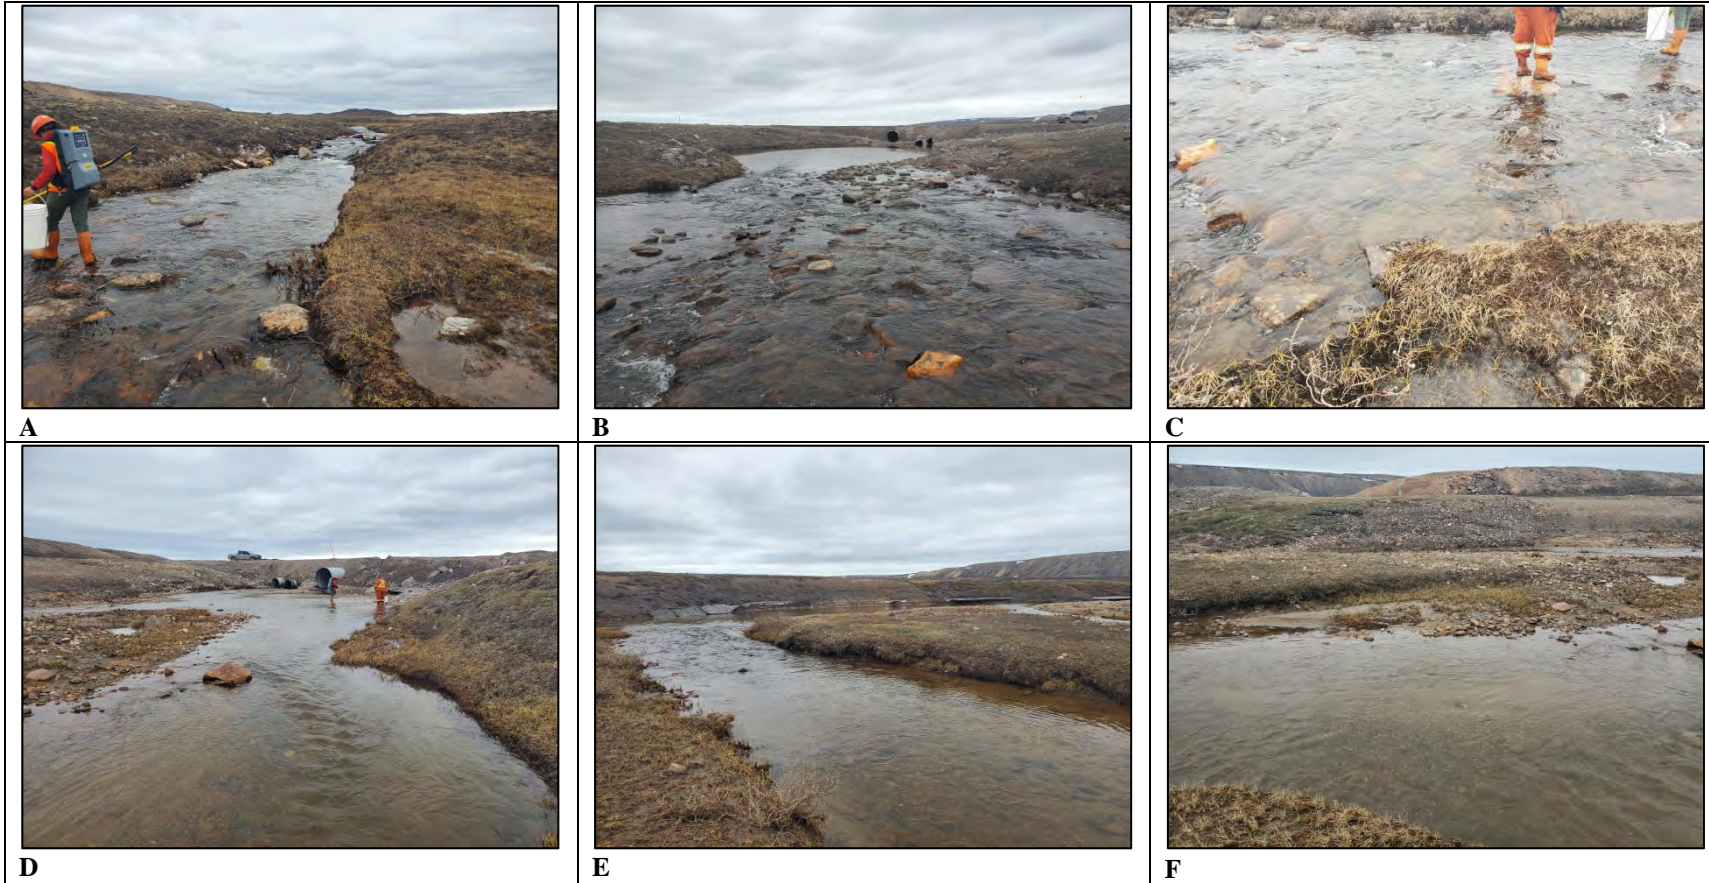
Summary: Site provides summer rearing habitat for both species. No fish passage issues were identified in 2020.

Photos 1. Photographs upstream (top) and downstream (bottom) of the Tote Road crossing BG-04: (A,D) looking upstream; (B,E) looking downstream; and (C,F) looking across.

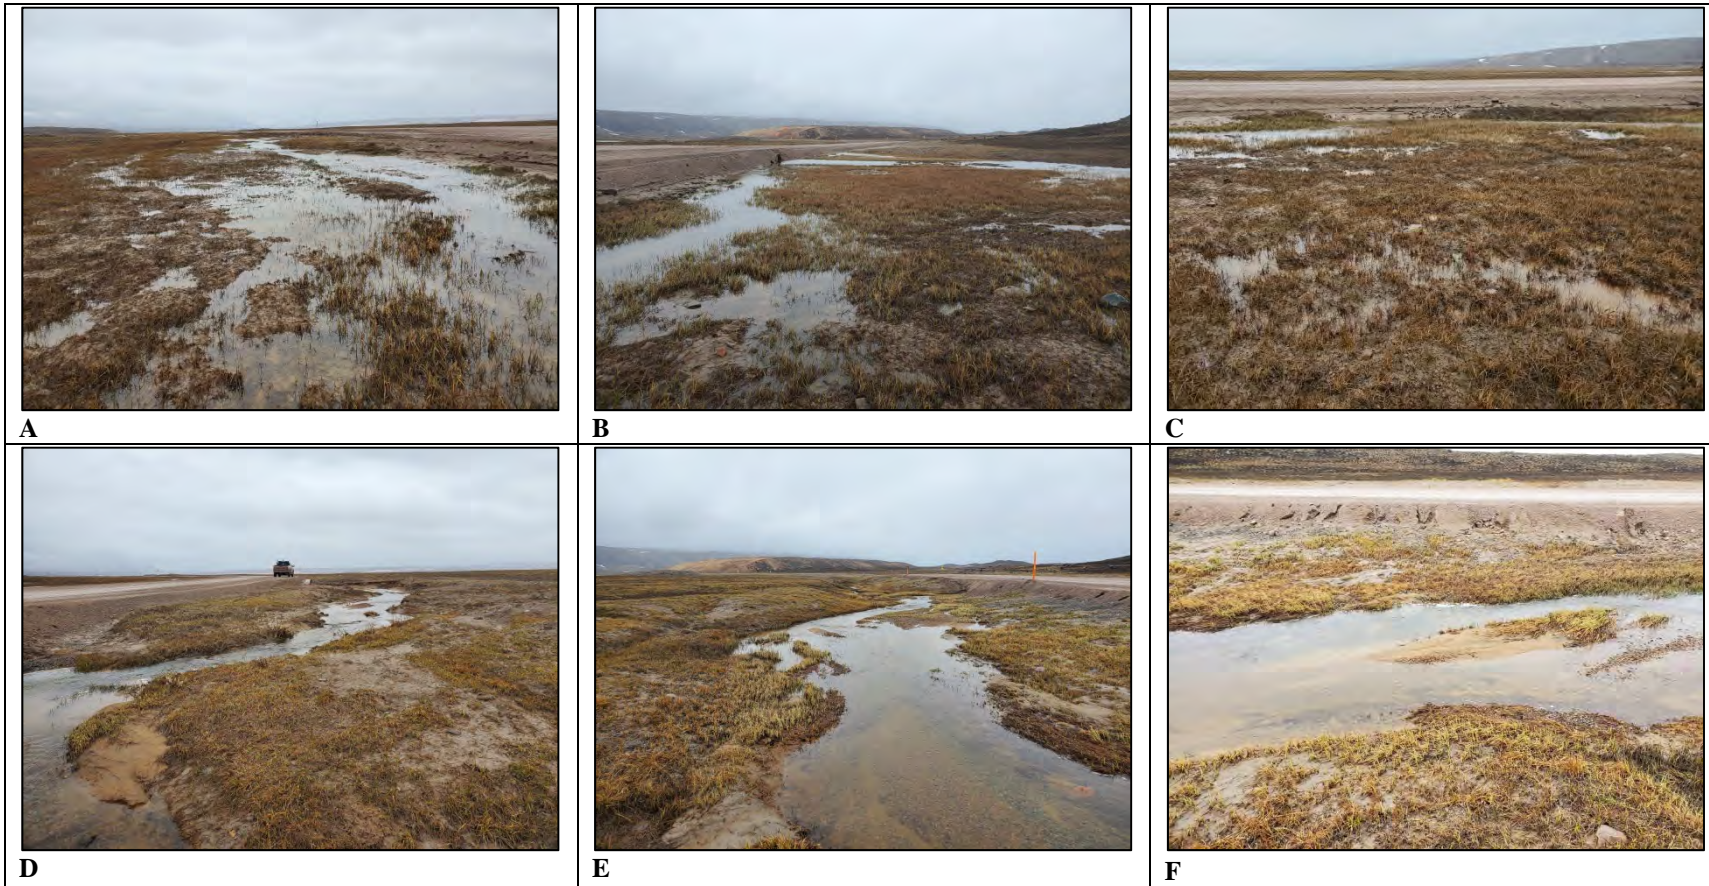
Summary: This stream typically provides summer rearing habitat for both species. No fish passage issues were identified in 2020.

Photos 1. Photographs upstream (top) and downstream (bottom) of the Tote Road crossing CV-001: (A,D) looking upstream; (B,E) looking downstream; and (C,F) looking across.

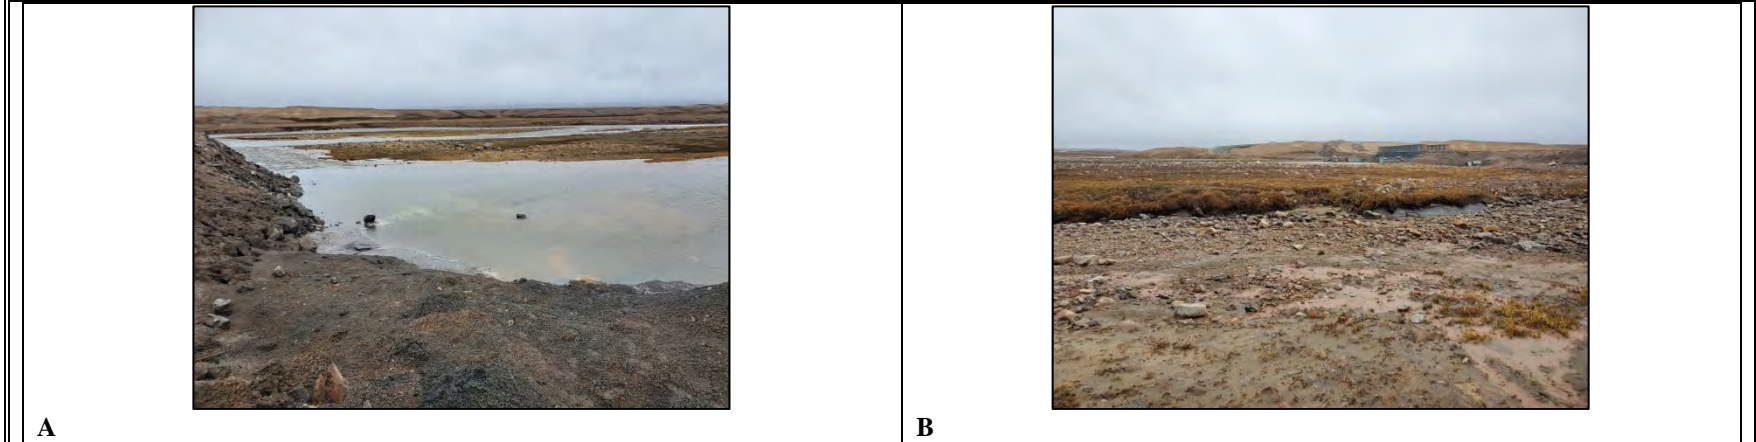
Tote Road Site CV-223

Summary: This large river (Tom River) includes both bridge and culvert crossings. All channels crossed by the road provide abundant summer rearing habitat for Arctic Char. No fish passage issues were identified in 2020.

Photos 1. Photographs upstream (A) and downstream (B) of the Tote Road crossing CV-223 culverts.

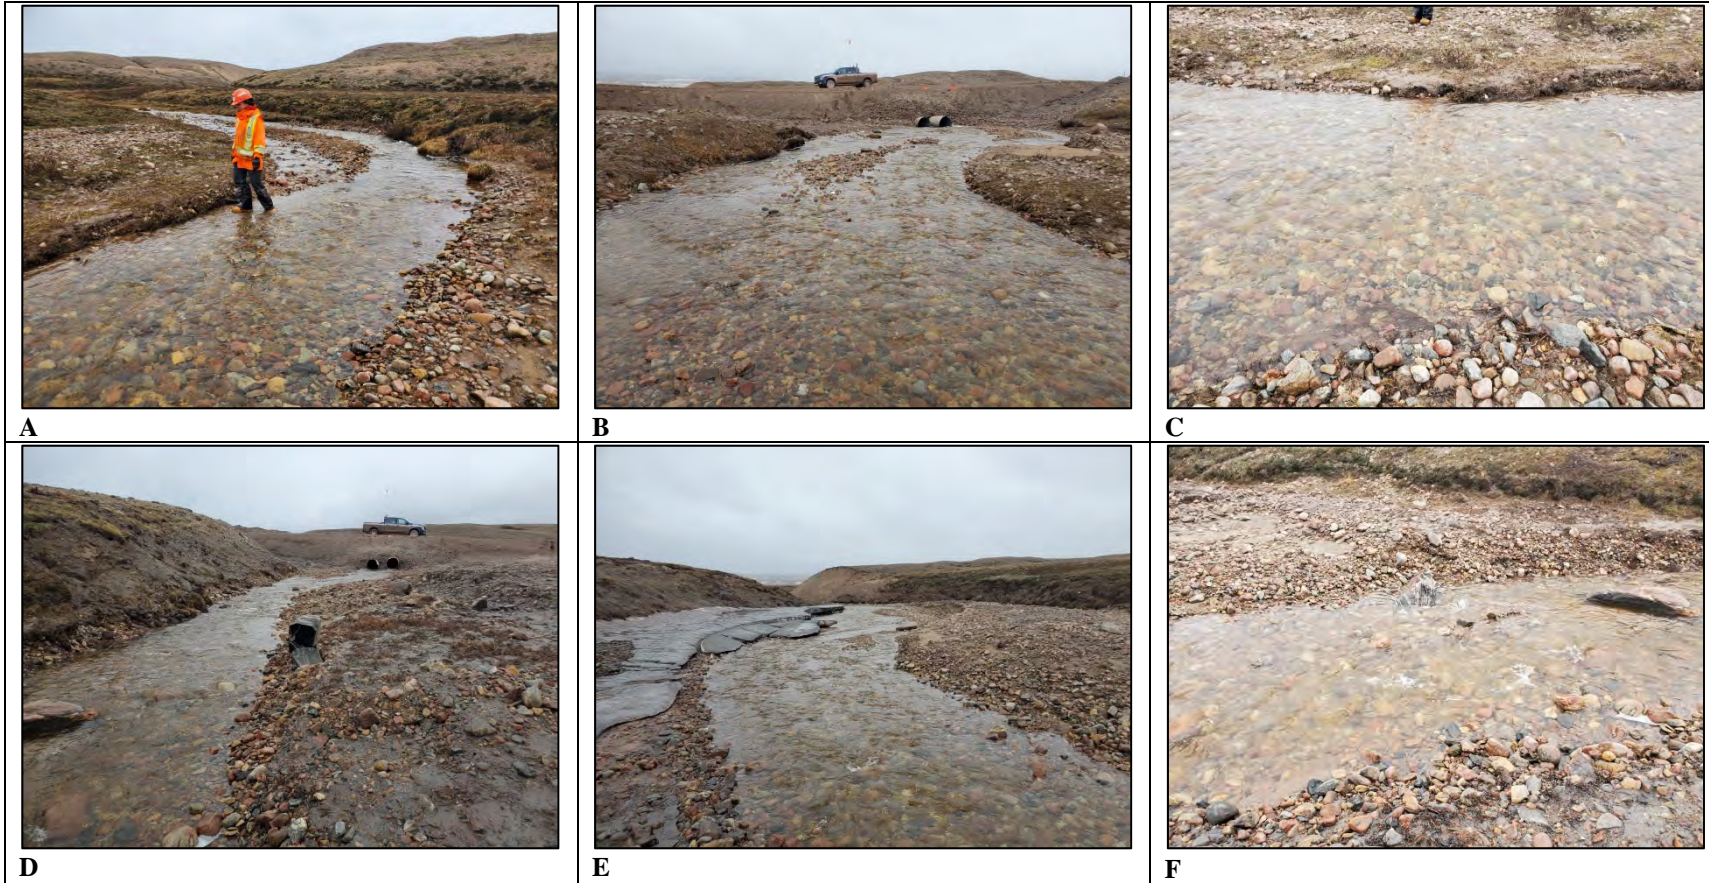
Summary: Site provides summer rearing habitat for both species. No fish passage issues were identified in 2020.

Photos 1. Photographs upstream (top) and downstream (bottom) of the Tote Road crossing CV-224: (A,D) looking upstream; (B,E) looking downstream; and (C,F) looking across.

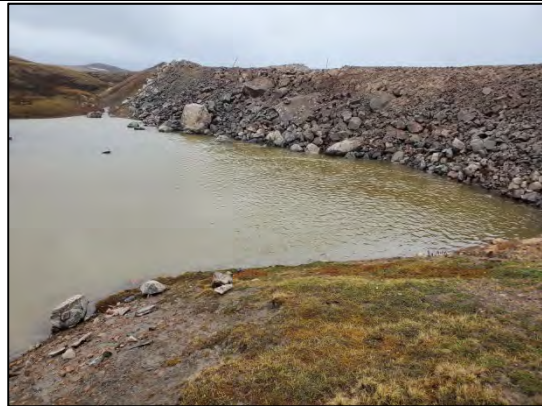
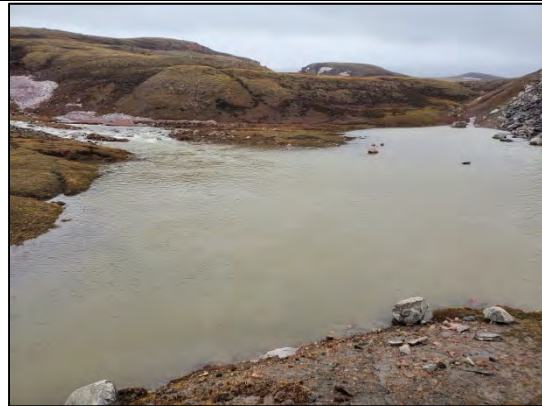
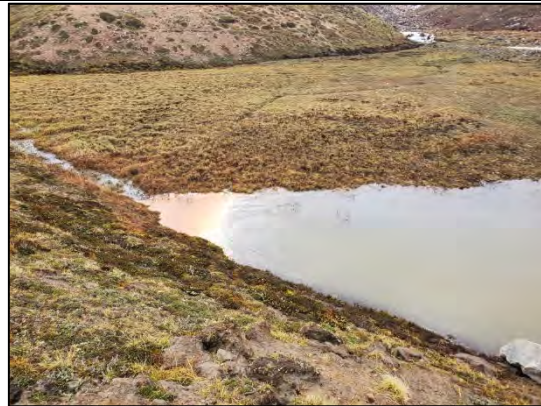
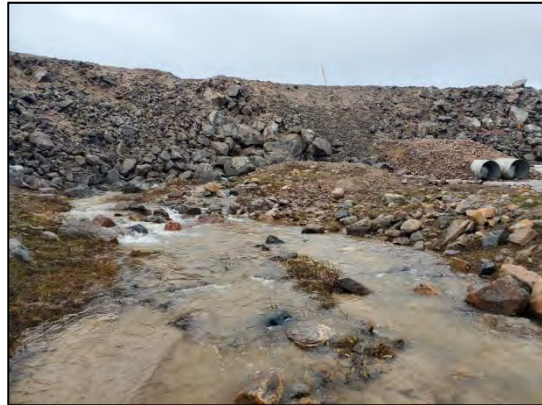
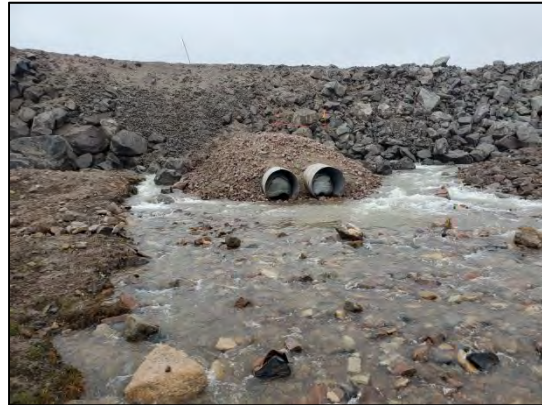
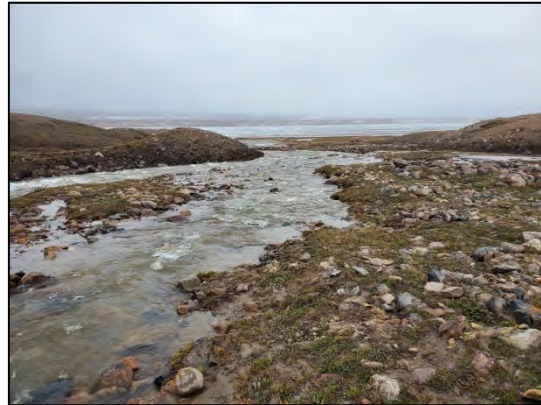
Summary: Site provides summer rearing habitat for both species. Remediation completed in early spring 2020 successfully reduced much of the culvert perching. However, water flow observed under the road due to frozen culverts at three locations, had caused erosion of the embankment and riparian habitat in spring 2020. Culverts were successfully cleared with steam immediately following the crossing survey. Continue monitoring of road and culverts going forward.

Photos 1. Photographs upstream (top) and downstream (bottom) of the Tote Road crossing CV-225 showing flooding caused by frozen culverts (A,B,C); flows underneath the road embankment (D,E); and (F) looking downstream.

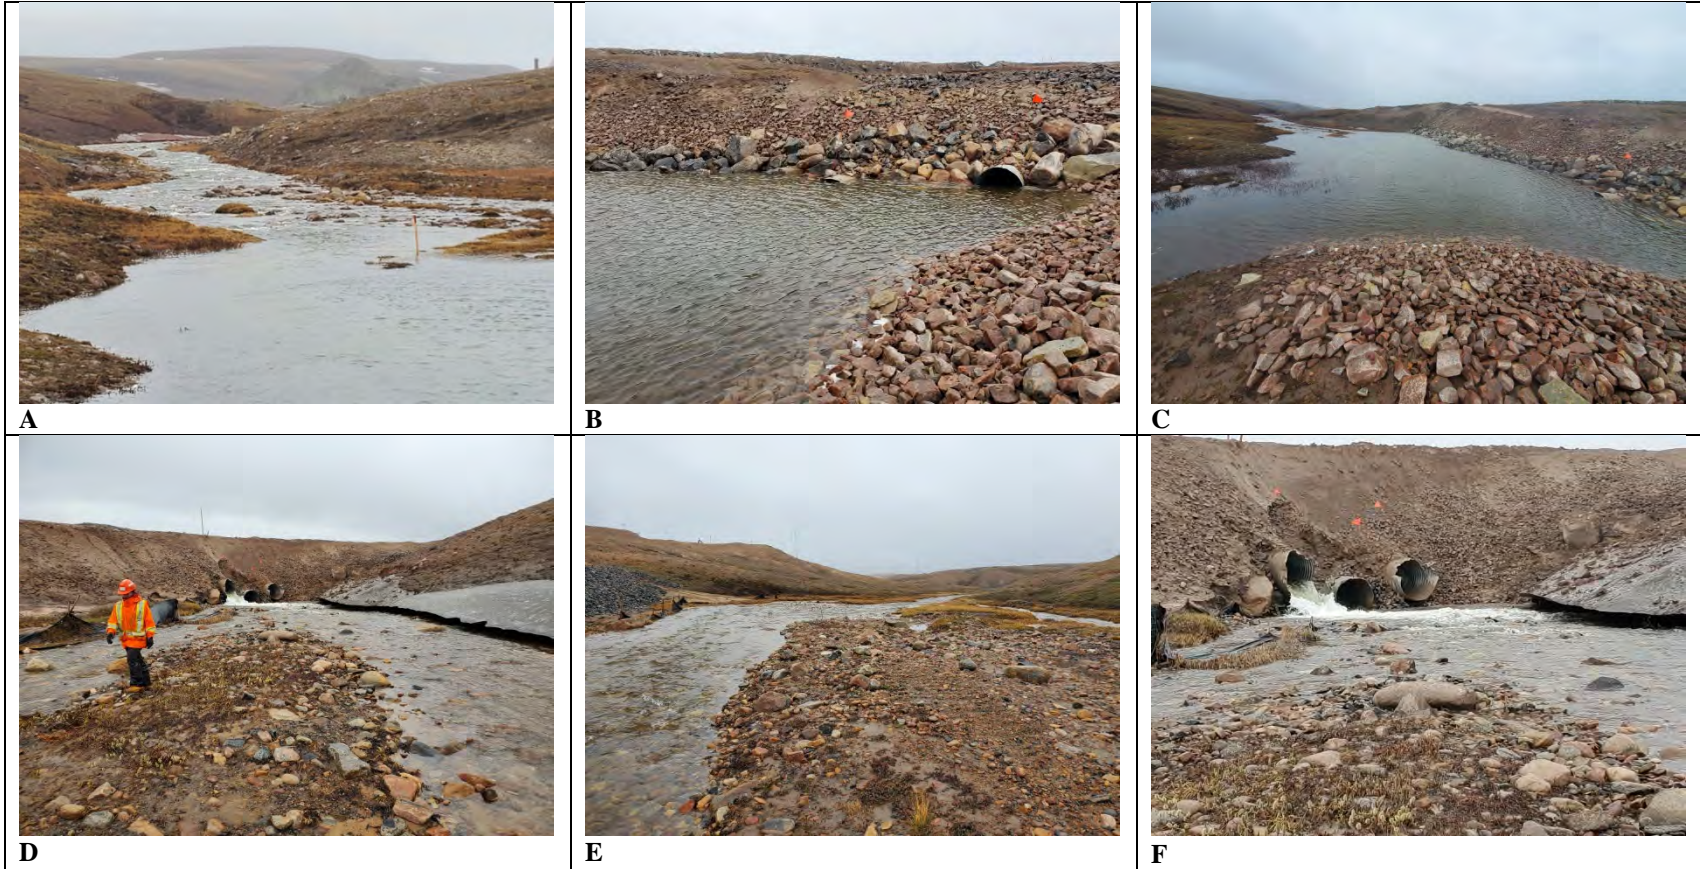
Summary: This stream provides summer rearing habitat for both species. During the spring 2020 survey, two of three culverts remained frozen causing constriction of flows. Culverts were steamed free of ice immediately following site survey to restore normal flows.

Photos 1. Photographs upstream (top) and downstream (bottom) of the Tote Road crossing BG-01: (A,D) looking upstream; (B,E) looking downstream; (C) looking across; and (F) looking at culverts.

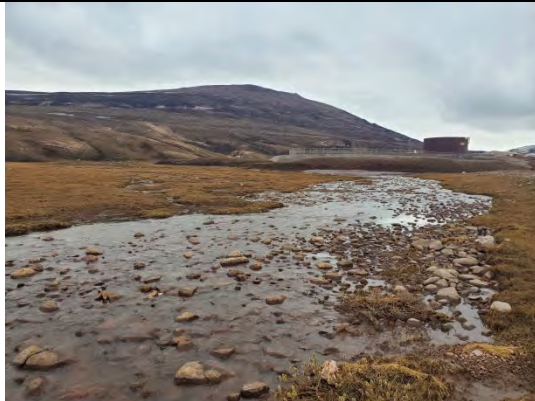
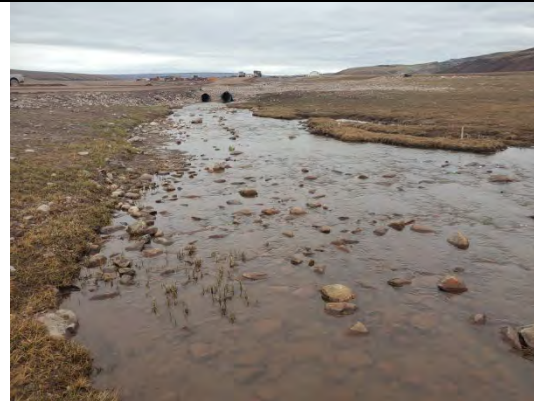
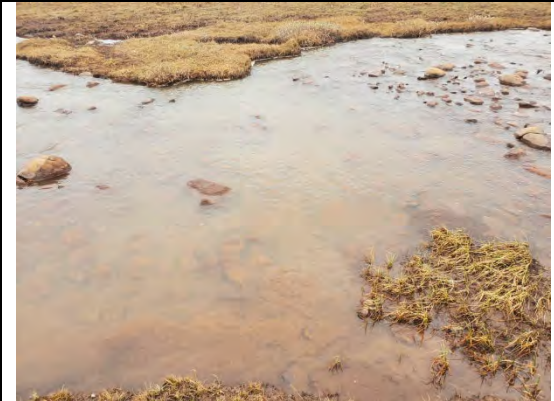
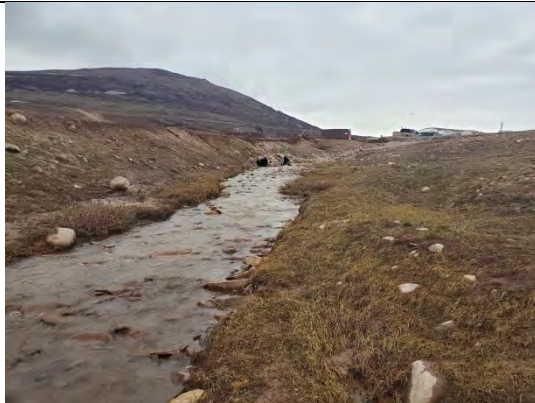
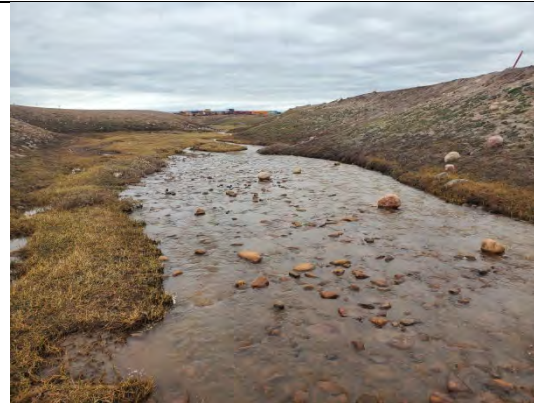
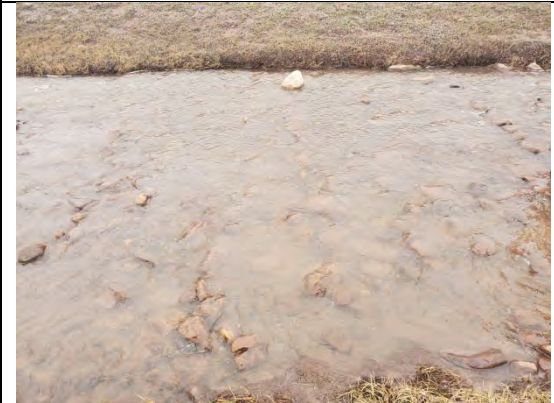
Summary: Site provides summer rearing habitat for both species. No fish passage issues were identified in 2020.

Photos 1. Photographs upstream (top) and downstream (bottom) of the Tote Road crossing CV-186: (A,D) looking upstream; (B,E) looking downstream; and (C,F) looking across.

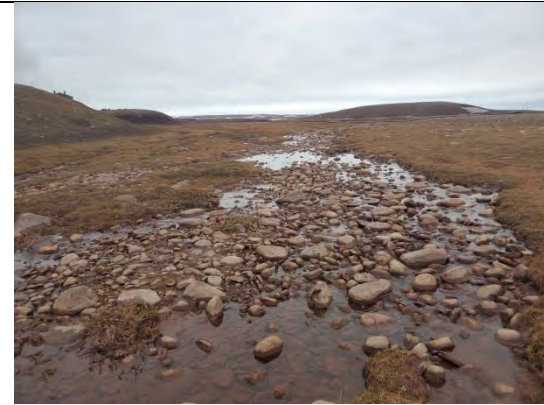
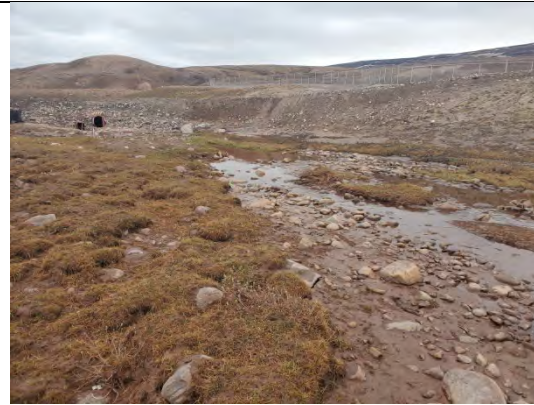
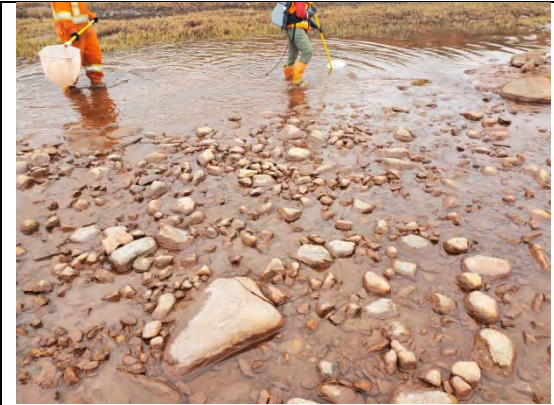
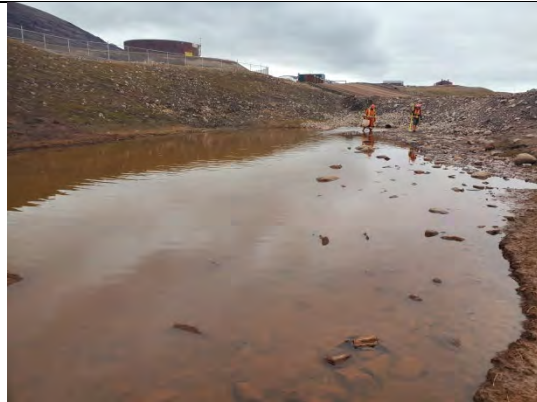
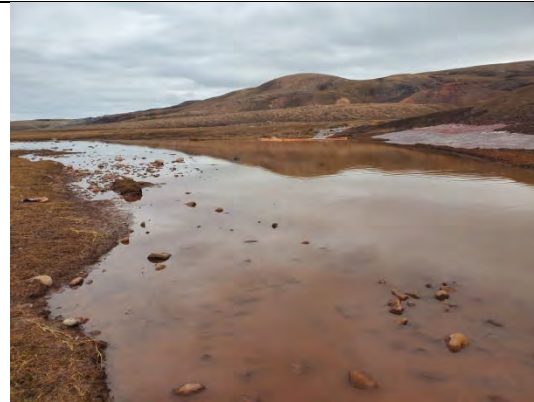
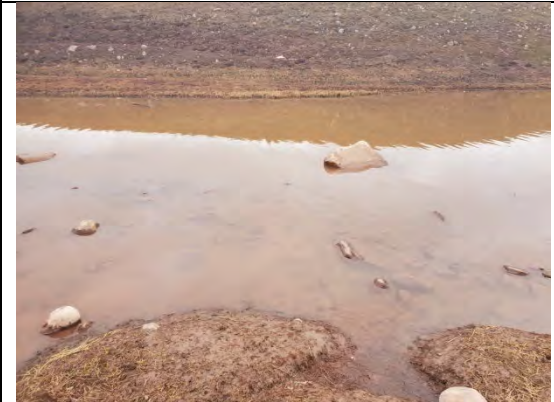
Summary: Site provides summer rearing habitat for both species, though upstream reaches become dry as water levels decrease. No fish passage issues were identified in 2020.

Photos 1. Photographs upstream (top) and downstream (bottom) of the Tote Road crossing CV-187: (A,D) looking upstream; (B,E) looking downstream; and (C,F) looking across.

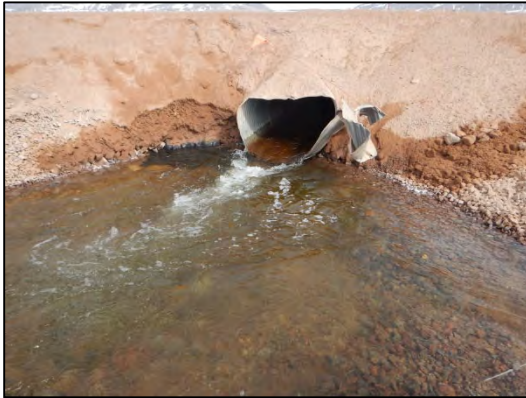
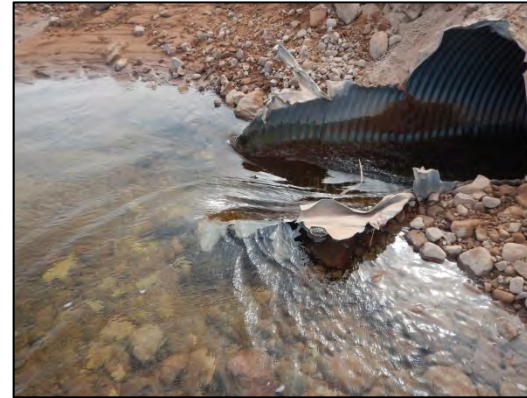
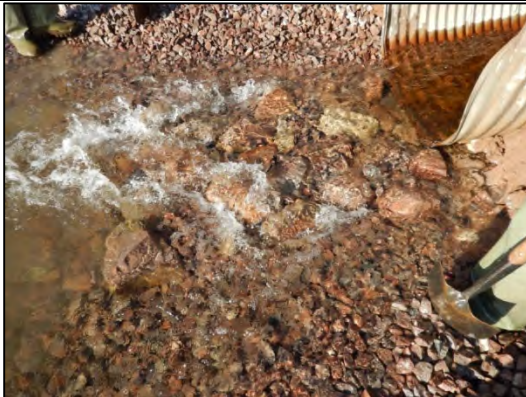
2020 Tote Road Stream Crossing Remediation – CV-129

Photos 1: Photographs of the downstream end of the perched culvert at CV-129 in spring 2020: (A) the damaged upstream end of the culvert in spring 2020; (B) the rocky ramp downstream of the road in spring 2020; and (C) the rocky ramp at the downstream end following repairs made in fall 2020.

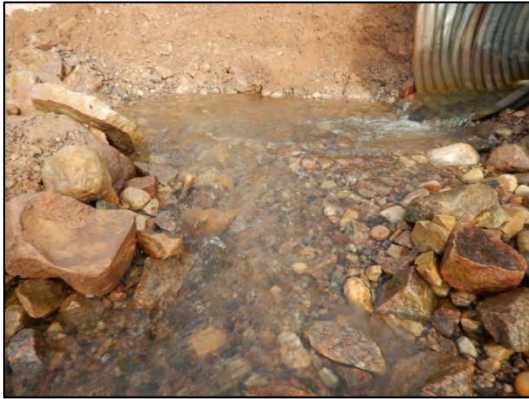
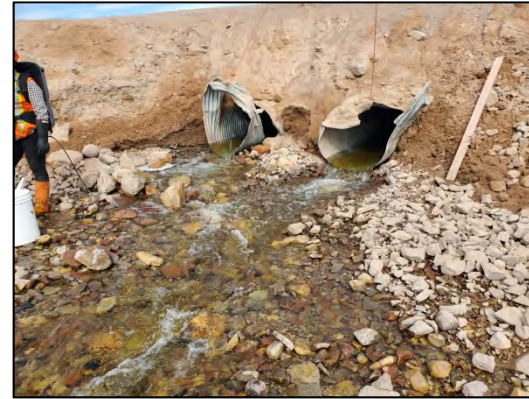
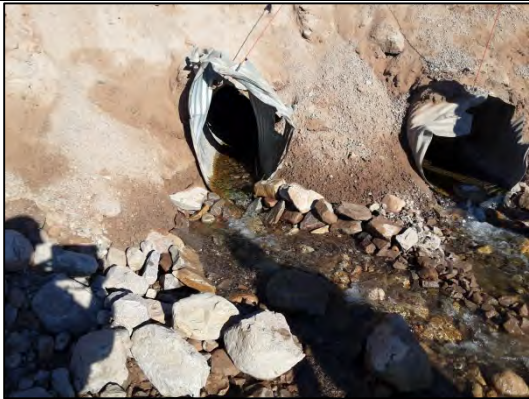
2020 Tote Road Stream Crossing Remediation – CV-114

Photos 1: Photographs of the downstream end of the perched culvert at CV-114: (A) after remediation in fall 2019; (B) during freshet 2020; and (C) after repairs to the ramp in fall 2020.

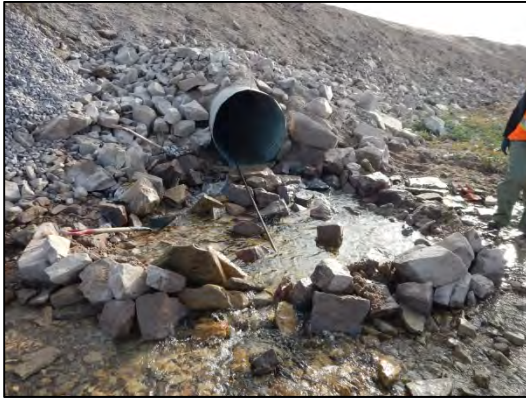
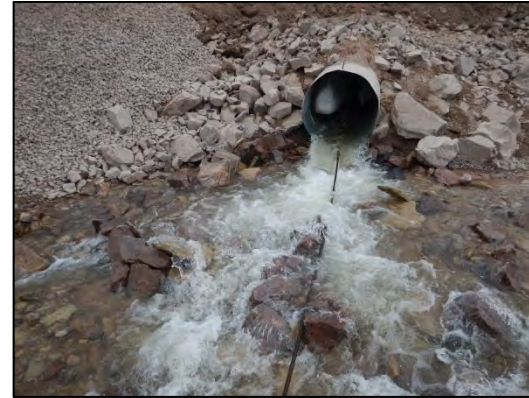
2020 Tote Road Stream Crossing Remediation – CV-111

The perch at CV-111 remains too high (0.25 m) to effectively mitigate with a rocky ramp and additional/alternative works will be required to restore access to upstream habitat for all of the size classes of juvenile Arctic Char found downstream of this crossing. The rock ramp installed at BG-50 in fall 2019 was washed away by high flows through the culverts during the 2020 freshet. Alternative remediation works will be required at this site, possibly by reconstructing the ramp with a base of larger, more erosion resistant material and placing smaller material over the base by hand or by reinstalling the culverts. Baffinland will work with the DFO prior to instream remediation work proceeding to decide upon a practical course of action for addressing the perched culvert outlets at the CV-111 and BG-50 crossings.

Photos 1: Photographs of the downstream end of the perched culvert at CV-111: (A) after remediation in fall 2019; (B) during freshet 2020, showing damage to the remediation works. A rocky ramp is unlikely to be effective at this site and a new remediation plan is required.

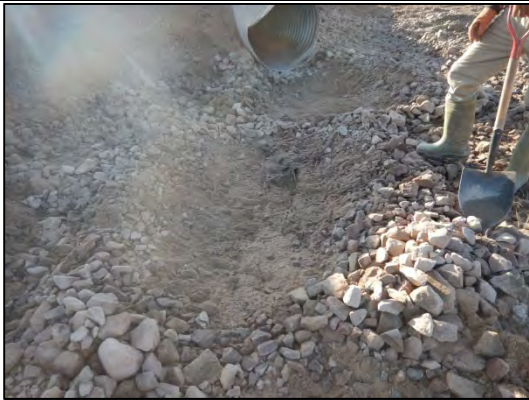
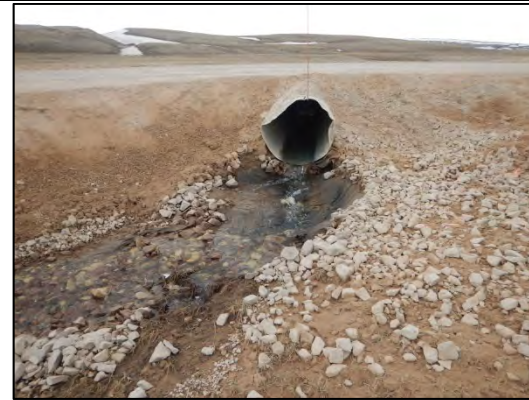
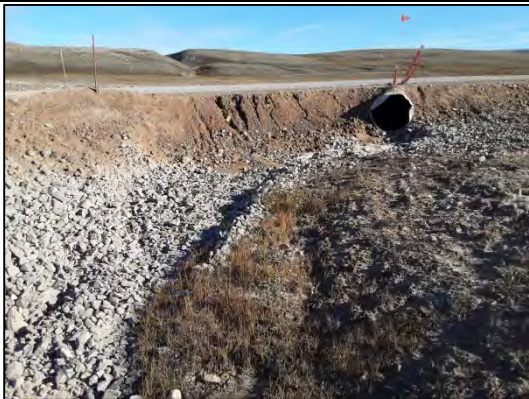
2020 Tote Road Stream Crossing Remediation – CV-106

Photos 1: Photographs of the downstream end of the perched culvert at CV-106: (A) after remediation in fall 2019 when the channel was dry; (B) during freshet 2020 when the channel was wetted, showing a slight perch; and (C) during fall 2020 when channel was dry again and some additional repairs were made to the structure. Effectiveness of measures at this site are difficult to quantify due to the short period during which there is surface flow in this stream.

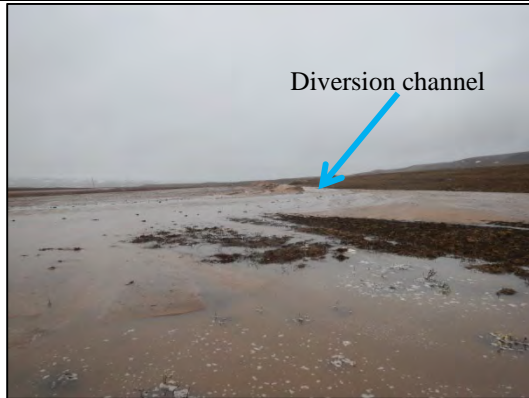
2020 Tote Road Stream Crossing Remediation – CV-030

During spring 2020, water was diverted from non fish-bearing crossing (CV-031), due to a frozen culvert, which caused ponding upstream of the crossing. The flow was diverted to a fish-bearing crossing (CV-030) to alleviate potential flooding of the road. Diverting stream flow was done as a safety and environmental measure to prevent washing out of the road embankment and resulting greater sedimentation of downstream fish bearing waters at the Muriel Lake outfall. This diversion caused flooding, erosion, and increased turbidity in the area of the stream at crossing CV-030. Water diversion was ceased after alleviation of flooding upstream of CV-031 shortly after peak freshet.

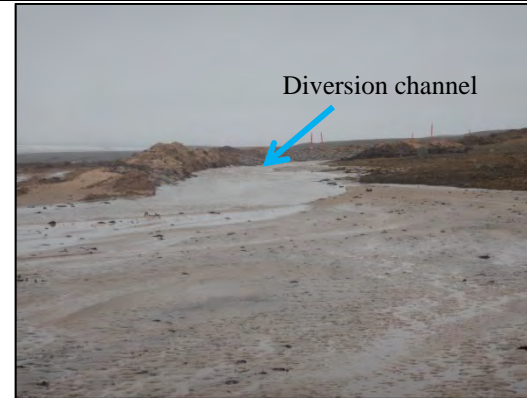
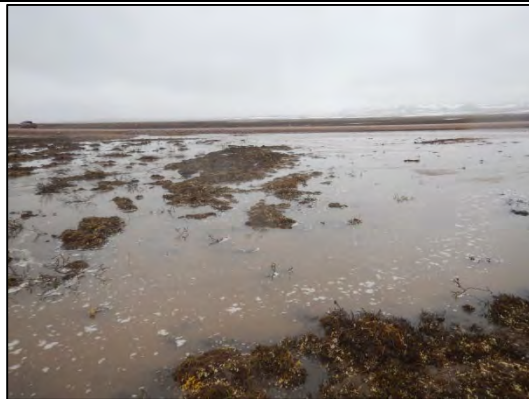
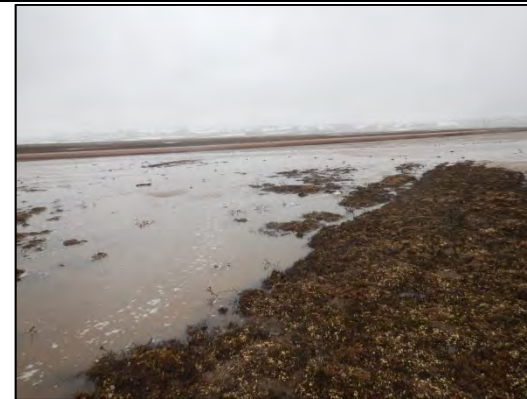
Photos 1: Photographs of the diversion of water from CV-031 to CV-030 in spring 2020: (A,B) the diversion channel from CV-031; (C,D) flooding, erosion and sedimentation at the upstream end of the CV-30 culverts.

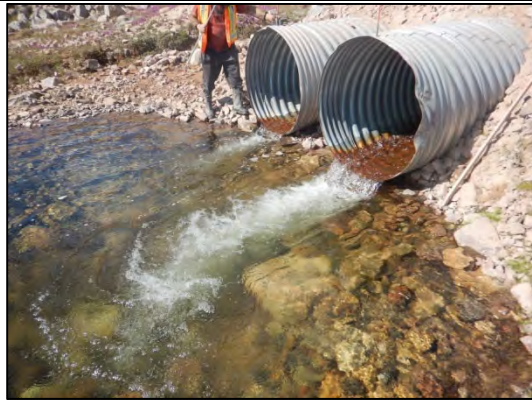
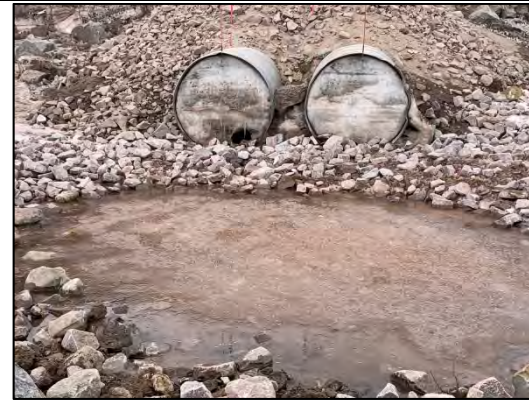
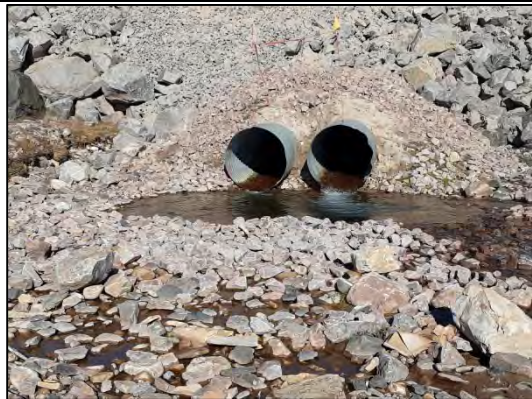
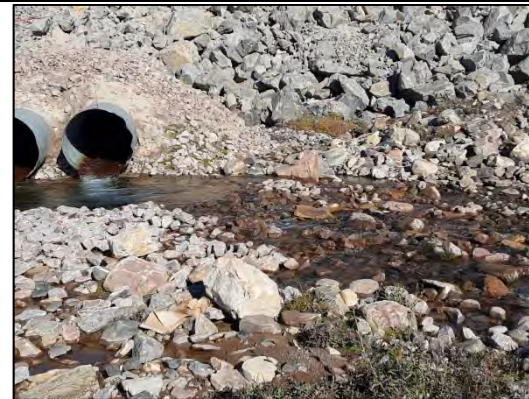
2020 Tote Road Stream Crossing Remediation – CV-225

Photos 1: Photographs of the downstream end of the perched culvert at CV-225: (A) in spring 2019; (B) following remediation works completed in early spring 2020; and (C, D) in fall 2020 showing reduction in perching and step-pool approach to the culverts..
